ADA Compliance Program

Clark County Facilities Transition Plan Public Works Operations Center

Date of Survey: November 5, 2007 and December 6, 2007

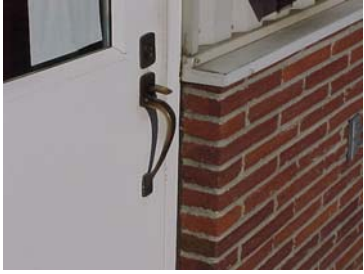
| | <p>Item # 3</p> <p>Issue: Inability to open door with a closed fist.</p> <p>Issue:</p> <p>Location: Public entrance (south side) Building A</p> <p>Code: ANSI 309 Operable Parts; 309.4 Operation – Operable parts shall be operable with one hand and shall not require tight grasping, pinching, or twisting of the wrist. The force required to activate operable parts shall be 5.0 pounds (22.2 N) maximum.</p> <p>Notes: Replace existing handle with lever action handle.</p> |

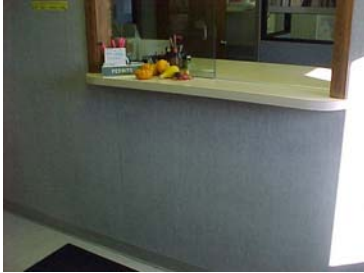
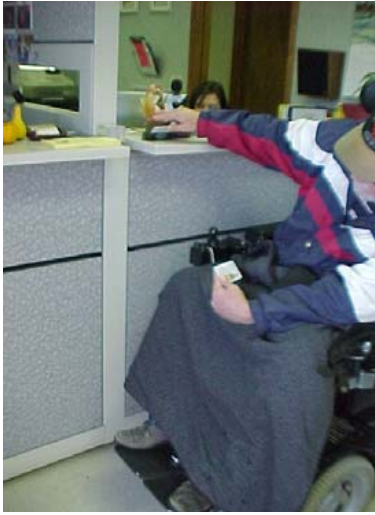
| <p>East Counter</p> <p>West Counter</p> | <p>Item # 4</p> <p>Issue: Counter height. Current height of west counter is 45"; east counter 43.5"</p> <p>Issue:</p> <p>Location: Lobby of Public entrance (south side) Building A</p> <p>Code: ANSI 904 Sales and Service Counters ANSI 904.3.1 Parallel Approach – A portion of the counter surface 36 inches minimum in length and 36 inches maximum in height above the floor shall be provided. (See entire code) ANSI 904.3.2 Forward Approach - A portion of the counter surface 30 inches minimum in length and 36 inches maximum in height above the floor shall be provided. (See entire code)</p> <p>Notes: Recommendations: Provide lower counter service.</p> |

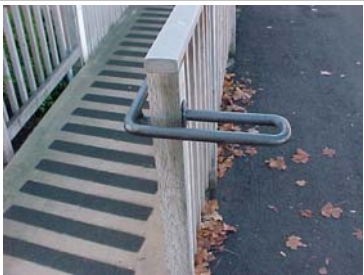
| | <p>Item # 5</p> <p>Issue: Handrail Extension</p> <p>Issue:</p> <p>Location: Conference center North side ramp</p> <p>Code: ANSI 505.10 Handrail Extensions – Handrails shall extend beyond and in the same direction of stair flights and ramp runs in accordance with Section 505.10. Exception – In alterations, full extensions of handrails shall not be required where such extensions would be hazardous due to plan configurations.</p> <p>Notes: Construct handrail to extend beyond and in same direction of ramp run. (Minimum - One side of ramp)</p> |

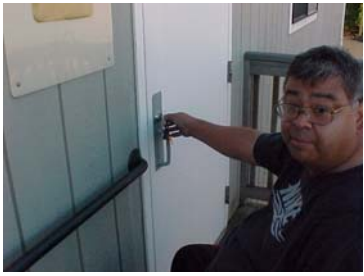
| | <p>Item # 6</p> <p>Issue: Inability to open door with a closed fist</p> <p>Issue:</p> <p>Location: Public entrance (North side) Conference Center</p> <p>Code: ANSI 309 Operable Parts; 309.4 Operation – Operable parts shall be operable with one hand and shall not require tight grasping, pinching, or twisting of the wrist. The force required to activate operable parts shall be 5.0 pounds (22.2 N) maximum.</p> <p>Notes: Also, this door requires the operator to simultaneously push the locking device while pulling the door to open. Replace existing handle with lever action handle.</p> |

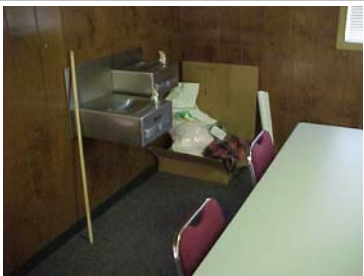
| | <p>Item # 7</p> <p>Issue: Clear floor space- Drinking Fountain</p> <p>Issue:</p> <p>Location: Conference Center</p> <p>Code: ANSI section 602 Drinking Fountains – ANSI 602.2 Clear Floor Space – A clear floor space complying with Section 305, positioned for a forward approach to the drinking fountain, shall be provided. ANSI Section 305 Clear Floor Space – Section 305.3 Size - The clear floor space shall be 48 inches minimum in length and 30 inches minimum in width.</p> <p>Notes: There is only 30" clearance (length) between table and drinking fountain. Move table as needed to provide necessary space for accessibility to drinking fountain.</p> |

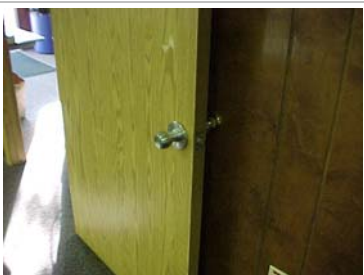
| | <p>Item # 8</p> <p>Issue: Inability to open door with a closed fist</p> <p>Issue:</p> <p>Location: Interior conference center door</p> <p>Code: ANSI 309 Operable Parts; 309.4 Operation – Operable parts shall be operable with one hand and shall not require tight grasping, pinching, or twisting of the wrist. The force required to activate operable parts shall be 5.0 pounds (22.2 N) maximum.</p> <p>Notes: Replace existing handle with lever action handle.</p> |

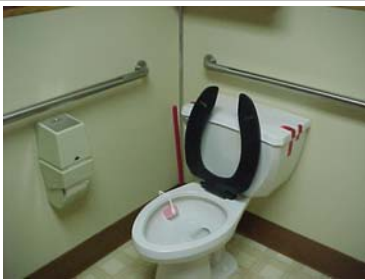
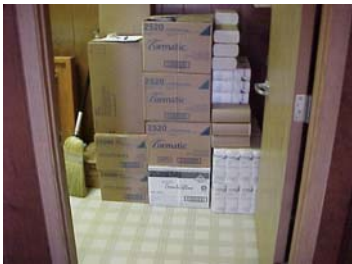
Item # 9
 Issue: Vertical Grab Bars
 Issue: Forward Reach
 Issue: Flush Controls
 Issue: Clear Floor Space
 Location: Conference Center
 Code: ANSI 604.5.1 – Vertical Grab Bar

Notes: There are two family restrooms identified as accessible on the west end of the conference center both of which need some corrective measures.

Access blockage due to stored items - Remove items from NW restroom

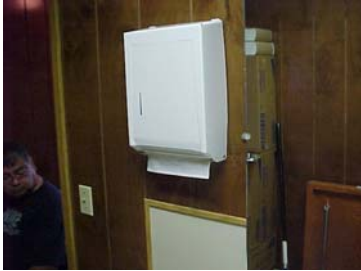
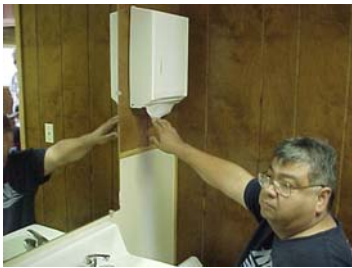
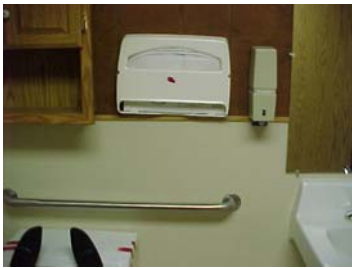
Code: Issue: Flush control location in SW restroom
 ANSI 604.6 Flush Control – Flush controls shall be hand operated or automatic. Hand operated flush controls shall comply with Section 309. Flush controls shall be located on the open side of the water closet.

Forward reach height of the towel dispensers is currently 56 inches high. Toilet seat cover dispenser height is currently 49.5" high in the SW restroom.

Code: ANSI 308.2 Forward Reach – 308.2.1 Unobstructed – Where a forward reach is unobstructed, the high forward reach shall be 48 inches maximum and the low forward reach shall be 15 inches minimum above the floor. All dispensers should be checked for correct height installation and lowered as needed.
 Recommendation: Lower dispensers per ANSI code.

Place flush control on open side of toilet in SW restroom.

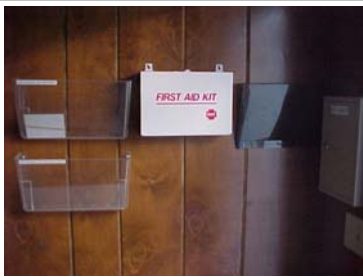
Item # 10
Issue: Forward reach height of the dispenser is currently 57.25 inches high and is obstructed by a small rectangular table.
Issue:
Location: Conference Center - First Aid Kit – Building B-1
Code: ANSI 308.2.2 Forward Reach – Obstructed High Reach – Where a high forward reach is over an obstruction, the clear floor space shall extend beneath the element for a distance not less than the required reach depth over the obstruction. The high forward reach shall be 48 inches maximum where the reach depth is 20 inches maximum. Where the reach depth exceeds 20 inches, the high forward reach shall be 44 inches maximum, and the reach depth shall be 25 inches maximum.
Notes: Lower the First Aid dispenser as required by code.

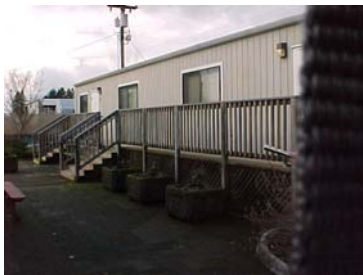
Item # 11
Issue: There are three entrances in to Building B-1. Per code, 60% of the entrances into this building must be accessible. Currently, only the North side entrance is accessible.
Issue:
Location: Conference Center
Code:
Notes: A ramp needs to be constructed on the South side of Building B-1. The ramp must meet slope and distance requirements for accessibility.

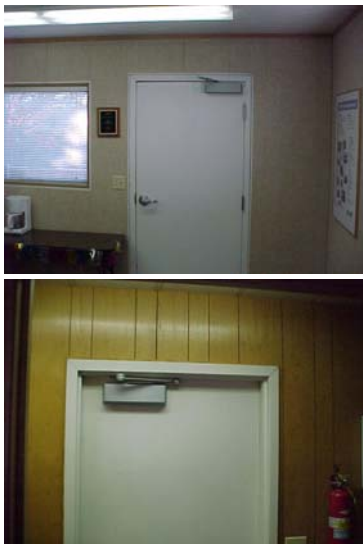
Item # 13
Issue: Signage - No exit signs
Issue:
Location: Two interior exit doors from small conference room
Code:
Notes: ANSI 1011.3 Tactile Exit Signs – A tactile exit sign stating EXIT and complying with ICC A117.1 shall be provided adjacent to each door to an egress stairway, an exit passageway and the exit discharge.
