2008 Stormwater Needs Assessment Program

Salmon Creek (RM 03.83)/Cougar Creek
Subwatershed Needs Assessment Report

Clark County Public Works Clean Water Program

April 2009

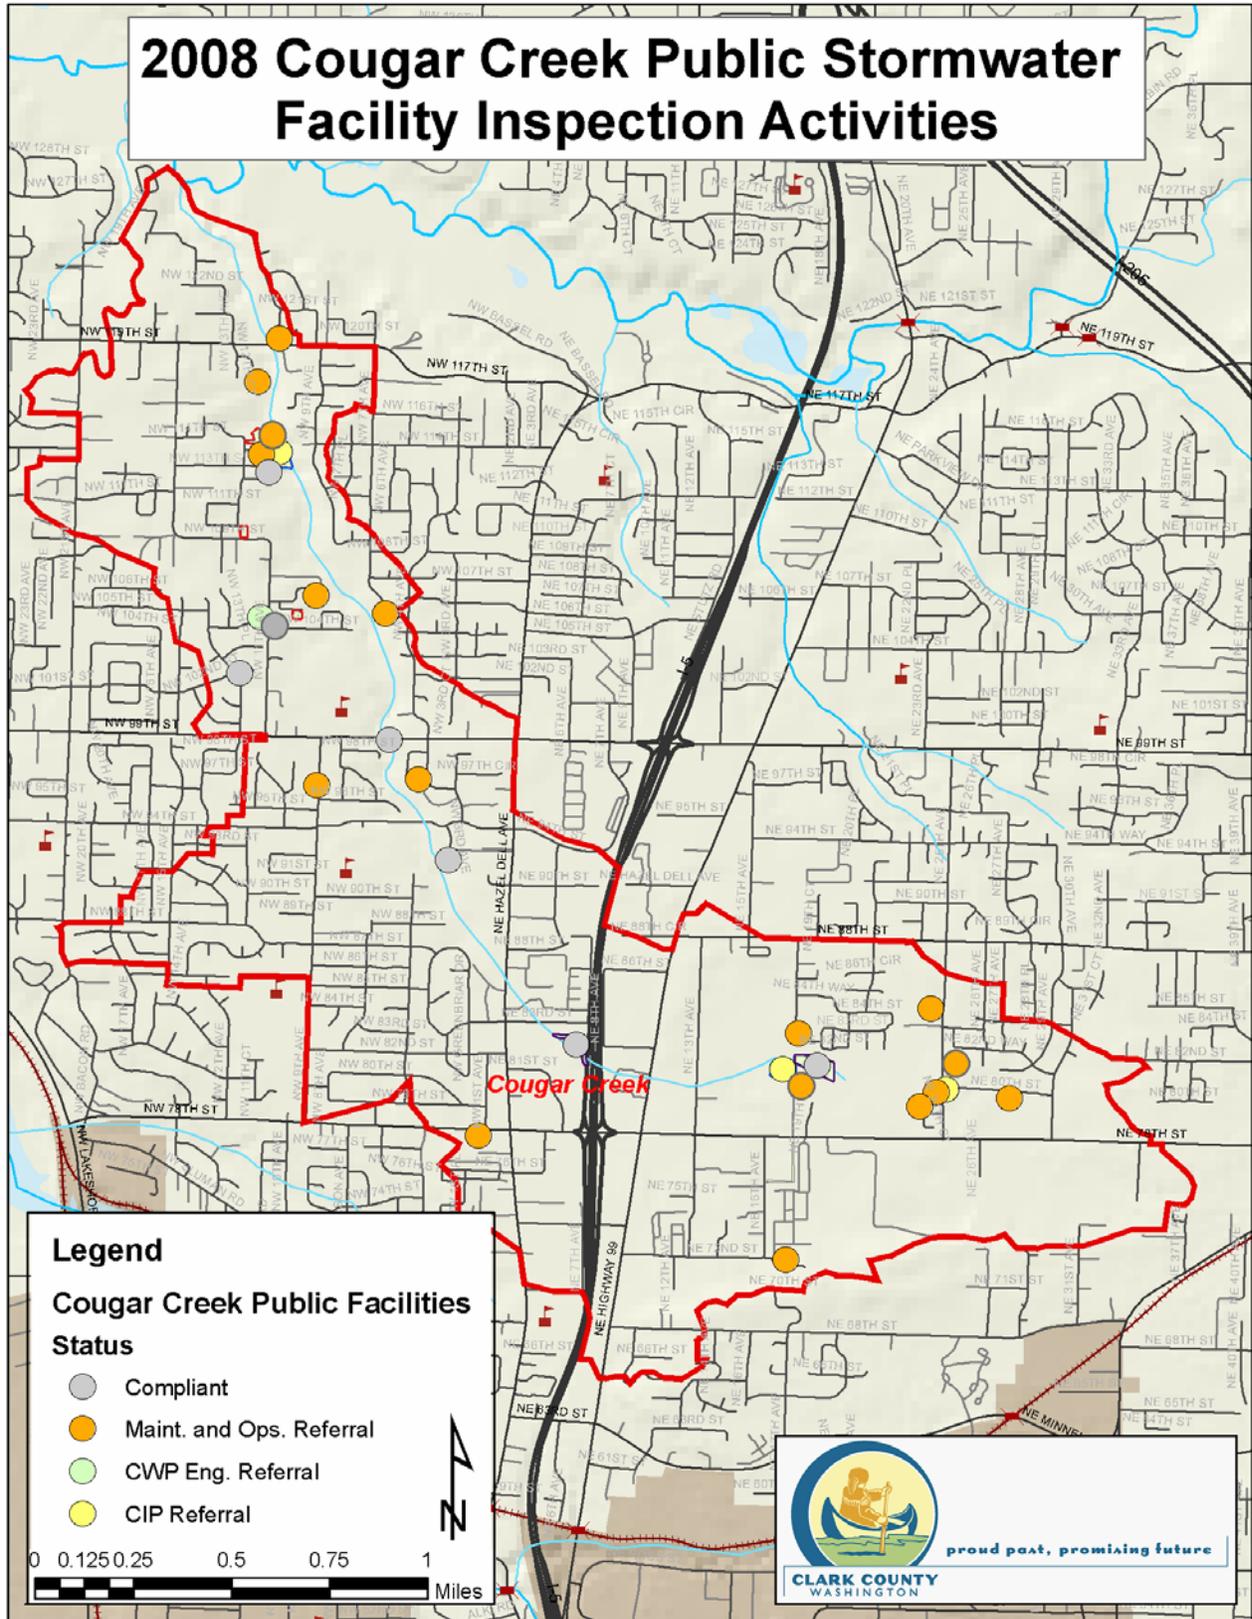
Figure 5: Summary of 2008 Public Stormwater Facility Inspection Activities in the Cougar Creek Subwatershed

The most common facility objects found out of compliance during the public stormwater facility inspection process were energy dissipaters, bioswales, and lack of stormwater facility signage. Excessive sedimentation was the most common noncompliant defect across facility objects. Vegetative management issues were the most common noncompliant defects regarding bioswales. These defects included overgrown bioswales where grasses exceeded 10 inches in height with nuisance weeds and other vegetation starting to take over.

Approximately 45 percent of public stormwater facilities were missing signage. Correcting facility sedimentation issues and maintenance of bioswales, and adding appropriate signage will bring most facilities into compliance.

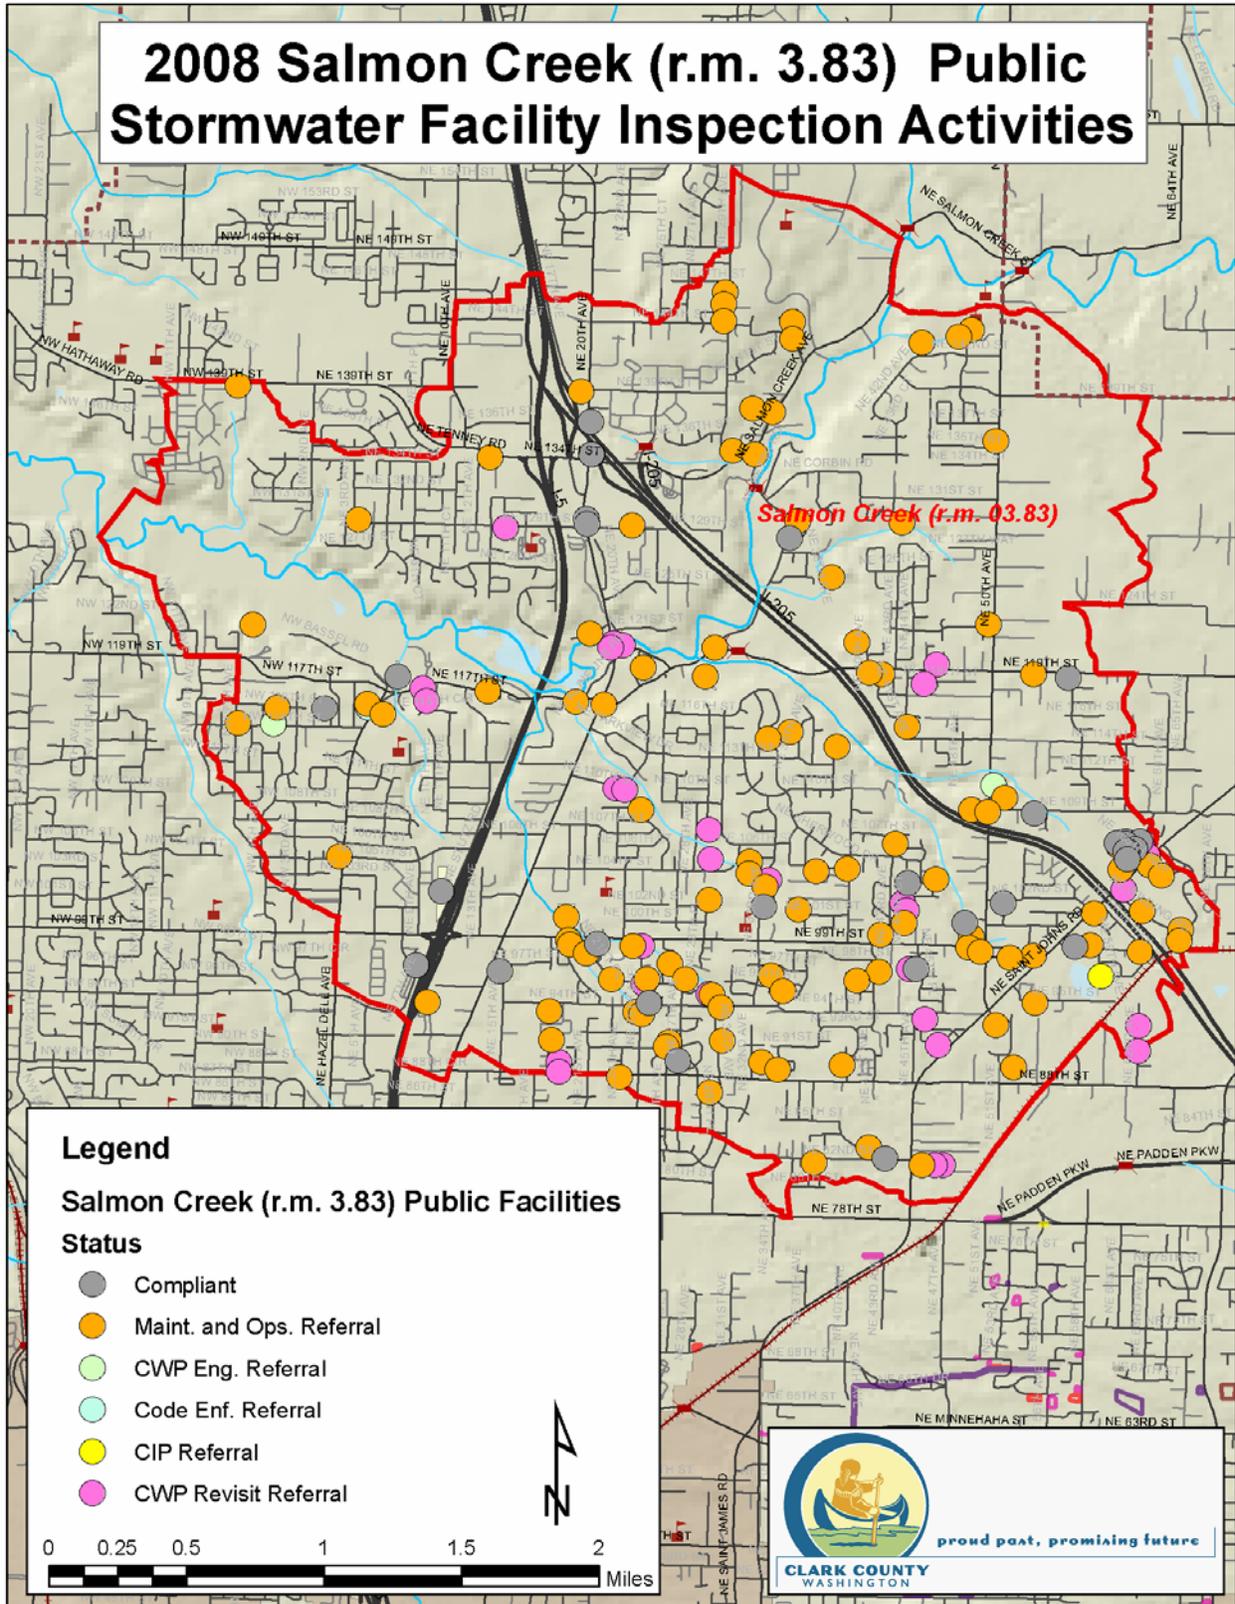
Figure 6: Summary of 2008 Public Stormwater Facility Inspection Activities in the Salmon Creek (RM 03.83) Subwatershed

The most common facility objects found out of compliance during the public stormwater facility inspection process were flow control structures, conveyance stormwater pipes, energy dissipaters, bioswales, and lack of stormwater facility signage. Excessive sedimentation was the most common noncompliant defect across facility objects. Sedimentation defects were the common noncompliant issue for flow control structures, conveyance stormwater pipes, sediment traps, and energy dissipaters. Vegetative management issues were the most common noncompliant defects regarding bioswales. These defects included overgrown bioswales where grasses exceeded 10 inches in height with nuisance weeds and other vegetation starting to take over. Approximately 33 percent of public stormwater facilities were missing signage. Correcting facility sedimentation issues and maintenance of bioswales, and adding appropriate signage will bring most facilities into compliance.

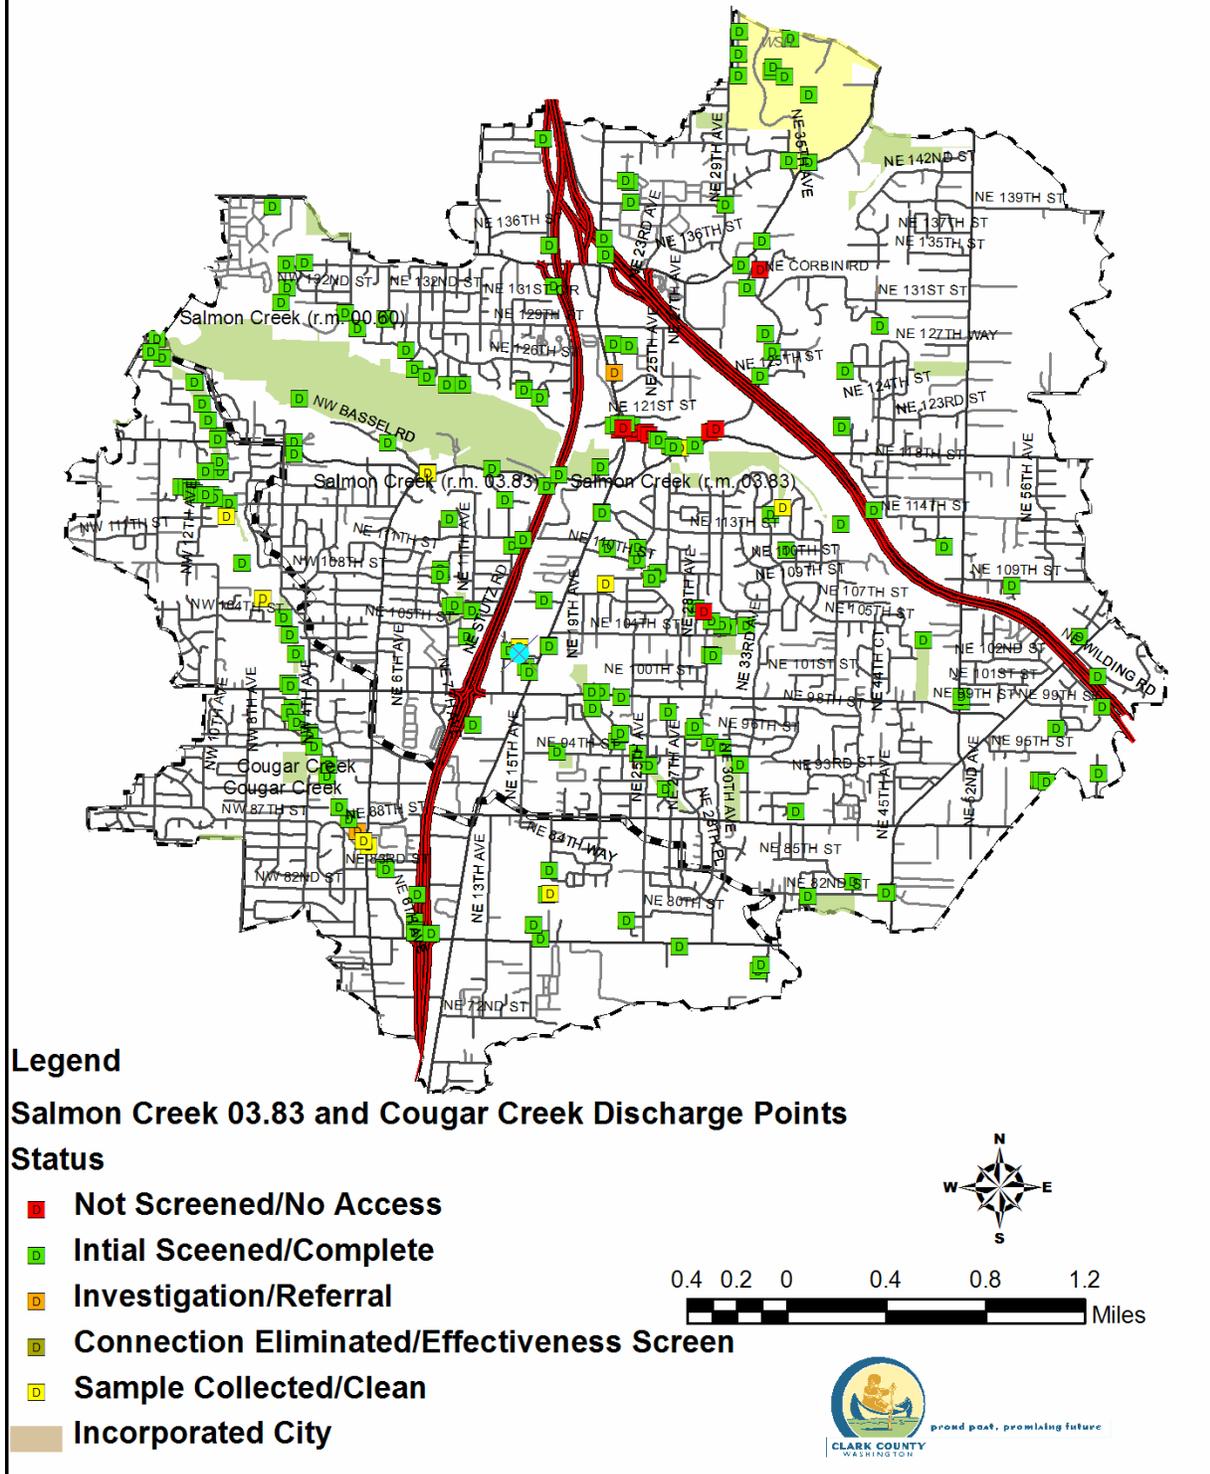
Figure 9: 2008 IDDE Screening Project in Salmon Creek (RM 03.83) and Cougar Creek Subwatersheds

Clark County Development Inspector found "Floatables" in a county storm water facility at Teal Pointe (Unique ID 022) on March 7, 2008.

Clark County IDDE staff noticed soapy water running from a motorcycle dealership across a parking lot and entering catch basin that drains to a county stormwater facility (Unique ID 1254) on September 4, 2008. Investigation GM15041 was initiated by visual confirmation, no samples were taken. The site was referred to code enforcement and an on-site investigation was coordinated with CWP section Waste Reduction Specialist. Soap run-off was determined to be motorcycle washing in the shop area. Removal activities included education outreach with both business managers and property owners on September 8, 2008. Business will attempt to reduce use of soap in wash water. Wash water enters a treatment facility where it is appears to get proper treatment.

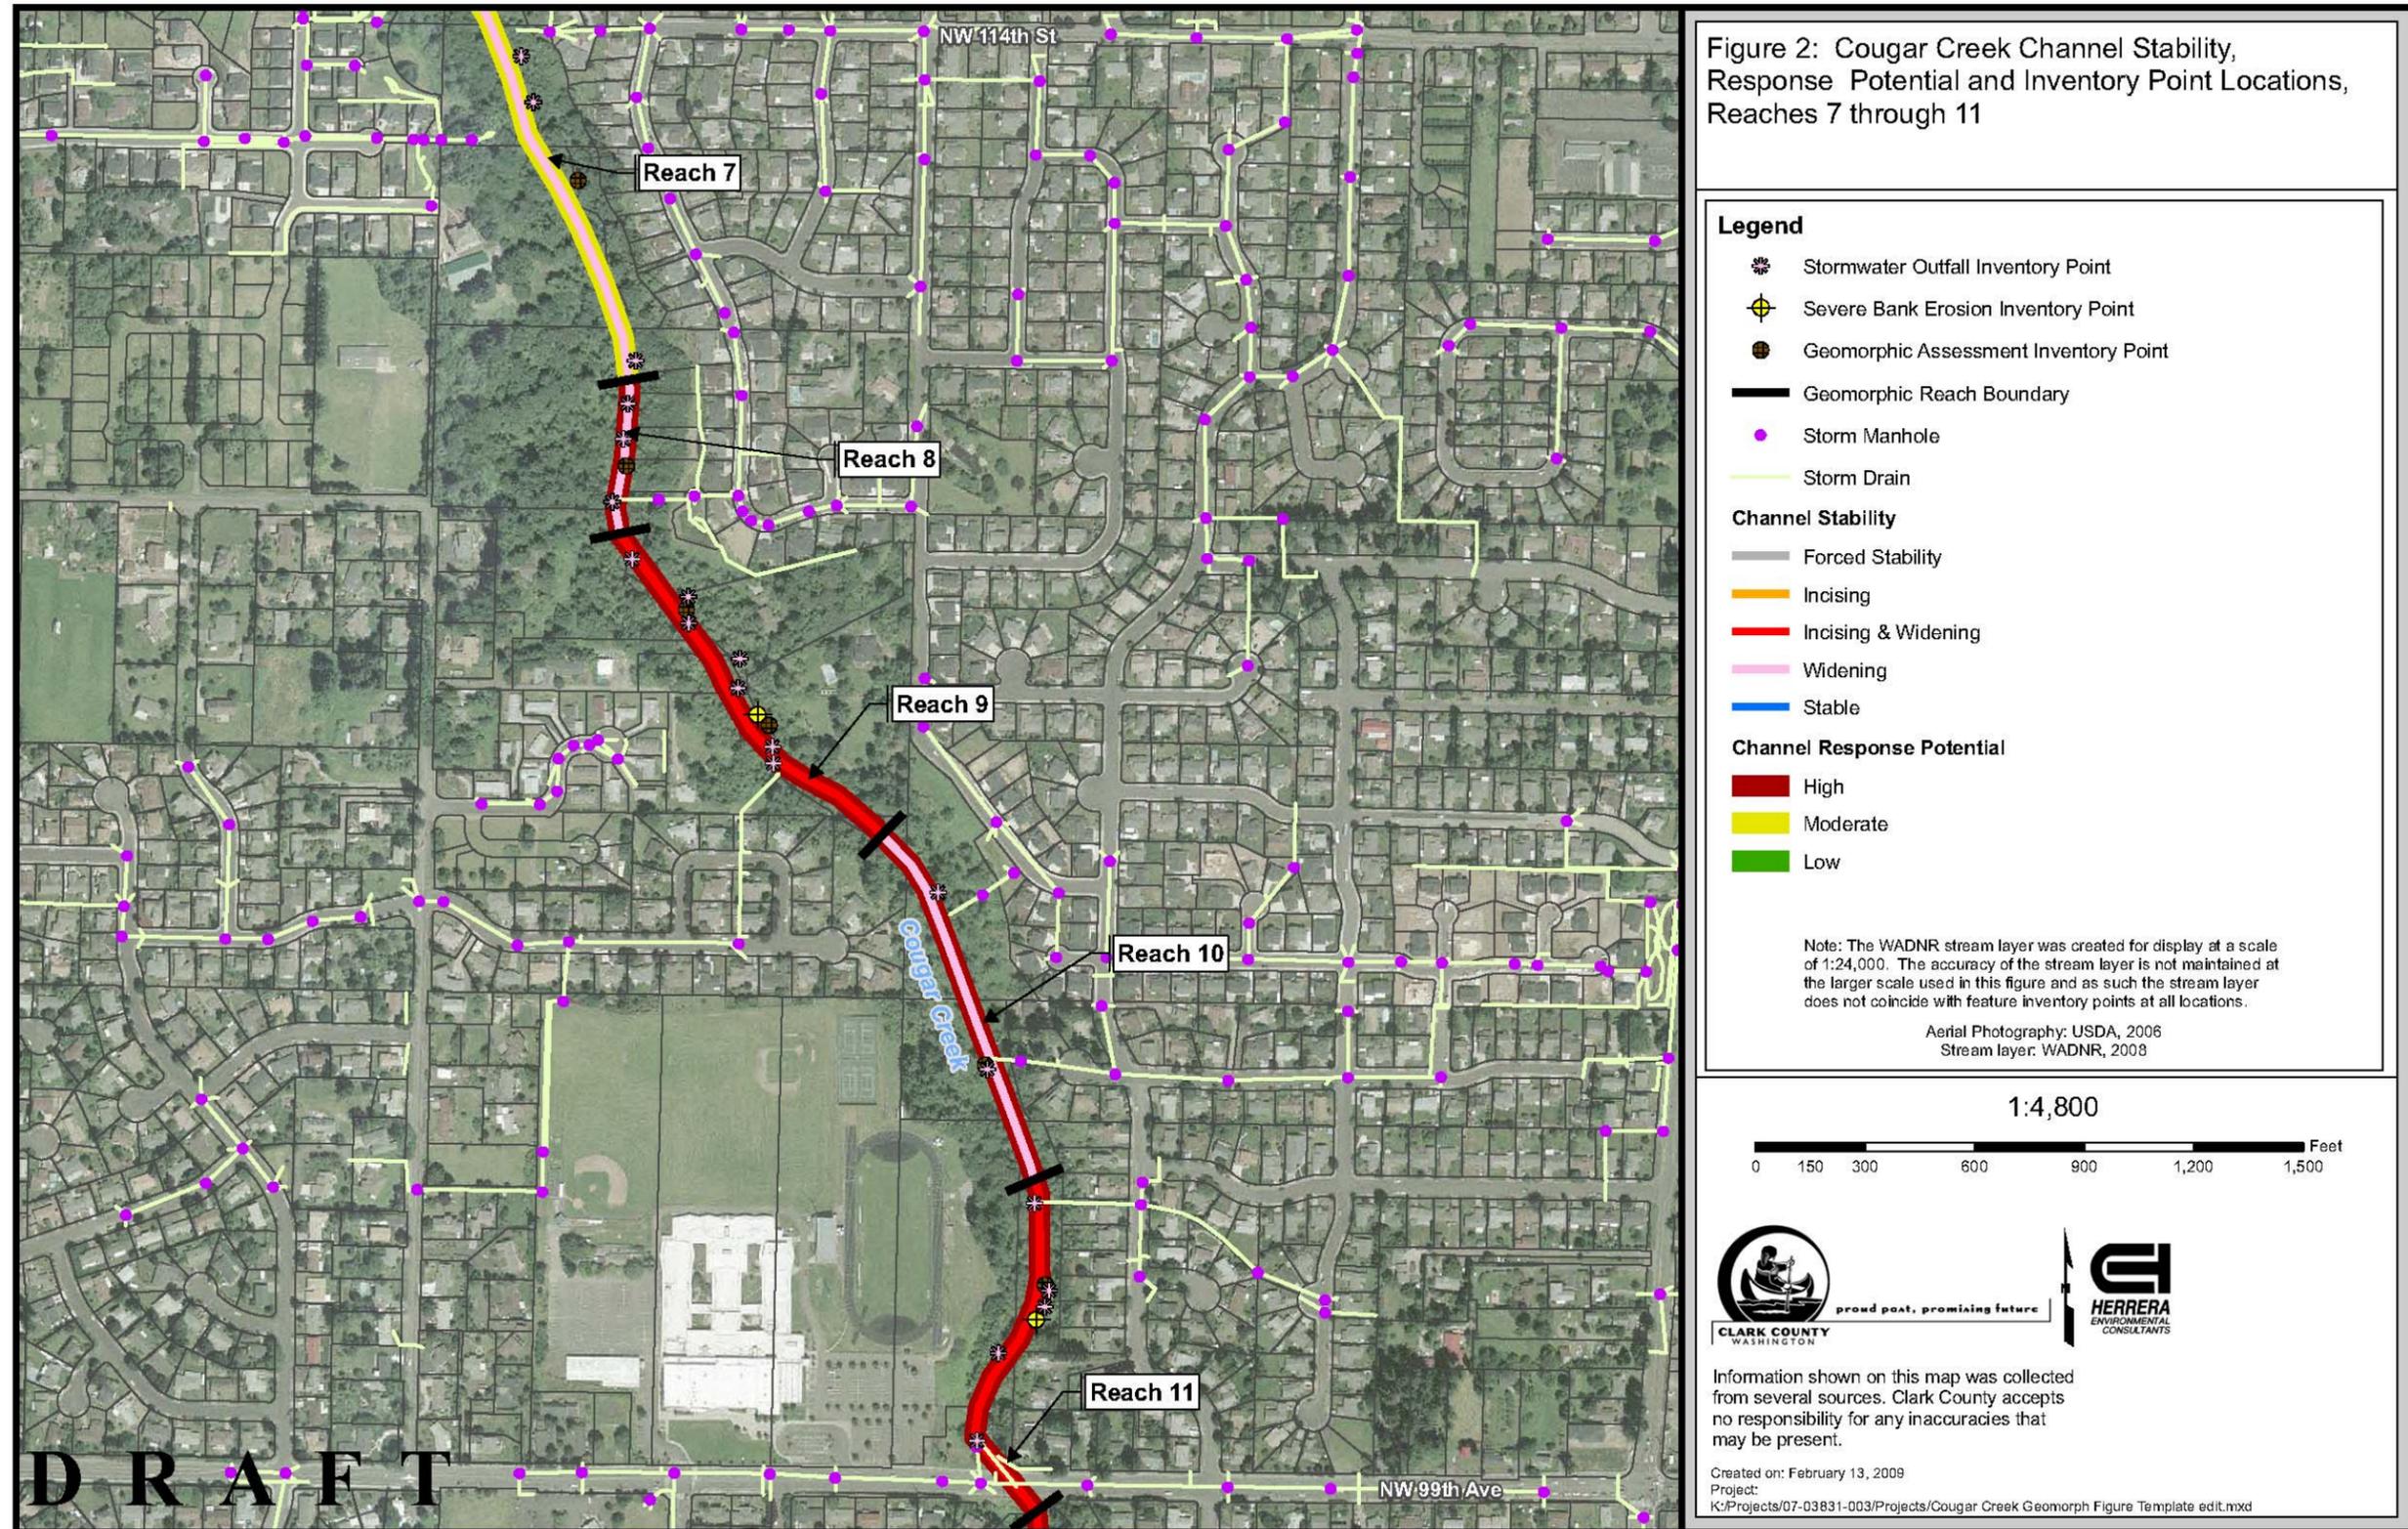
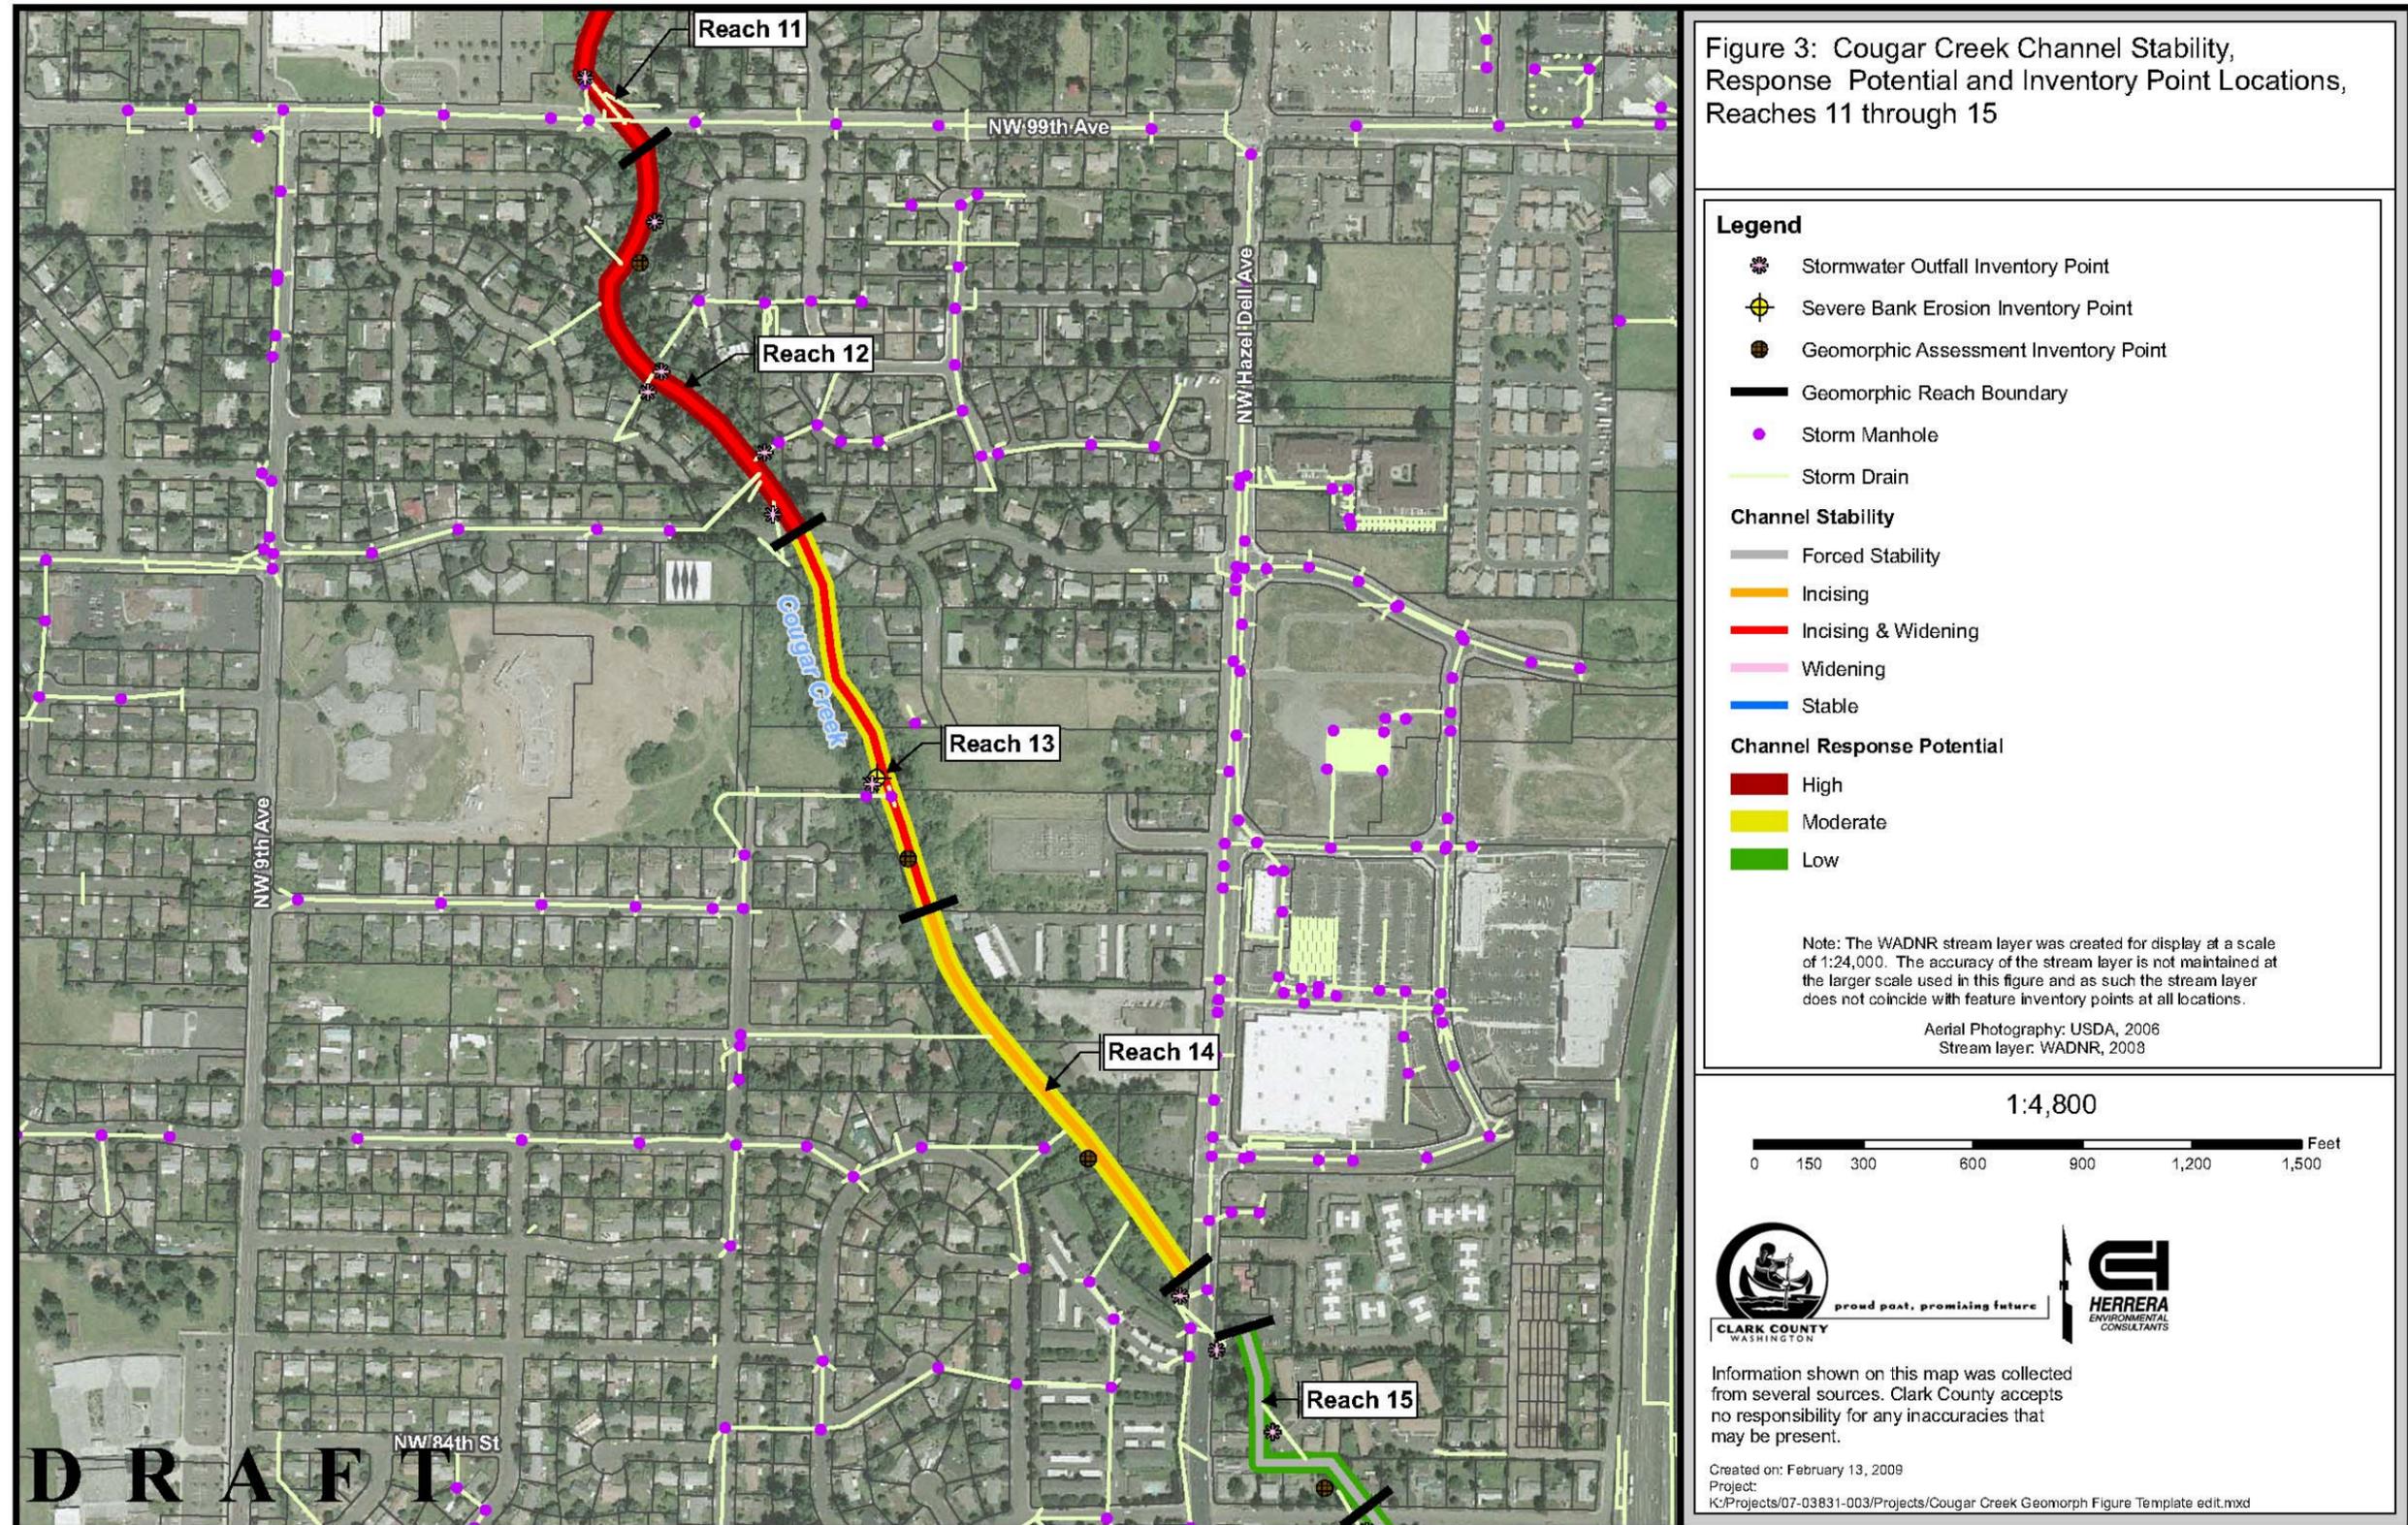
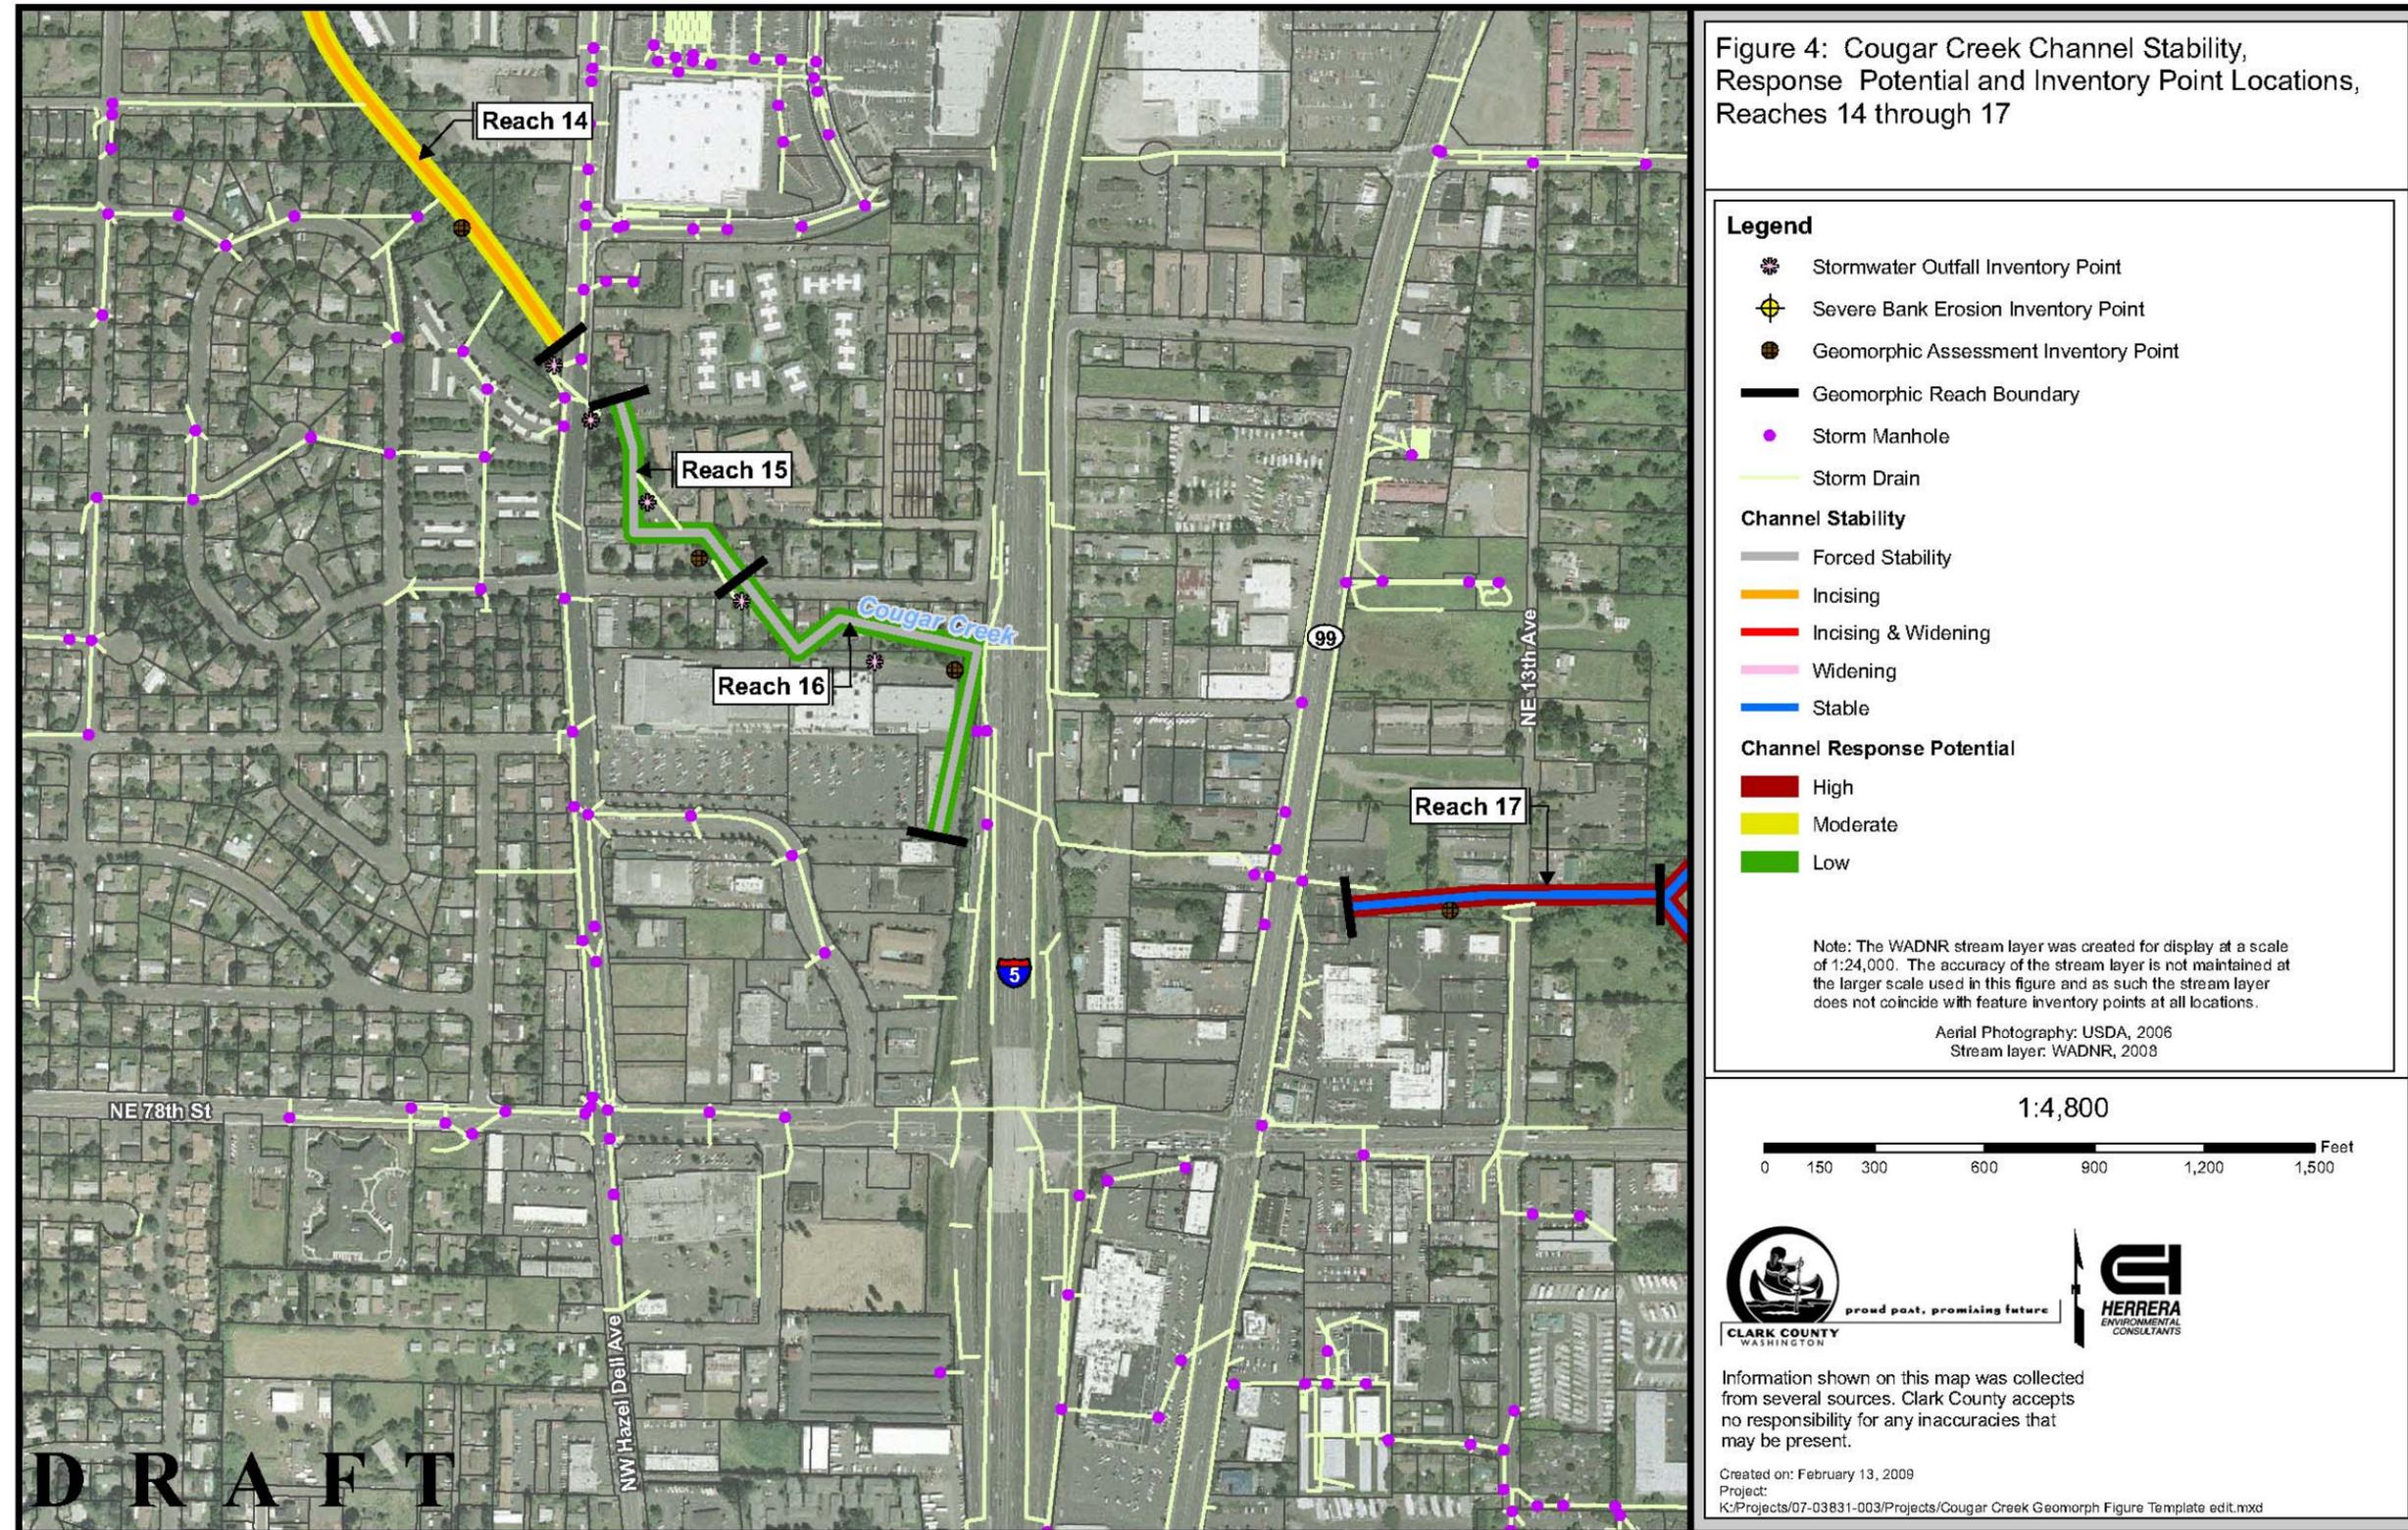
Middle Cougar Creek (Reaches 6 through 16) extends from NW 119th St upstream to the drainage system beneath Interstate 5 (I-5) (Figures 13 through 15). The reaches in middle Cougar Creek demonstrate the greatest impacts of past and ongoing changes in watershed land use and the hydrologic regime. In contrast to lower Cougar Creek, middle Cougar Creek generally has a moderate to high channel response potential. The only exceptions are Reaches 15 and 16 which are hardened by bank armoring and were therefore classified as having forced channel stability and a low response potential. Urban residential land use characterizes much of the middle portion of the watershed. A protected riparian buffer exists along most of the channel, with the exception of the reaches farthest upstream (Reaches 15 and 16), where Cougar Creek weaves through residential backyards and is channelized along lot boundaries.

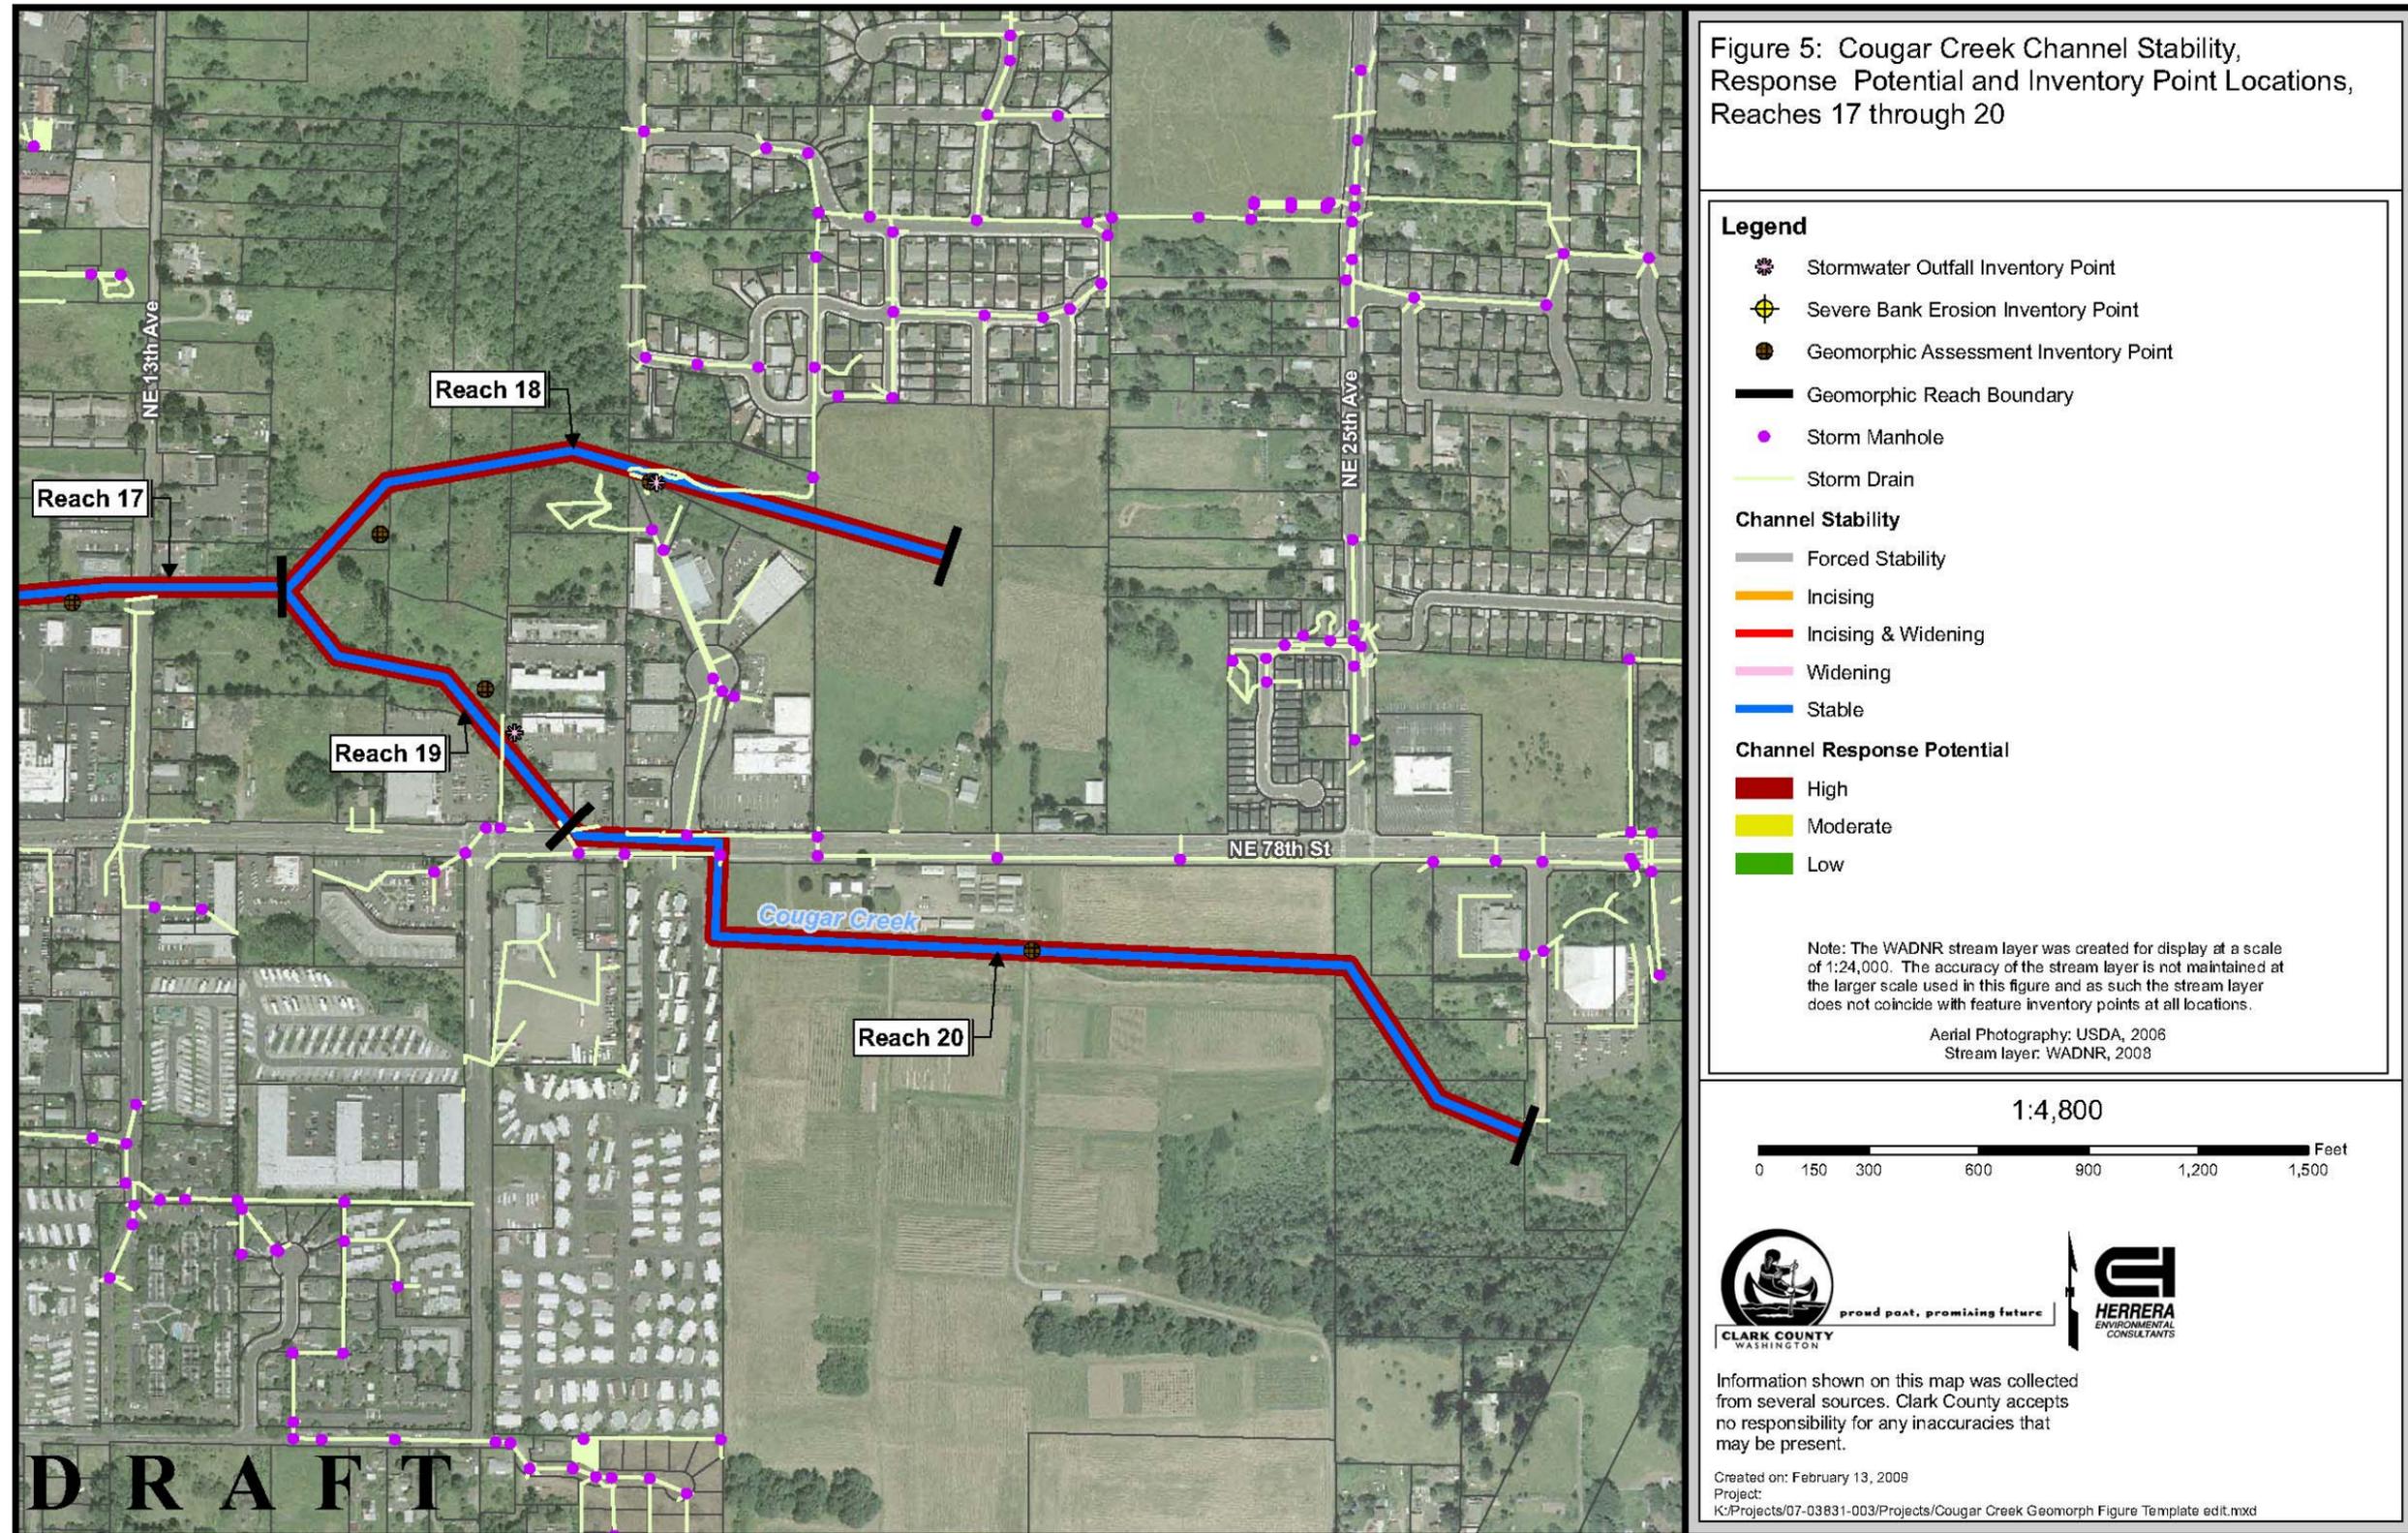
Figure 16: Cougar Creek: Channel Stability, Response Potential and Inventory Point Locations, Reaches 17 through 20.

Upper Cougar Creek (Reaches 17 through 20) extends from the storm drainage network under I-5 to the backwaters located in pastures and open wetland fields east of Highway 99 (Figures 4 and 5). Upper Cougar Creek is naturally broad and flat and was historically characterized by wetlands formed on depressions in cataclysmic flood deposits. The channel bed and banks predominantly composed of fine material. The upper Cougar Creek watershed includes a variety of land uses that have altered the hydrologic regime, including agricultural, industrial, residential, commercial, and transportation uses. There are stormwater contributions from NW 78th Street, as well as from the urban residential developments and the commercial and industrial land uses that lie adjacent to headwater wetlands and channel. However, there is still significant open space in this portion of the subwatershed, providing unique opportunities to preserve and restore natural hydrologic function and geomorphic processes. At the same time, upper Cougar Creek has a high potential to respond unfavorably to future development of these open spaces.

The downstream limit of Reach 17 is the storm drain network that conveys the flow below parking lots, Highway 99, and I-5. The open channel of Reach 17 continues upstream to the confluence of two tributaries (here termed the south and north tributaries), located just east of NE 13th Avenue (Figure 16). The riparian vegetation downstream of NE 13th Avenue is dominated by invasive vegetation, including reed canary grass, Himalayan blackberry, and cattails. There is no overstory and no distinctive channel form. Instead the water filters through a 50- to 80-foot-wide floodplain composed of fine sediment and full of dense, invasive vegetation. The dense vegetation and fine wetland sediments cause a backwater condition through the culvert beneath NE 13th Avenue. On the day of the geomorphic survey, backwater filled two-thirds of the culvert. It is possible that some of the backwater observed was compounded by high groundwater levels at the time of the observations. There is some deciduous canopy upstream of NE 13th Avenue, but invasive vegetation such as Himalayan blackberry, reed canary grass, and nightshade, surround the creek. Throughout the reach, the channel type was characterized as wetland; however, portions of the reach exhibit modified or excavated characteristics and it is likely that the channel was at one time excavated or realigned and has subsequently become infested with invasive vegetation.
