# Chelatchie Prairie Railroad

## Improvement of Crossing at 119<sup>th</sup> Street

# June 2014 Repair

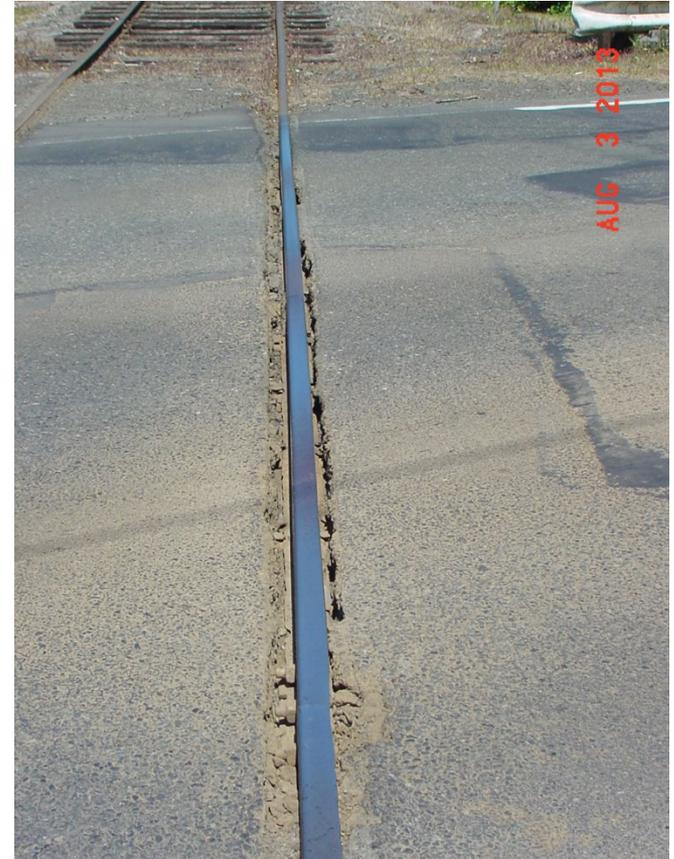
- Crosstie, track, and crossing surface condition were all deteriorated such that the motoring public (and non-motorized facility users such as bicyclists) were subject to risk. Additionally, the railroad risked derailment due to widening gauge resulting from these conditions.
- 
- This photo shows the condition of the East rail at this crossing in 2013. The railroad tie condition deteriorated to the point the rail was “floating” above the grade. Traffic on 119<sup>th</sup> Street struck this rail when passing through the grade crossing. The bond wire for the crossing signal was broken rendering the crossing signal inoperable.
- 
- There were no reported accidents or incidents, but as the condition of the crossing rapidly deteriorated safety concerns increased.
