CLARK COUNTY STAFF REPORT

REQUESTED ACTION: Approve the 2017 Annual Bridge Report

2017 Annual Bridge Report

Prepared by David Dolan, P.E.
Clark County Public Works, Engineering and Construction Division
Submitted June 2018

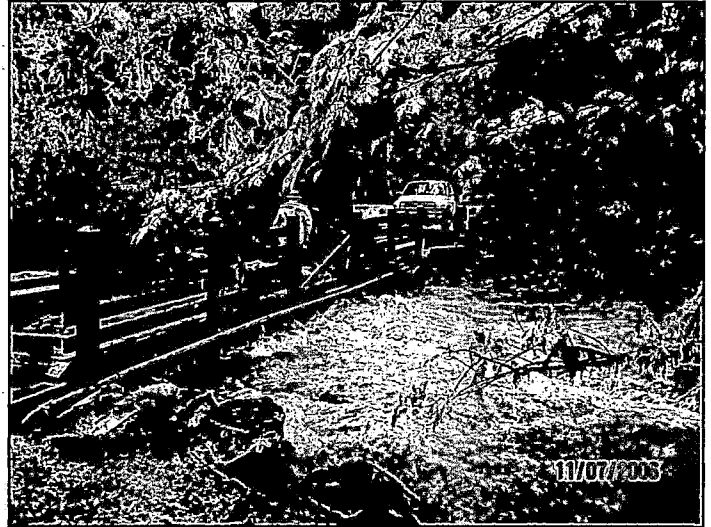
High flow at scour critical bridge.

Thirteen county bridges are considered scour critical and require special inspection after storms for erosion, debris and stream bank instability. As a result of these post-flooding inspections, several county bridges were submitted for scour mitigation preventative maintenance grants. One bridge, Davis Bridge No. 232, is scheduled for replacement.
