78th Street Heritage Farm Preservation & Maintenance Plan

County Council Work Session, Aug. 8, 2018, 6th Floor Training Room

Preservation and Maintenance Plan

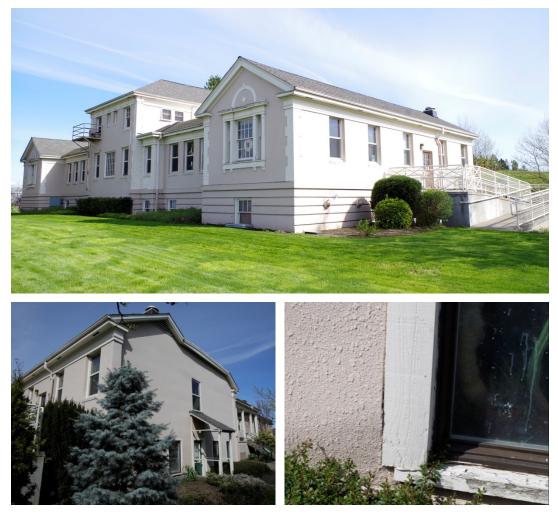
Administration Building (1926)

- Water infiltration behind insulated panels
- Improper flashing over windows
- Organic growth of roof
- Unattached post and beam frame
- Water damage in basement laboratory

Overall Condition: Good

Immediate – Minor Repair broken cornice return. Repair exterior wood trims and make watertight. Remove peeling paint and rust and repaint. Repair and repaint damaged interior doors. 	 Long Term – Minor/Maintenance Remove biological growth. Prevent animal infestation. Infill and repaint cracks in floors and ceilings.
 Immediate – Major Inspect and repair or replace EIFS system on south elevation's west wing. 	 Long Term – Major Restore the original main entrance. Evaluate post-and-beam structure for seismic capacity.

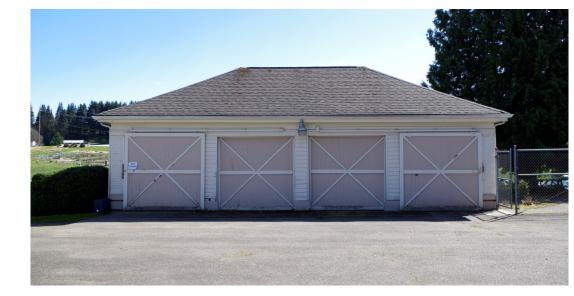
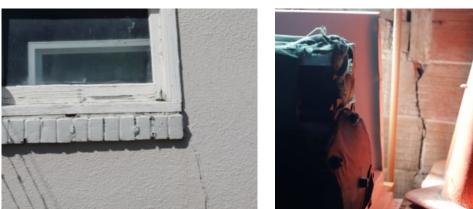
Garage (1926)

Overall Condition: Fair

- Cracking in structural tile on east elevation
- Cracking in structural tile under windows
- Organic growth of roof
- Crumbling mortar on window sills
- Broken wood window frame

Immediate – Minor Repair missing horizontal board siding. Repair broken window frames. Prepare surfaces and repaint peeling paint and rust. Repair and finish exterior walls structural cracking. 	 Long Term – Minor/Maintenance Remove biological growth. Monitor structural cracks. Infill and repaint cracks in floor. Removed abandoned electrical wiring.
Immediate – Major • N/A	 Long Term – Major Finish walls and ceilings. Insulate building. Install new electrical system. Install new mechanical equipment.

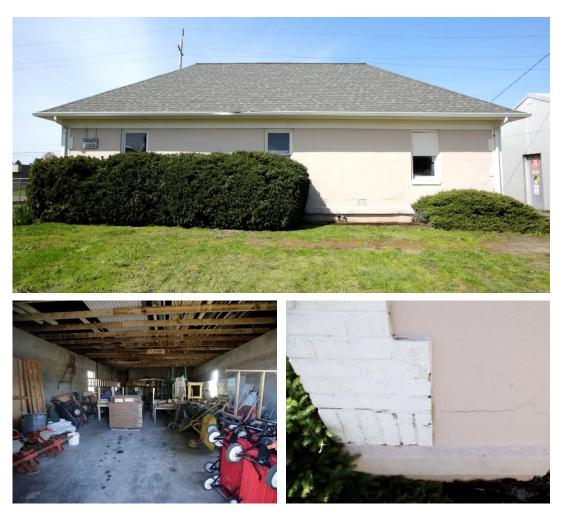
Milk House (c. 1936)

- Structural cracking at southeast corner
- Cracking in exterior stucco
- Exposed structural tile
- Organic growth on foundation
- Rotting wood on doors

Overall Condition: Good

Immediate – Minor	Long Term – Minor/Maintenance
 Replace rotting wood door panels. Repair and refinish structural cracking. 	 Remove biological growth. Repair damaged aluminum gutter Remove abandoned electrical wiring. Infill and repaint exterior cracks in stucco. Infill and repaint exposed structural block. Repair and repaint peeling paint. Infill and repaint cracks in floor and ceiling.
Immediate – Major	Long Term – Major
• N/A	Finish walls and ceilings.
	Insulate building.
	 Install new electrical system.
	 Install new mechanical equipment.

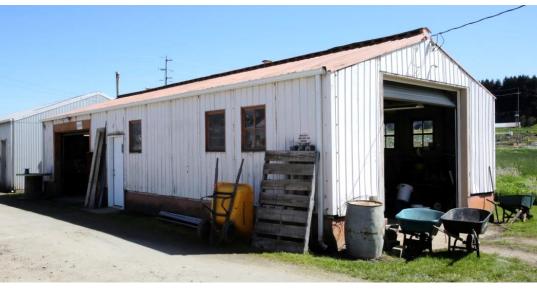
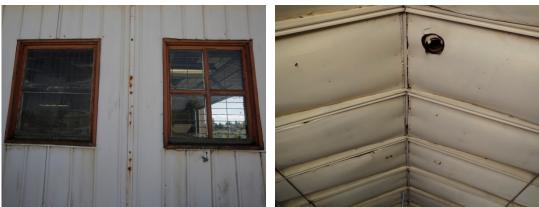
Agricultural Shop (1962)

- Organic growth on foundation
- Rust on metal siding
- Rotting wood window frames
- Sagging ceiling wood boards
- Abandoned chimney openings

Overall Condition: Fair

Immediate – Minor Repair rotting window frames. Replace sagging wood ceiling boards. Infill abandoned chimney opening. 	 Long Term – Minor/Maintenance Remove biological growth. Repair and replace wood windows. Infill cracks in floors. Remove abandoned electrical wiring. Replace wall panels.
Immediate – Major • N/A	 Long Term – Major Replace roof. Replace exterior metal panel siding.

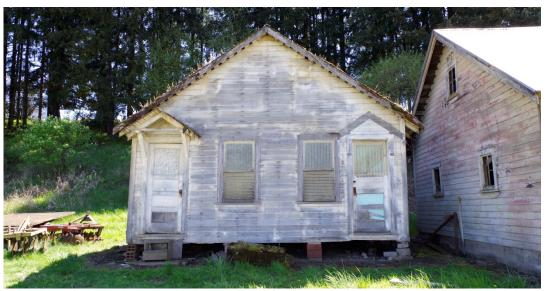
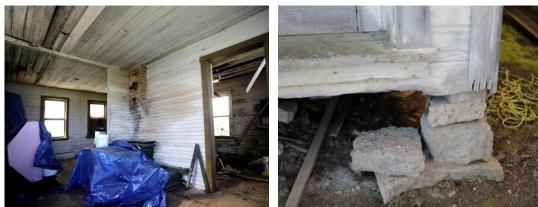
Bunk House (c. 1925/c.1955)

- Lacks permanent foundation
- Leaning exterior walls
- Collapsing roof
- Sagging floor boards
- Collapsing ceiling
- No accessible entry (no stairs)

Overall Condition: Poor

Immediate – Minor	Long Term – Minor/Maintenance
 Secure entries to prevent unsafe access to building interior. 	 Interpret building's Poor Farm history.
Immediate – Major	Long Term – Major

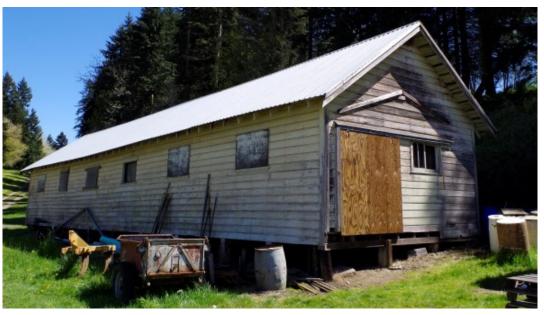
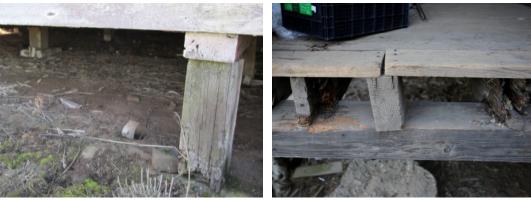
Hog Barn (c.1920/c.1955)

- Lacks permanent foundation
- Deficient foundation beams
- Sagging roof
- Rotting floor joists
- No accessible entry (no stairs)

Overall Condition: Poor

Immediate – Minor Remove and repaint peeling paint. Replace missing windows. Replace rotting wood door. Repair rotting floor joists. Install formal entry. 	 Long Term – Minor/Maintenance Remove and repaint interior peeling paint. Remove abandoned electrical wiring.
Immediate – Major Replace foundation. Replace roof. 	Long Term – Major ● N/A

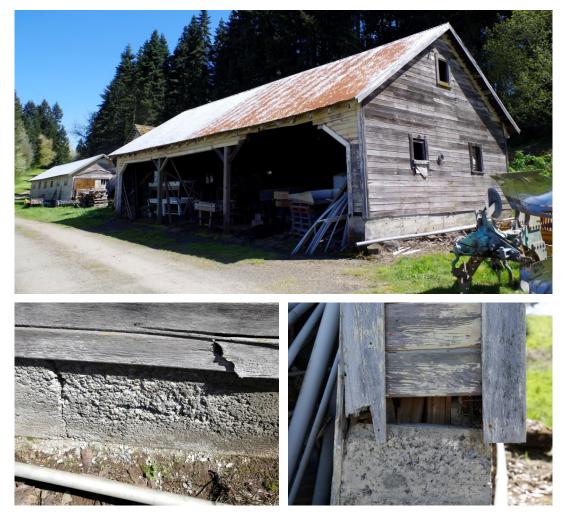
Machine Shed (c.1930)

- Cracks in foundation
- Spalling concrete on foundation
- Rotting wood framing members
- Rotting wood siding
- Sagging and missing bay headers

Overall Condition: Fair

Immediate – Minor	Long Term – Minor/Maintenance			
 Infill and repair foundation. Repair rotting wood posts. 	Remove biological growth.			
	 Repair and install missing bay headers. Remove and repaint peeling paint. 			
	 Repair rotting wood siding. 			
	Replace missing wood windows.			
	Remove abandoned electrical system.			
	 Interpret building's Poor Farm history. 			
Immediate – Major	Long Term – Major			
• N/A	Replace roof.			
	Finish walls and ceilings.			
	Insulate building.			
	Install new electrical system.			
	Install new mechanical equipment.

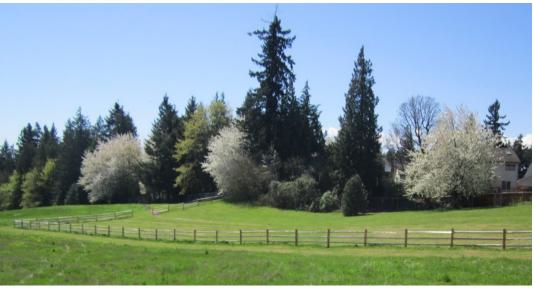
Cemetery (1913) Current Use: Cemetery

Overall Condition: Good

- Commemorative boulder at northwest corner
- Missing burial makers
- Wood fence delineates cemetery boundary
- Chain link fence at west end
- Vegetation abuts north access

Immediate – Minor	Long Term – Minor/Maintenance
Install interpretive sign.	 Identify and locate individuals buried in cemetery. Improve north access to cemetery. Consider relocation of commemorative boulder.
Immediate – Major	Long Term – Major
• N/A	• N/A

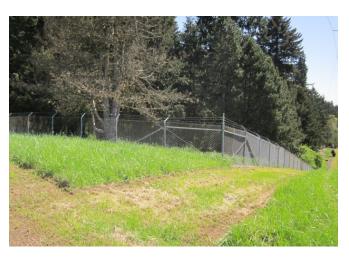
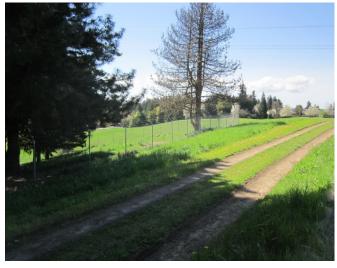
Hazel Dell Park Current Use: Cemetery

– Security concerns

Overall Condition: Good

- Security concerns
- Preserve wooded setting
- Interpret historic use and park development
