REQUEST FOR REVIEW AND COMMENT ON PROPOSED REMOVAL OF BUILDINGS AT THE HOUSE OF PROVIDENCE ACADEMY

The city received a request to demolish and remove demolish the Laundry and Boiler Buildings, Boiler Smokestack, and the El Presidente Restaurant on the House of Providence site at 400 East Evergreen Boulevard.

Laundry Building, Boiler Building, and Boiler Smokestack Description & Condition Assessment

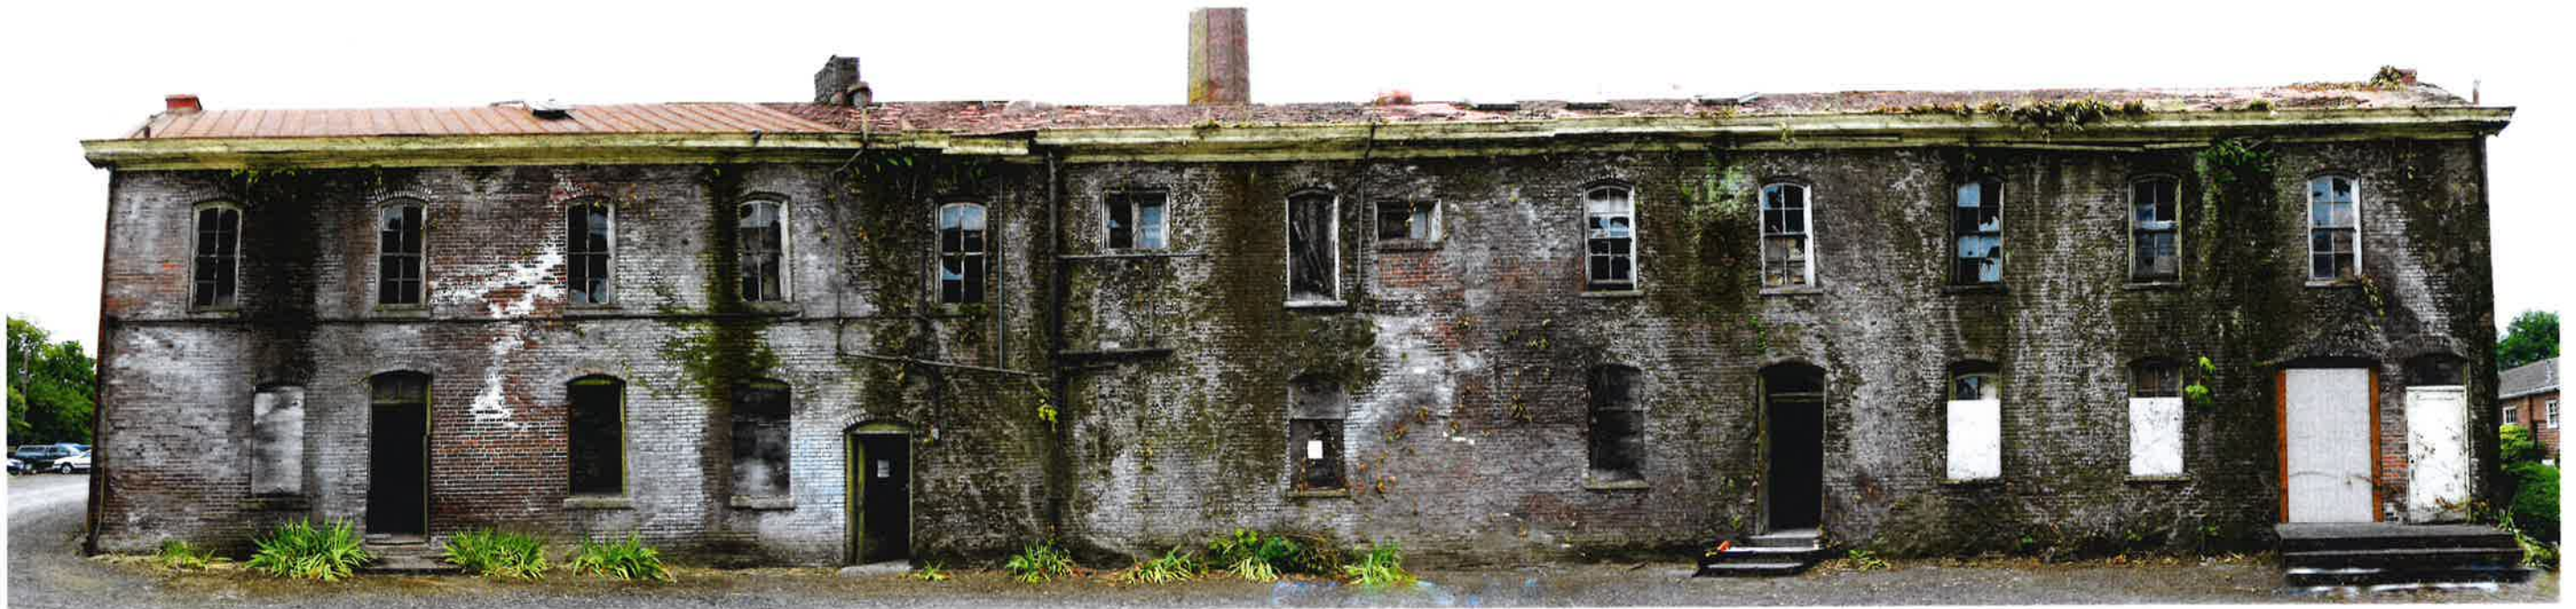
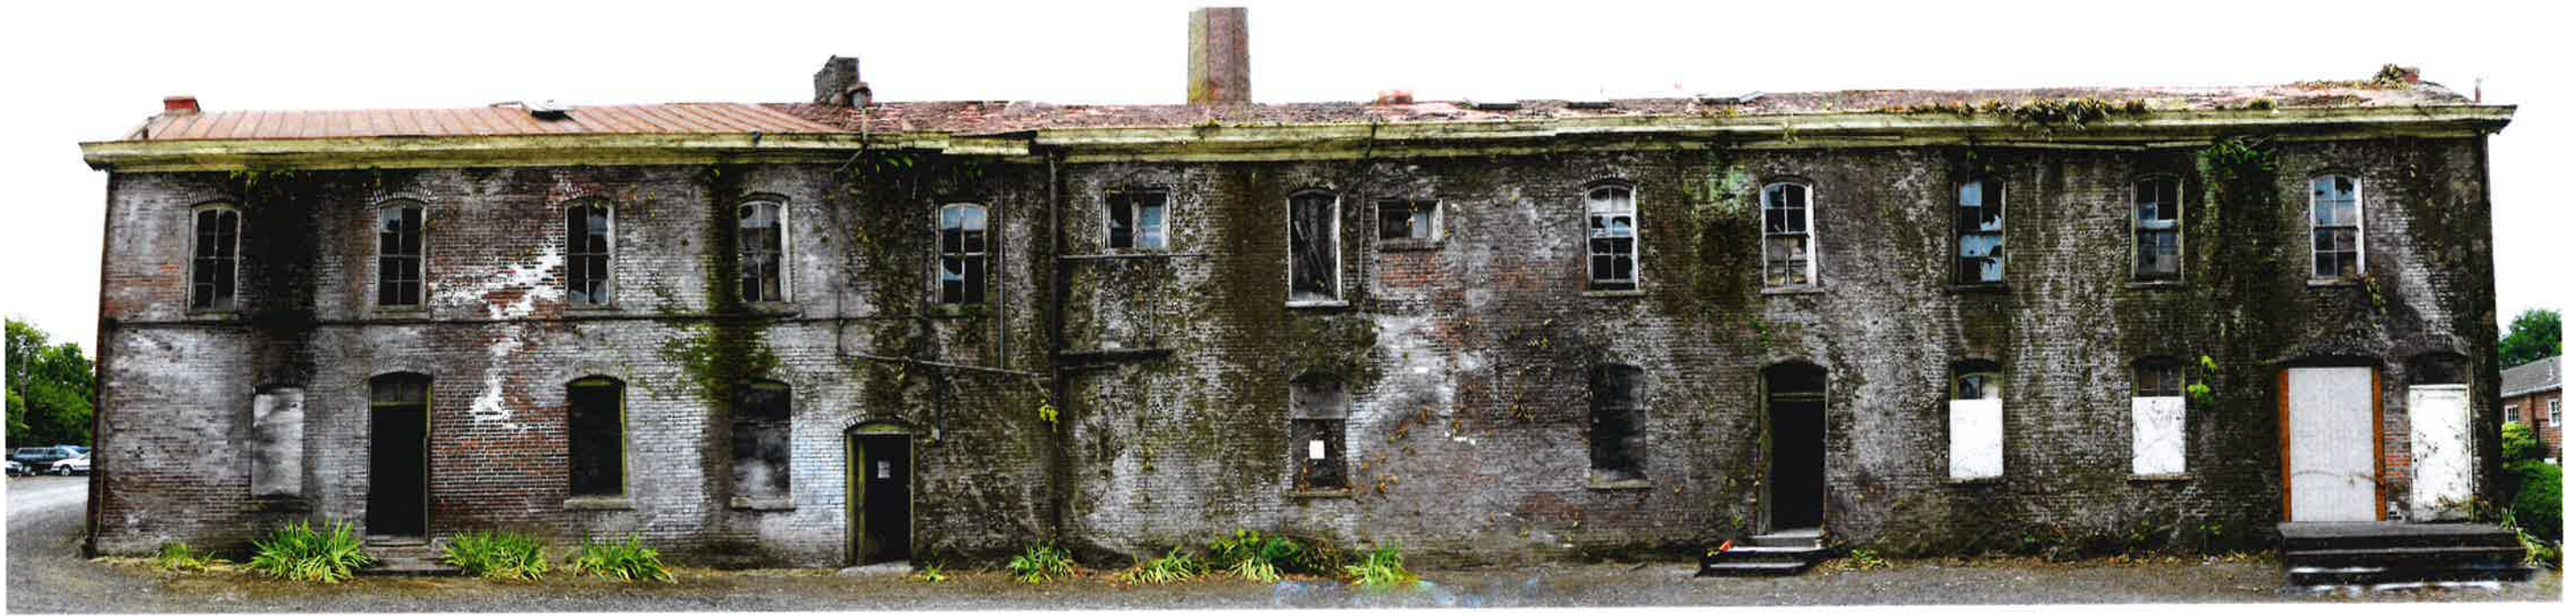
Laundry Building—East Elevation

This structure has evidence of significant distress. Notably, the roof and gutters failed many years ago, as have the original wood-sash windows. Water is acting on both sides of the wall, resulting in the deterioration of the wood and steel structural members. The masonry walls exhibit failing brick and deeply weathered joints. The mortar is soft and easily produces powder when scratched.

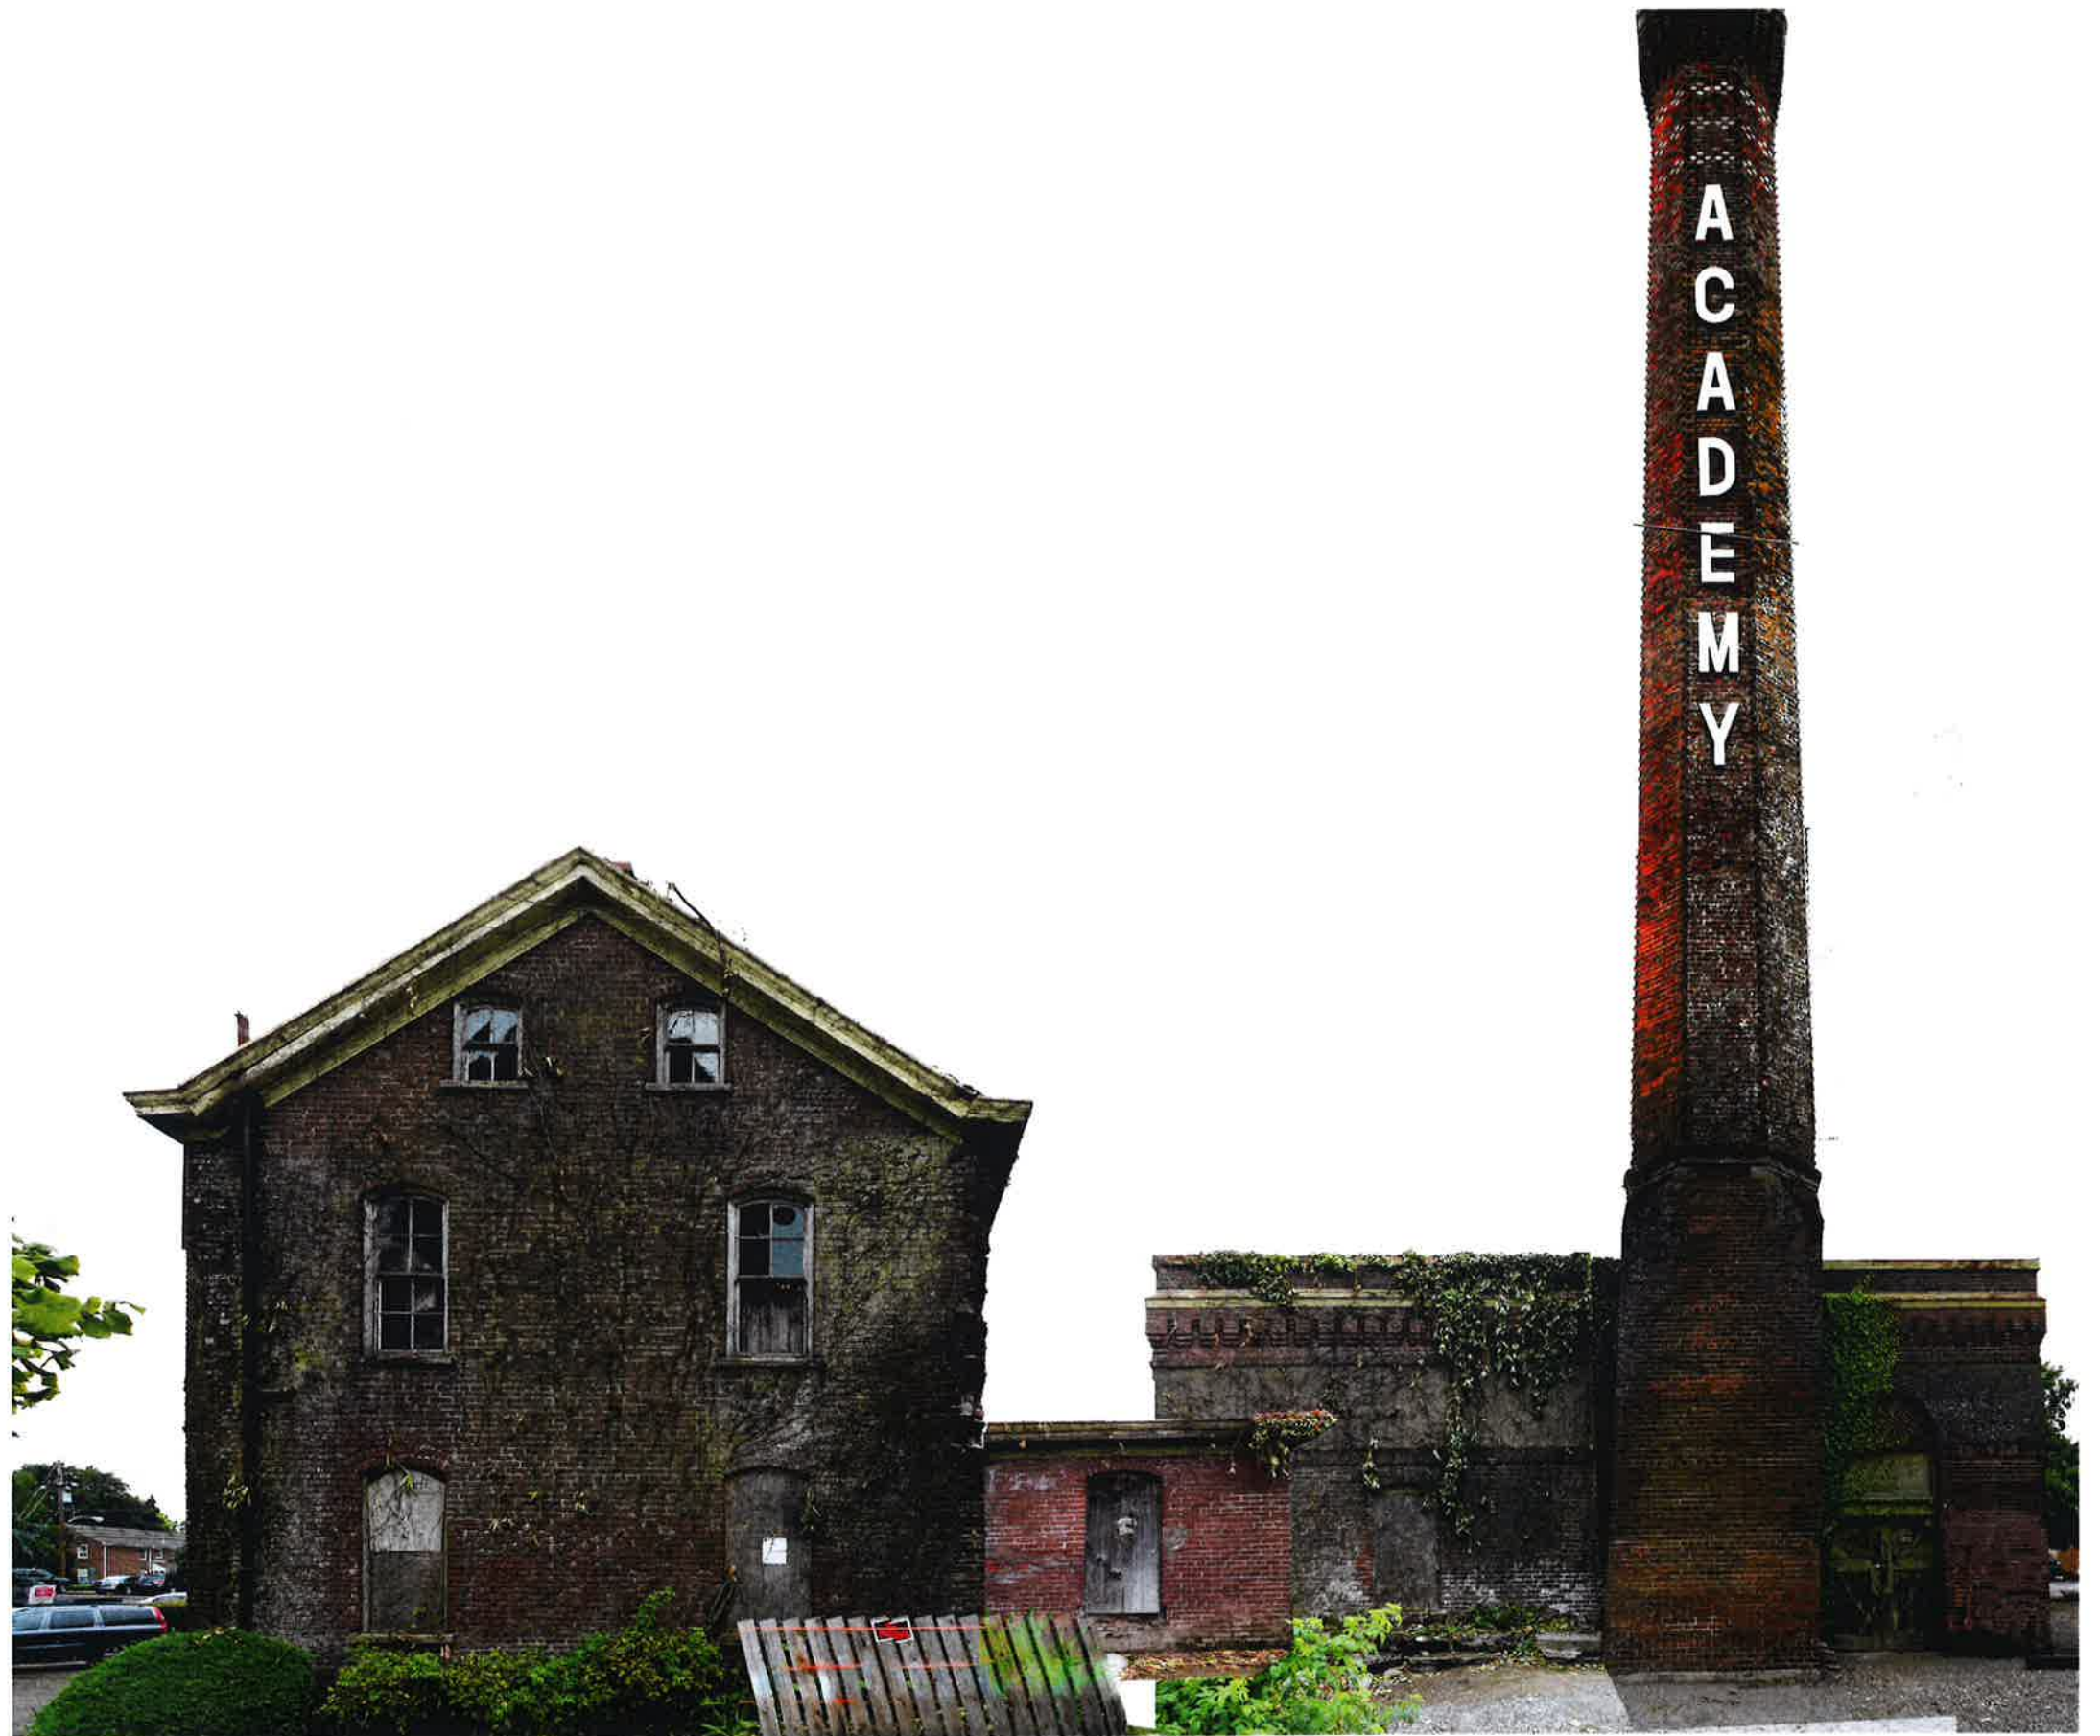
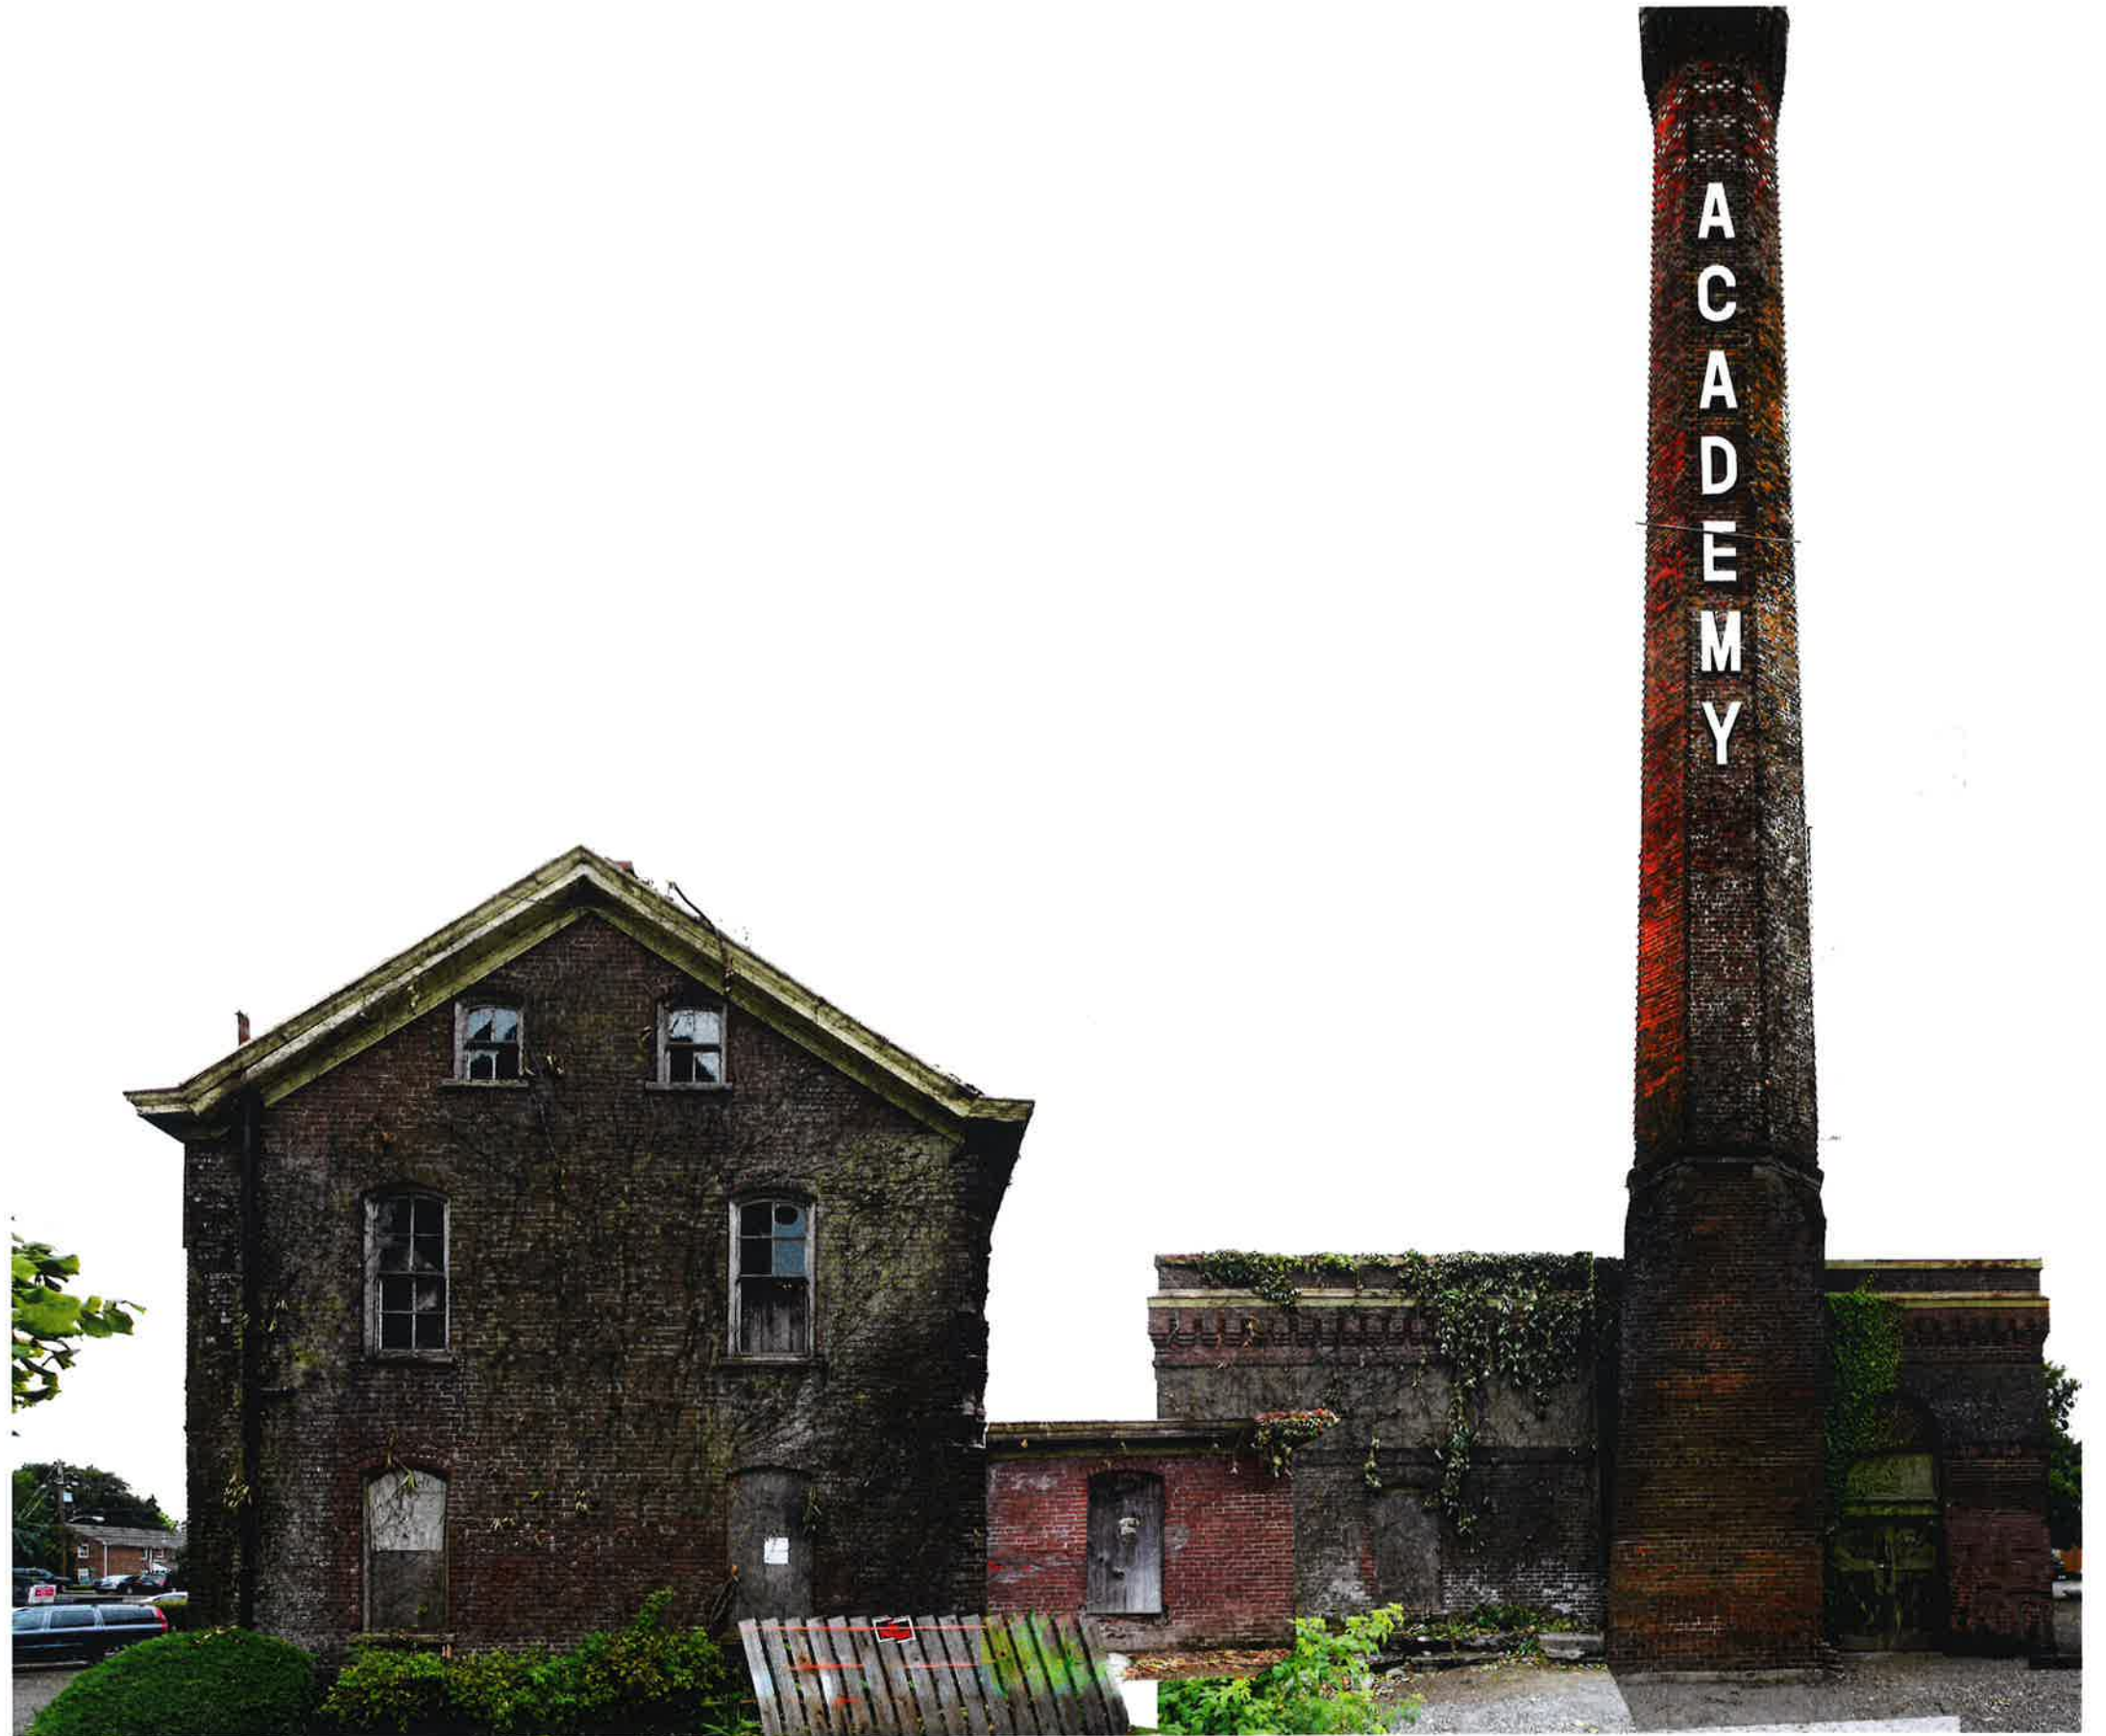
Laundry Building, Boiler Building & Boiler Smokestack—South Elevation

The Boiler Smokestack is in fair condition and requires some repointing of the brick. However, because the masonry is unreinforced, it poses a significant seismic risk in its current state.

Like the Laundry, the Boiler Building would also require a change of use to "B" occupancy. A full seismic upgrade would be required, including the smokestack. The roof, windows, and doors would also have to be replaced. All new mechanical, electrical, plumbing (including ADA-accessible restrooms), fire sprinklers, and telecommunications systems would be required for this building. The building would also require abatement of hazardous materials.

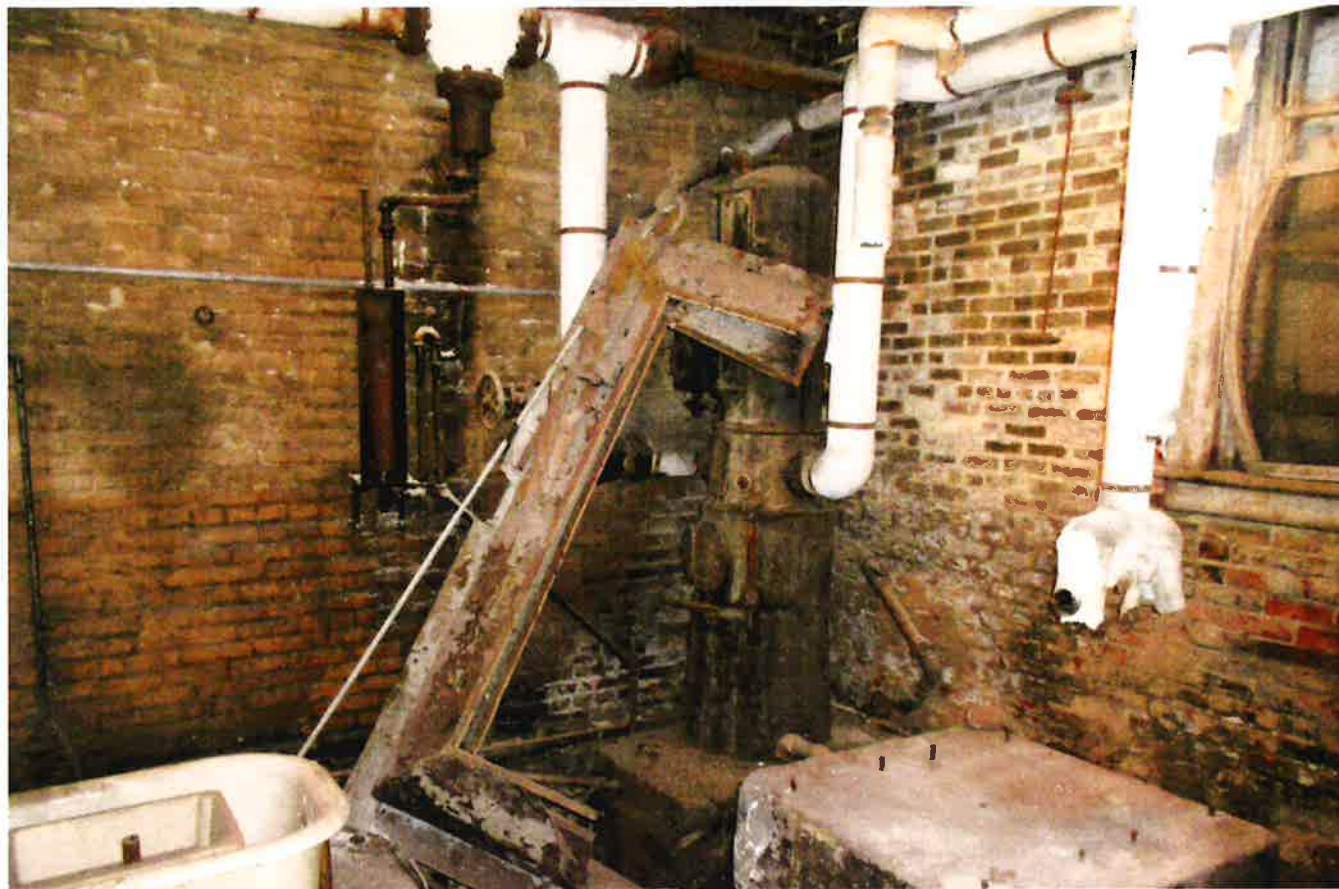
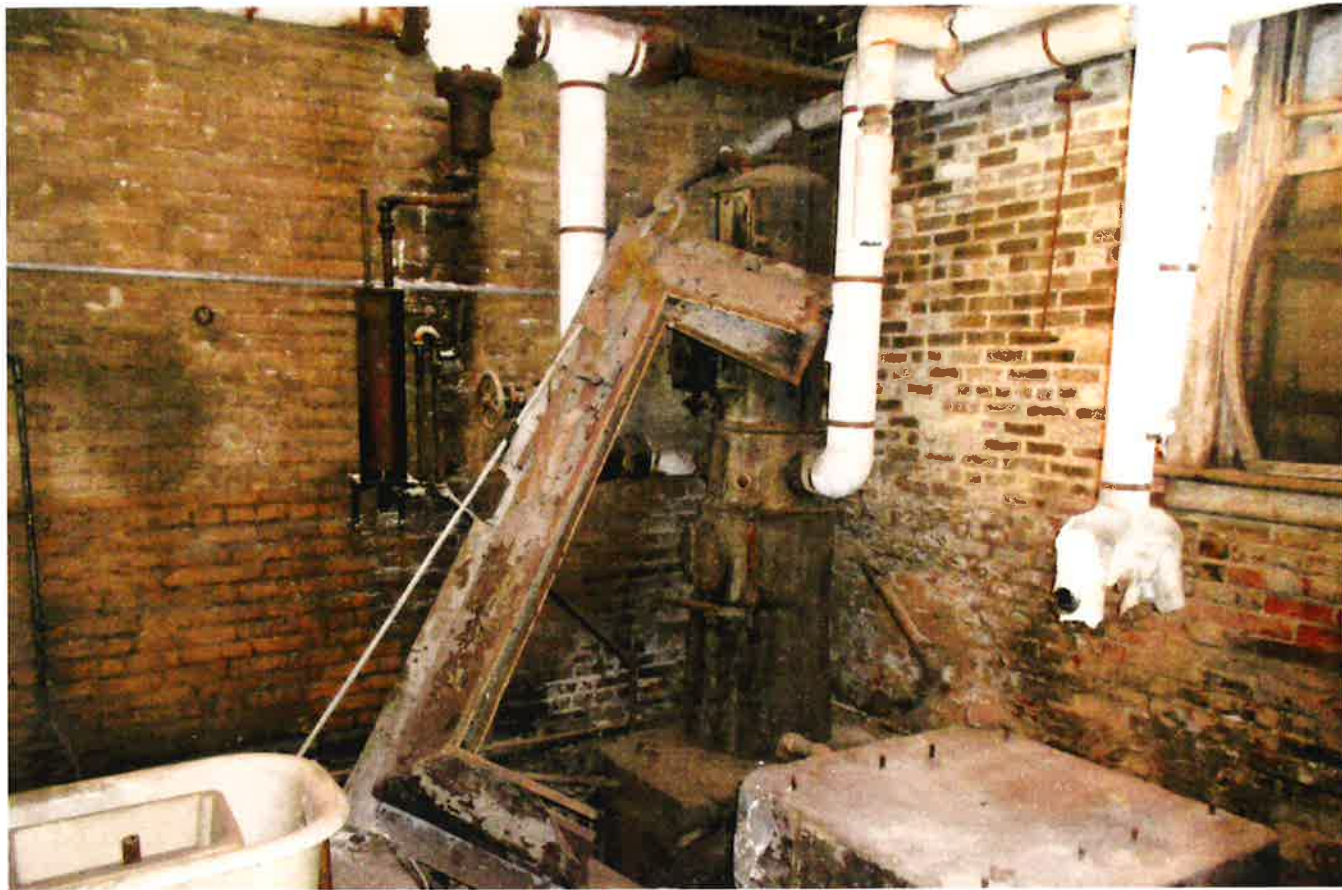
Laundry Building—Level 1 Interior

The first floor is composed of four large rooms. The interiors are characterized by wall and ceiling areas of failed plaster leaving exposed brick and wood joists. Several pieces of equipment from the laundry operations remain in the two southern rooms. Machinery, tanks, raised concrete equipment pads, open utility trenches, and large diameter piping associated with the building and/or campus utilities are present in the northern two rooms.

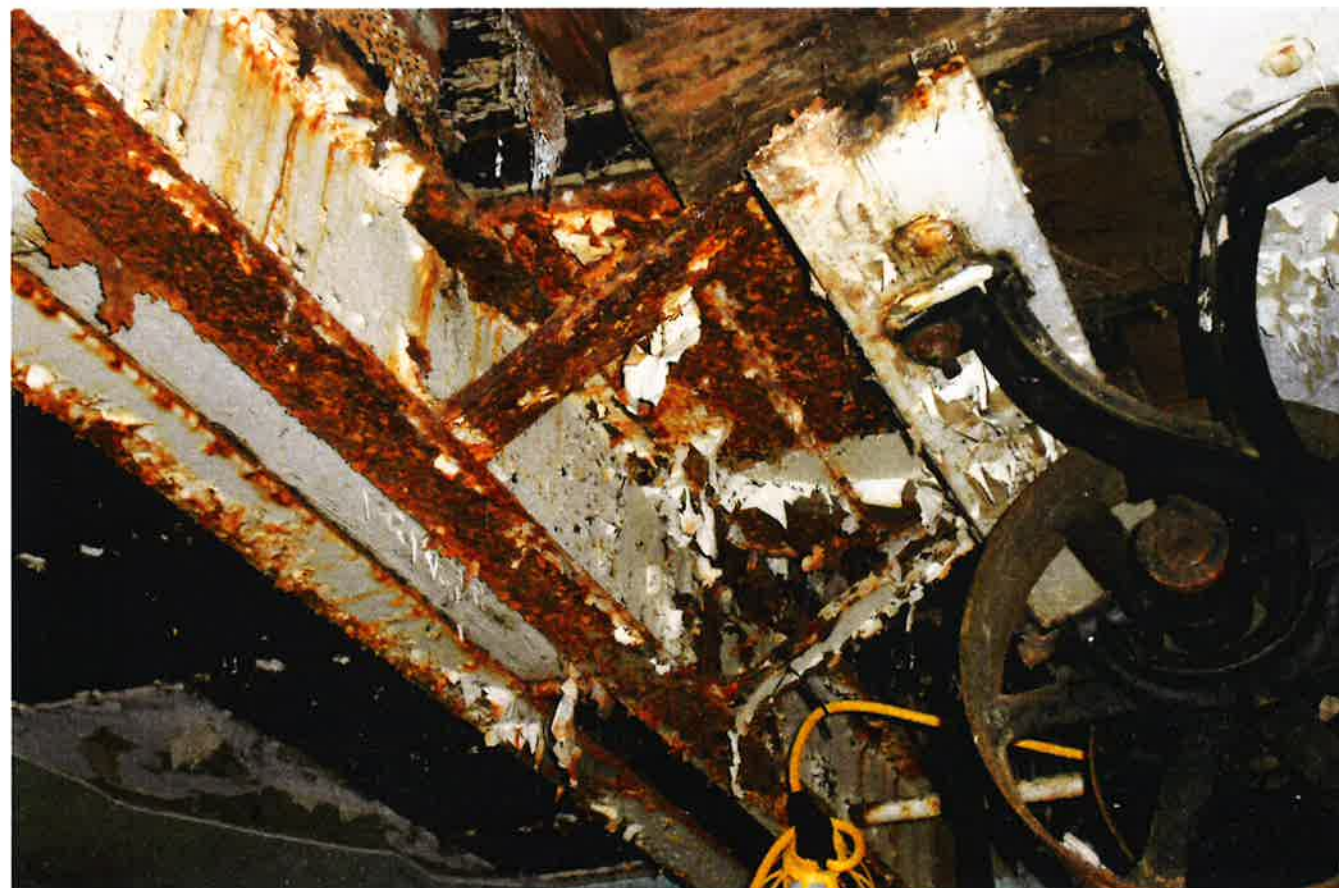
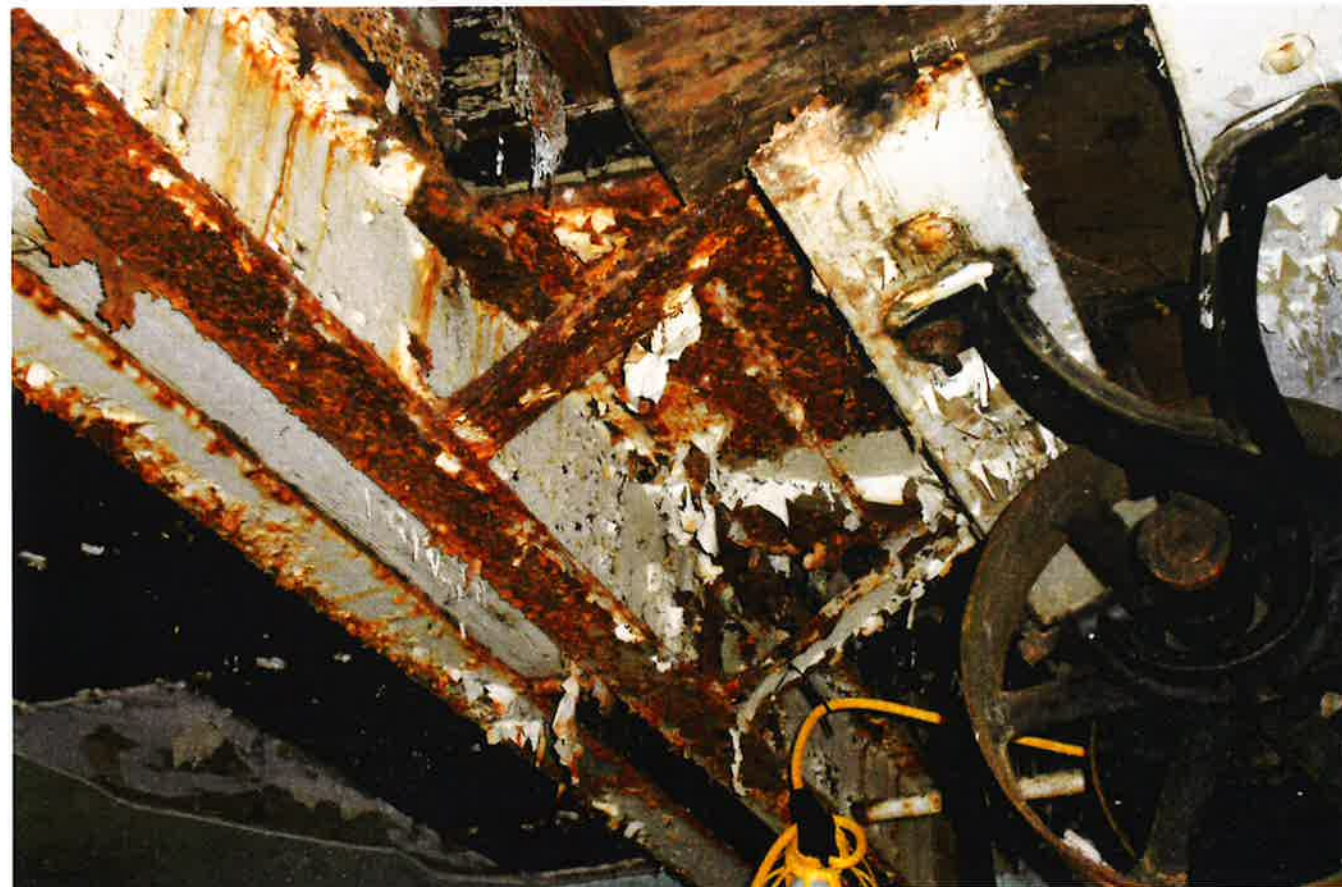
Laundry Building—Level 1 steel structure

The Laundry Building is a rectangular two-story brick structure with a partial-height attic. It is connected to the Boiler Building by a raised one-story connector. The current roof is a combination of standing-seam metal and composition shingles. The roof and floors are wood framing bearing on unreinforced masonry. The continuous wall opening for a small eastern one-story addition is framed with steel.

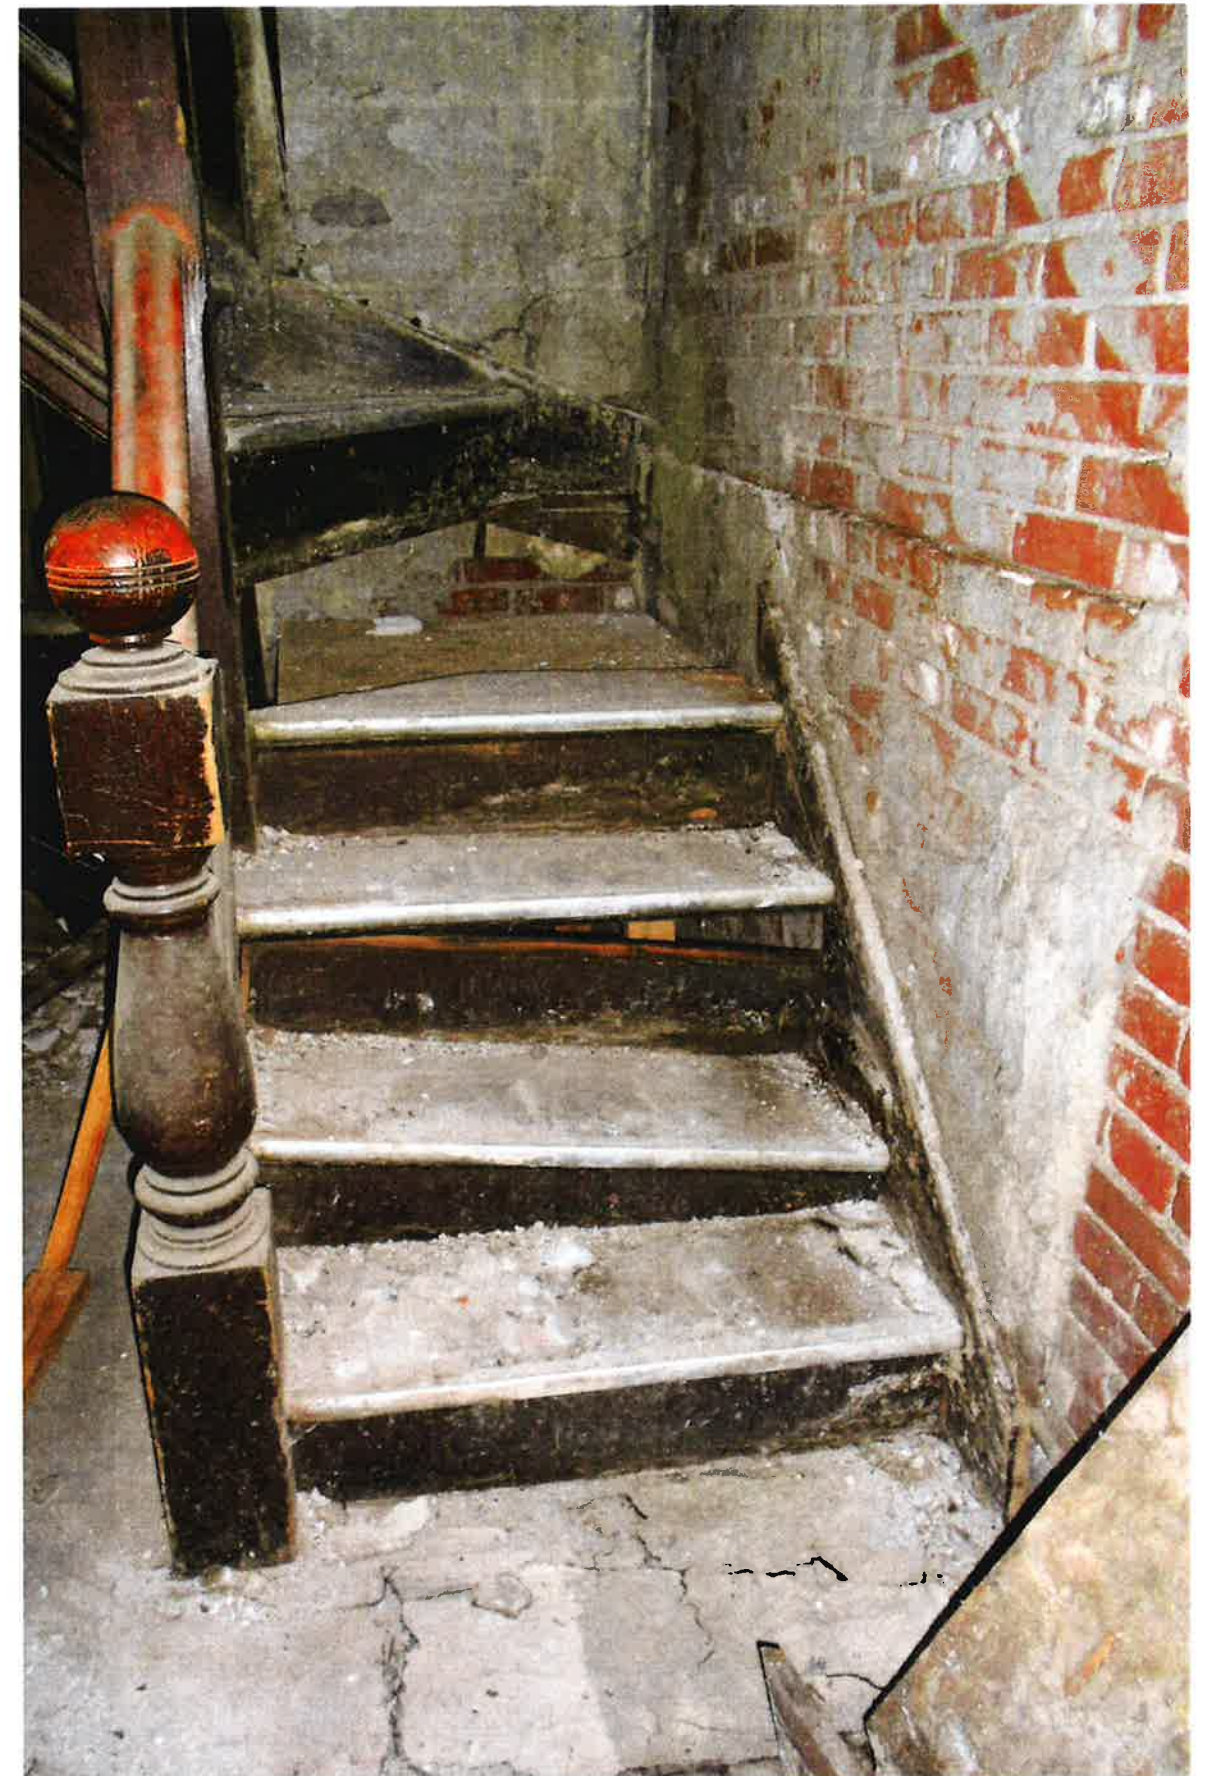
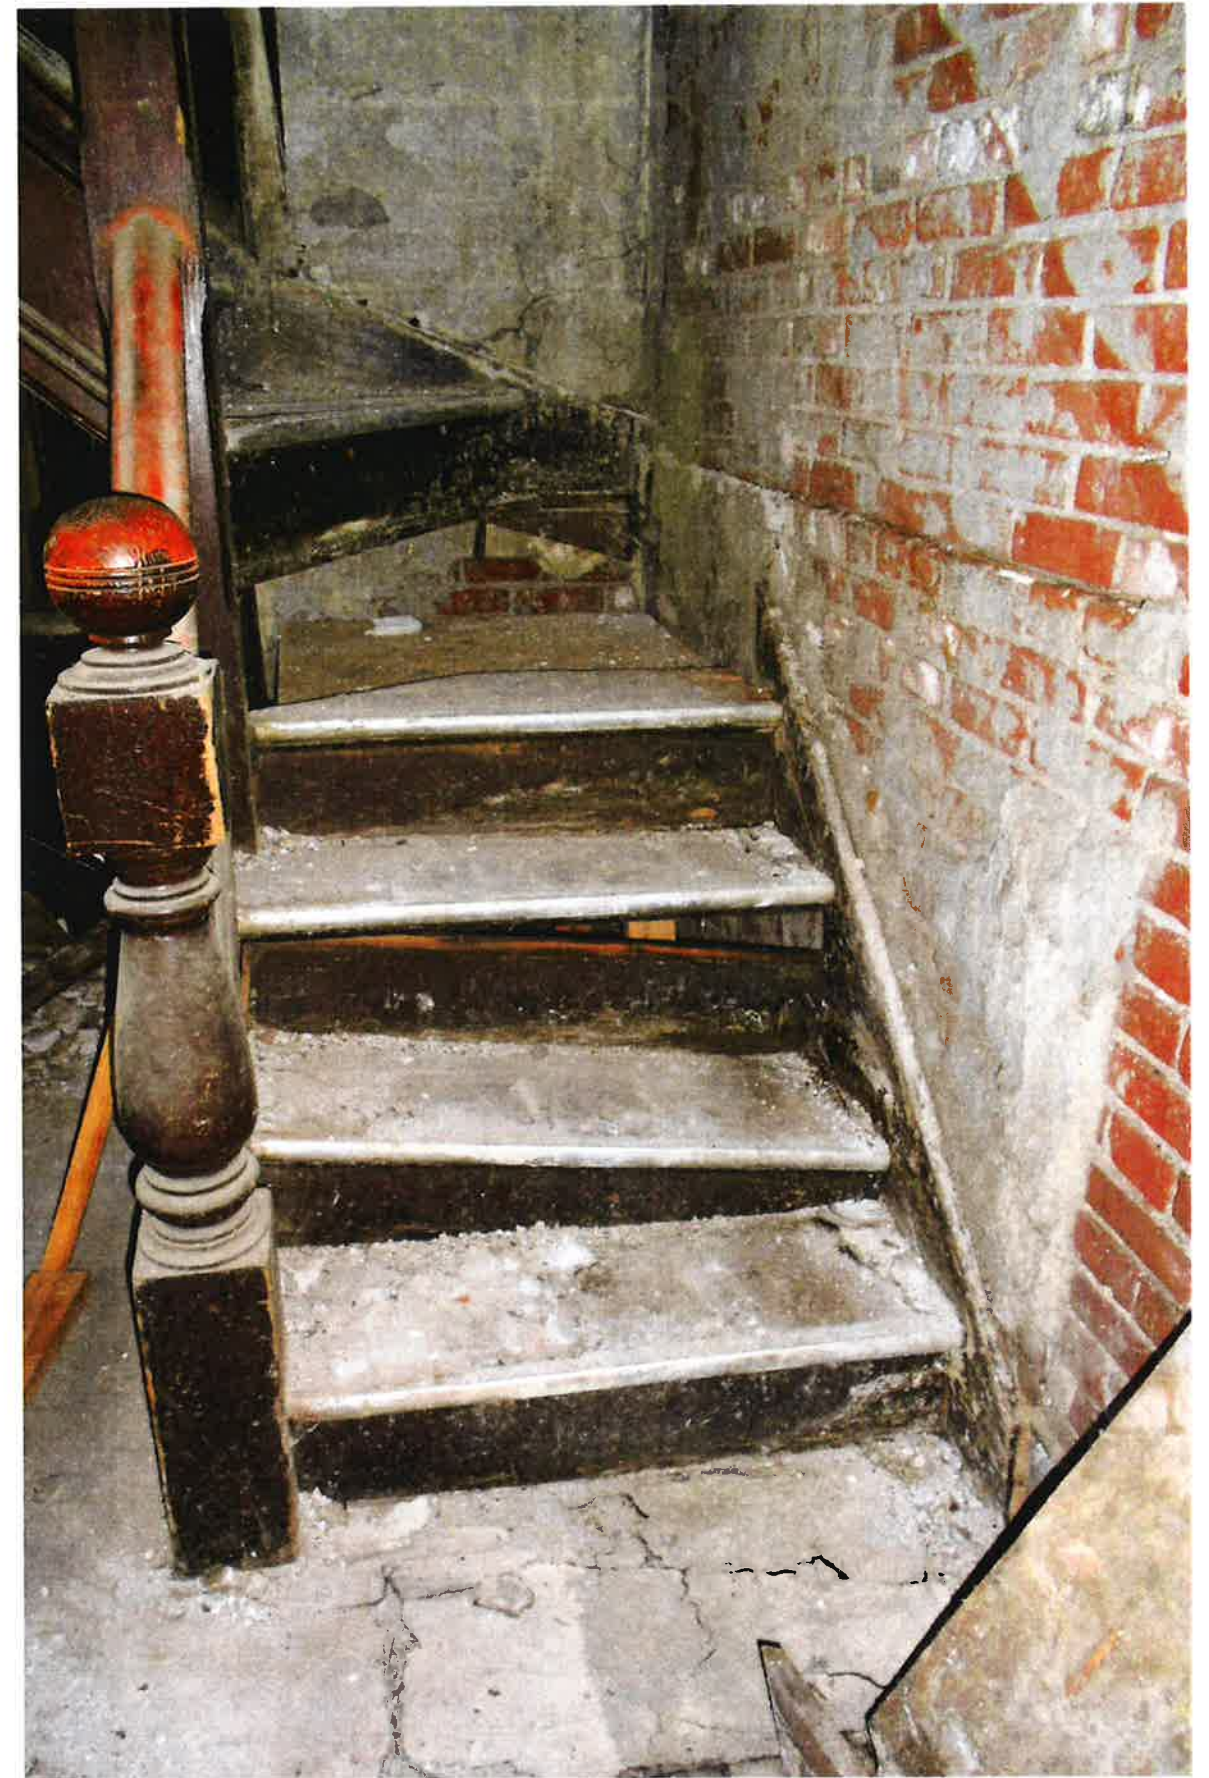
Laundry Building—Stairs at Level 1

There are wooden stairs connecting to the upper levels against the north and south exterior walls. These stairs have failed in sections. The second floor is characterized by smaller tenant rooms in the northern half and two large open rooms in the southern half. Interior finishes include plaster on wood and brick, ranging in condition from poor to failed. The floor finishes include wood strip flooring as well as tile products. Moisture and debris have compromised most of these finishes beyond repair with some floor areas feeling soft and spongy.
