REQUEST FOR REVIEW AND COMMENT ON PROPOSED REMOVAL OF BUILDINGS AT THE HOUSE OF PROVIDENCE ACADEMY

The city received a request to demolish and remove demolish the Laundry and Boiler Buildings, Boiler Smokestack, and the El Presidente Restaurant on the House of Providence site at 400 East Evergreen Boulevard.

Laundry Building, Boiler Building, and Boiler Smokestack Description & Condition Assessment

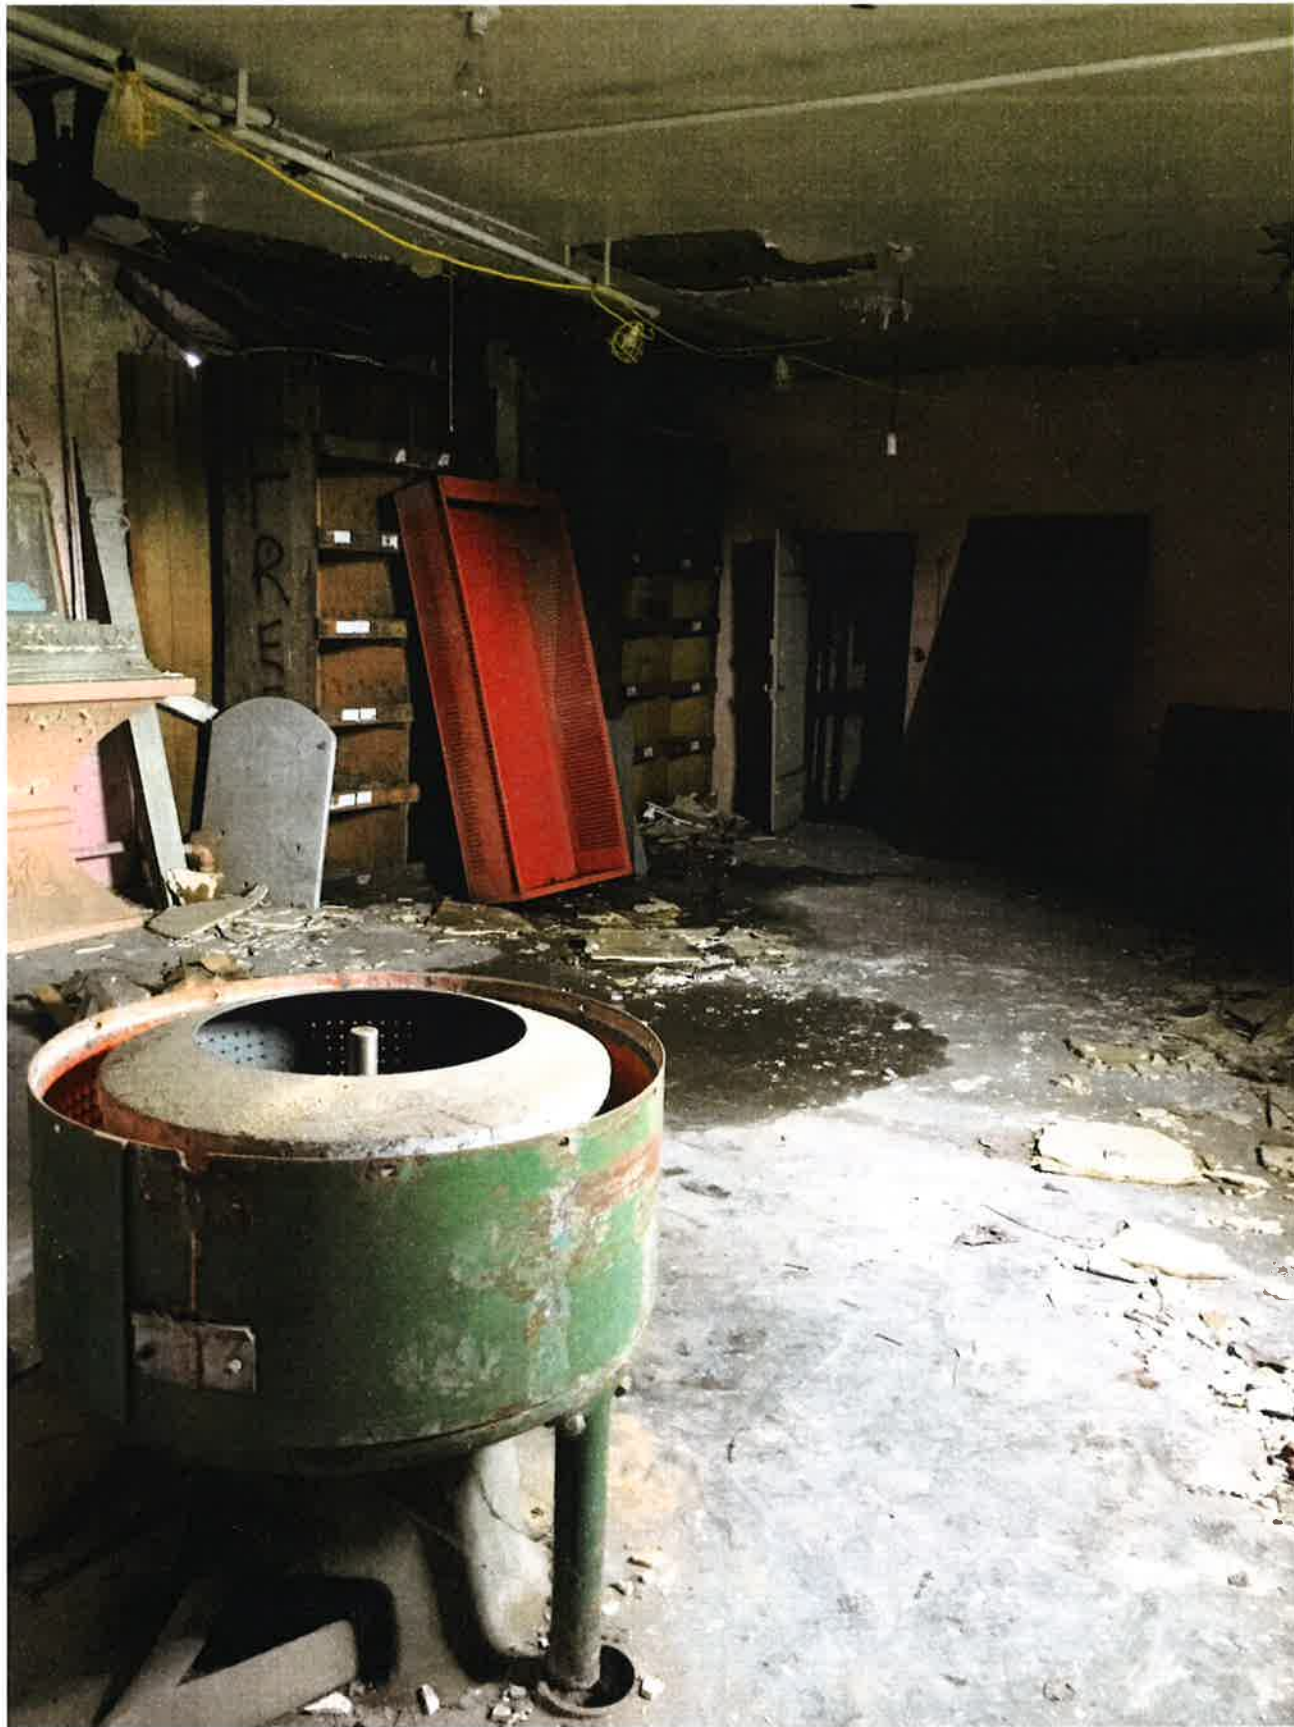
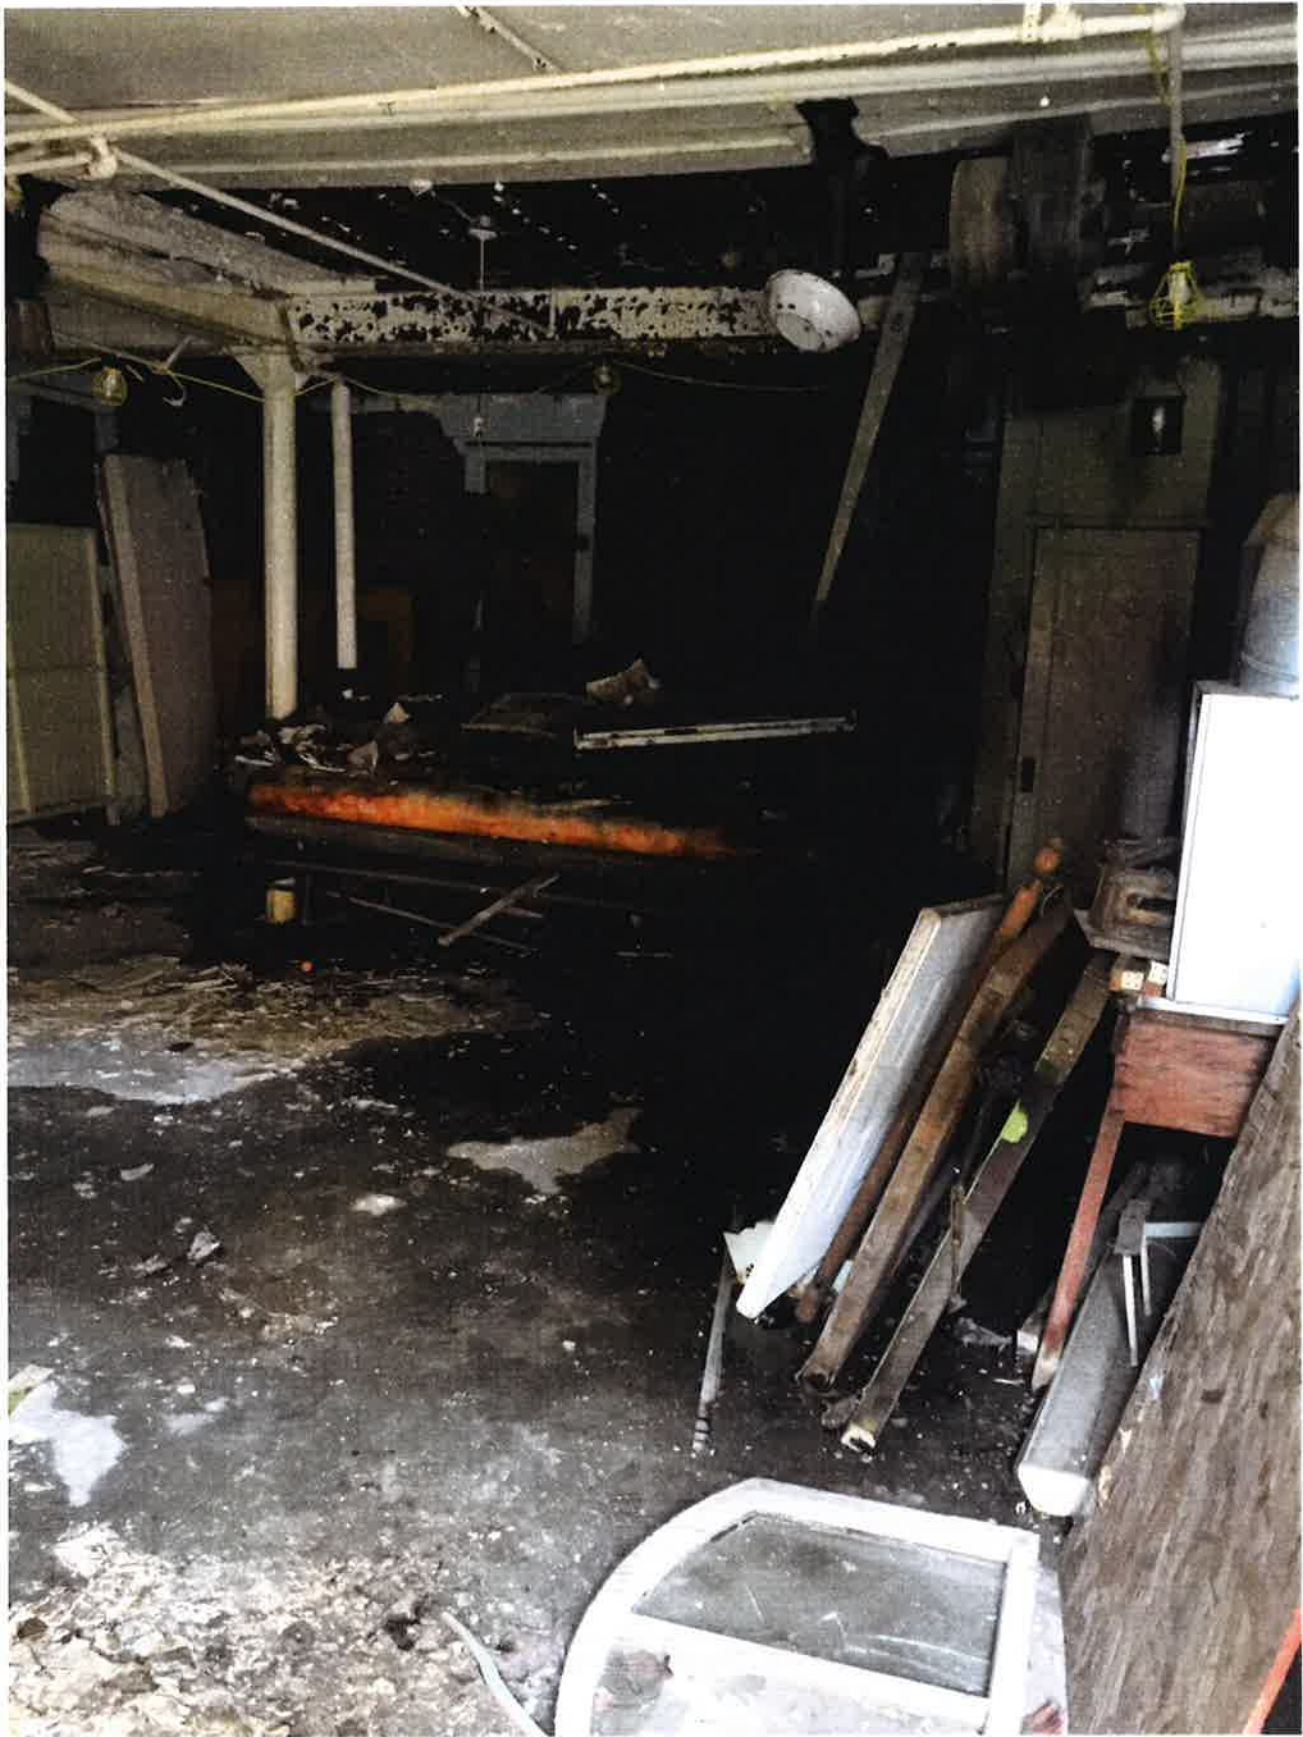
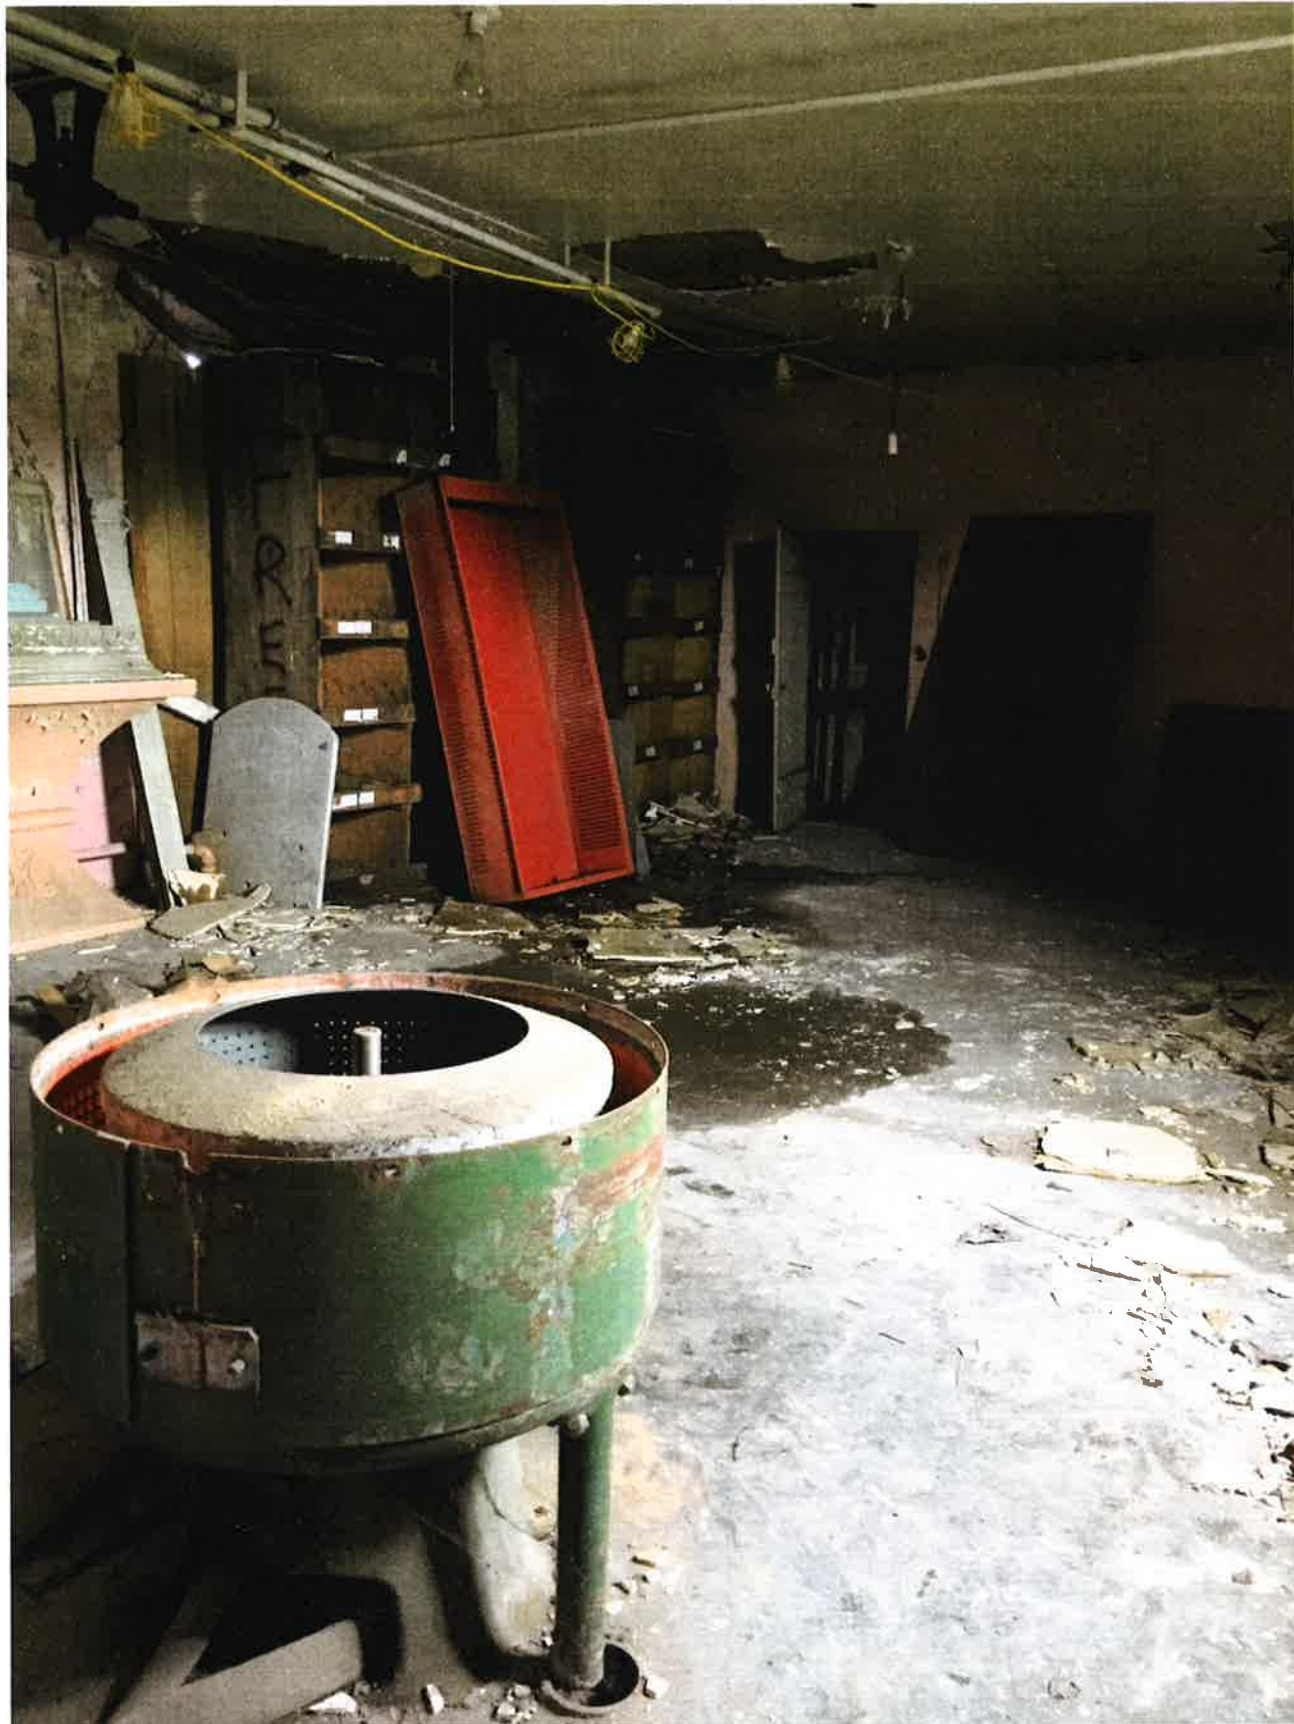
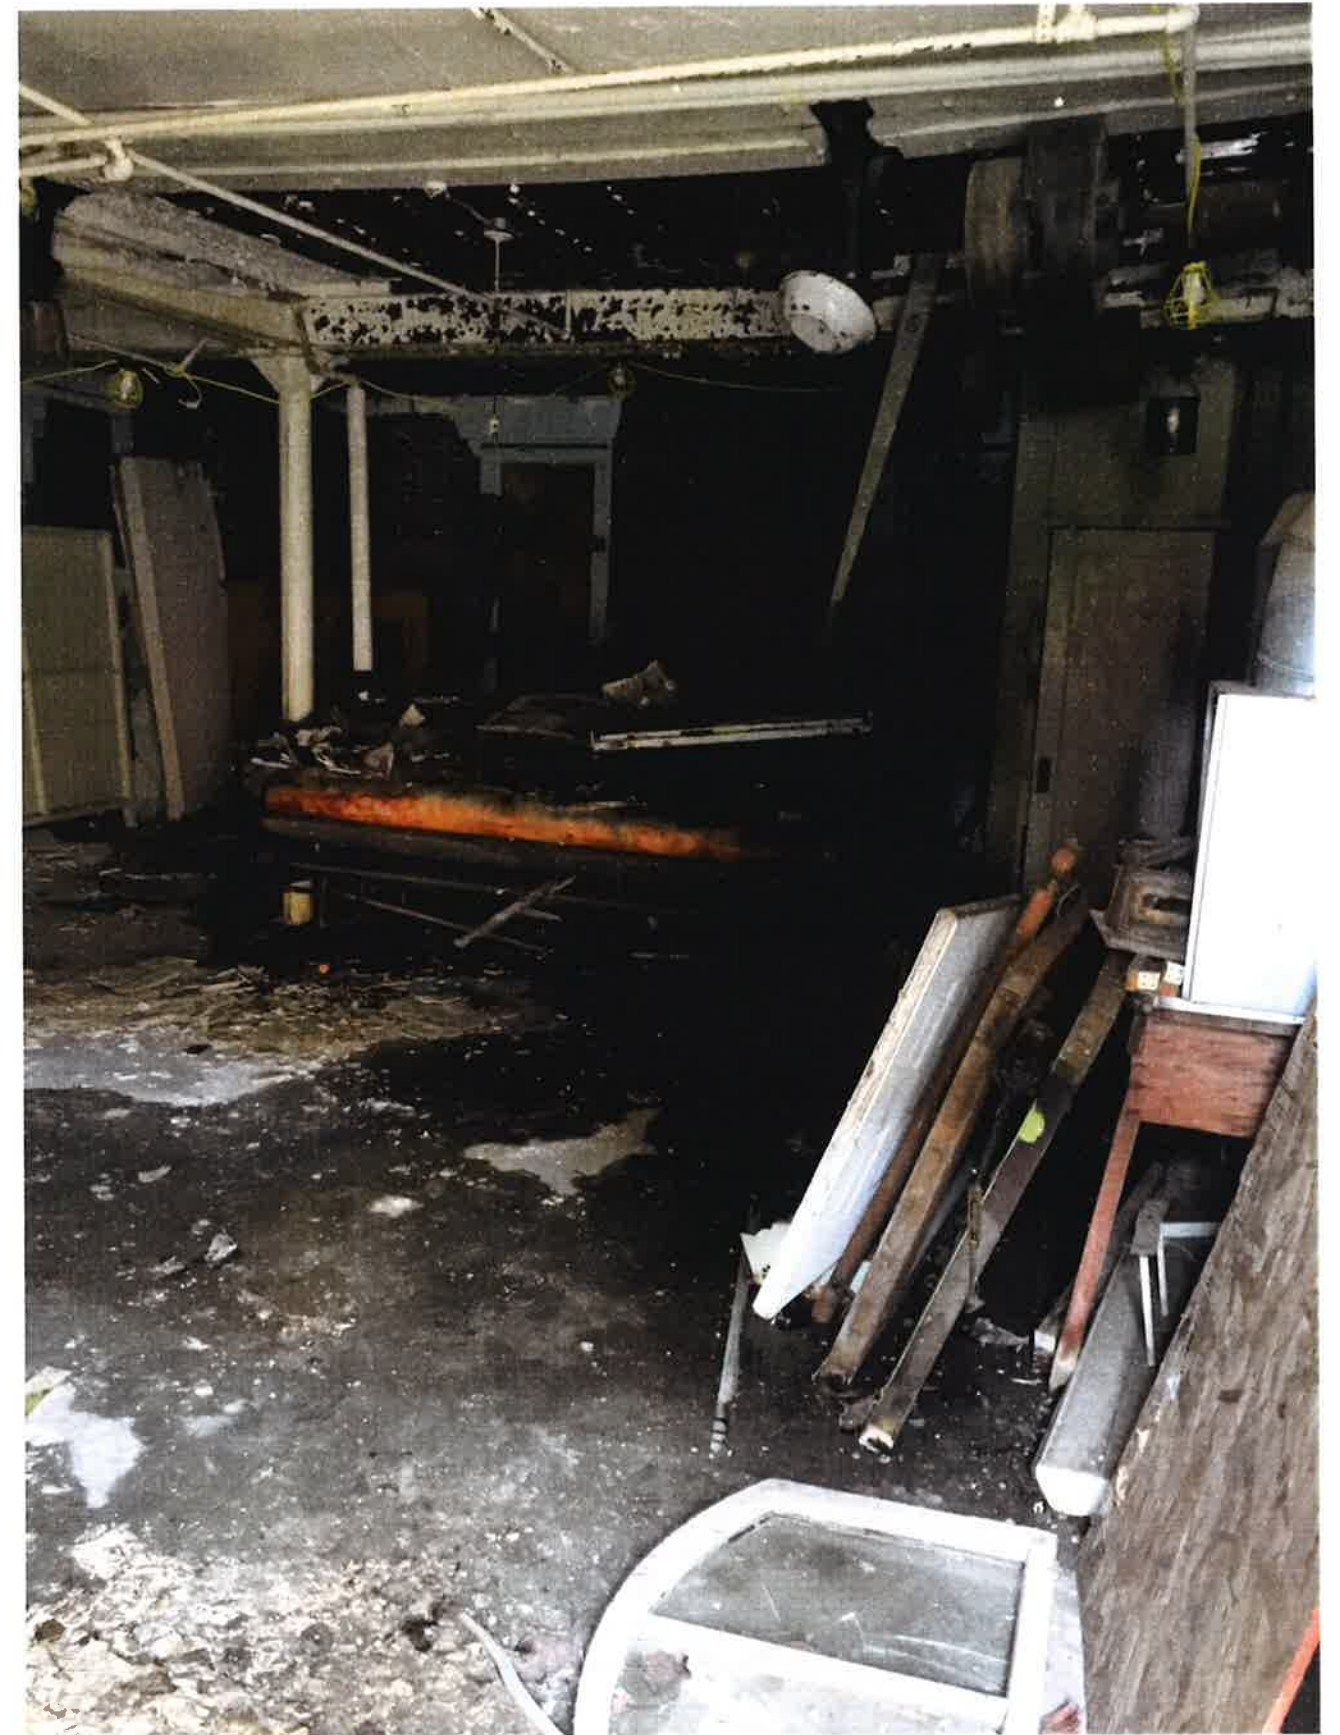
Laundry Building—Level 1 Interior

The first floor is composed of four large rooms. The interiors are characterized by wall and ceiling areas of failed plaster leaving exposed brick and wood joists. Several pieces of equipment from the laundry operations remain in the two southern rooms. Machinery, tanks, raised concrete equipment pads, open utility trenches, and large diameter piping associated with the building and/or campus utilities are present in the northern two rooms.

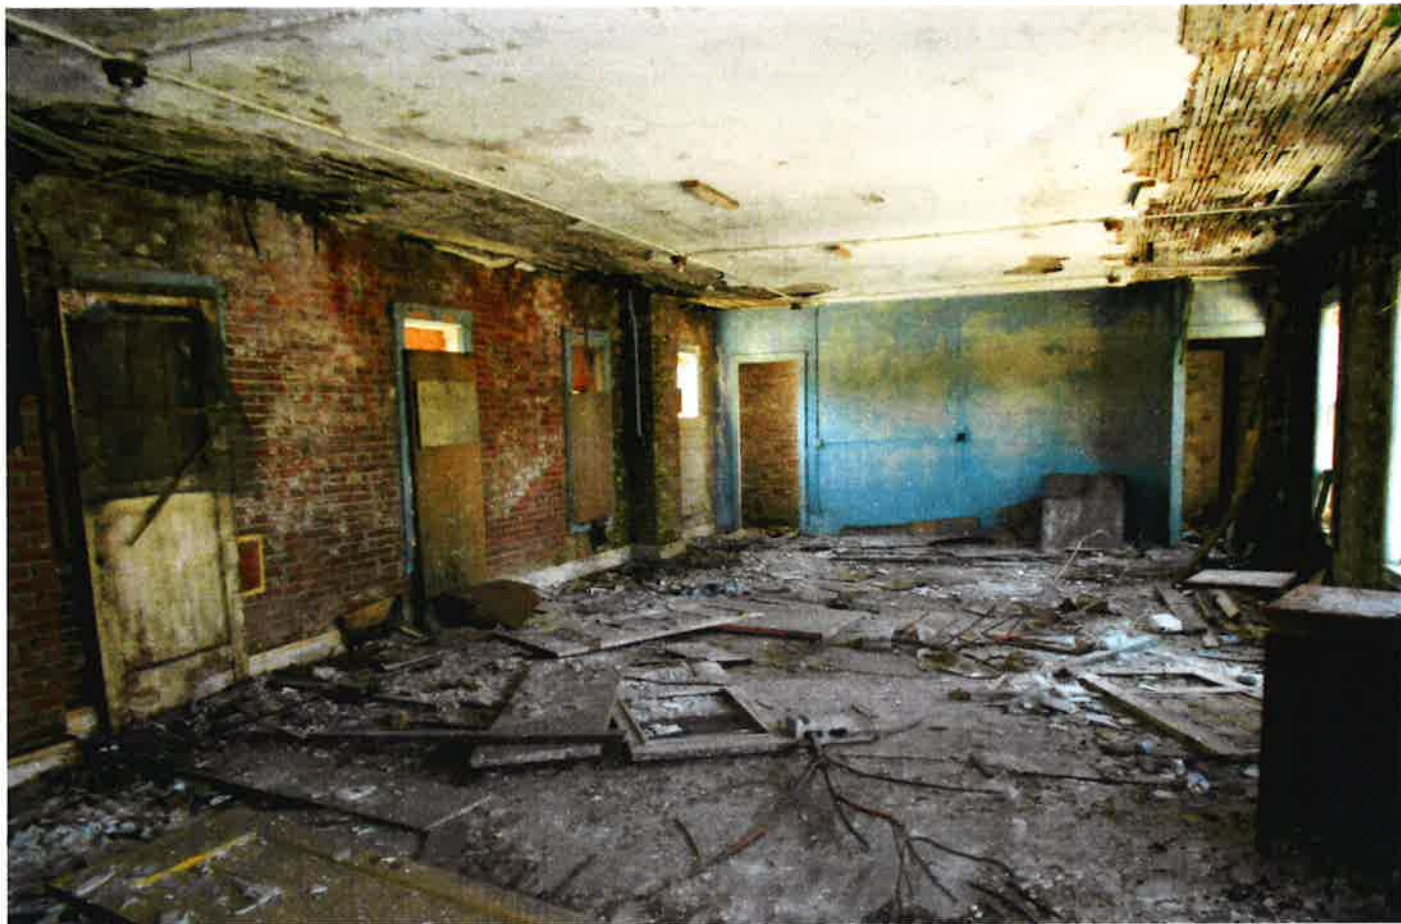
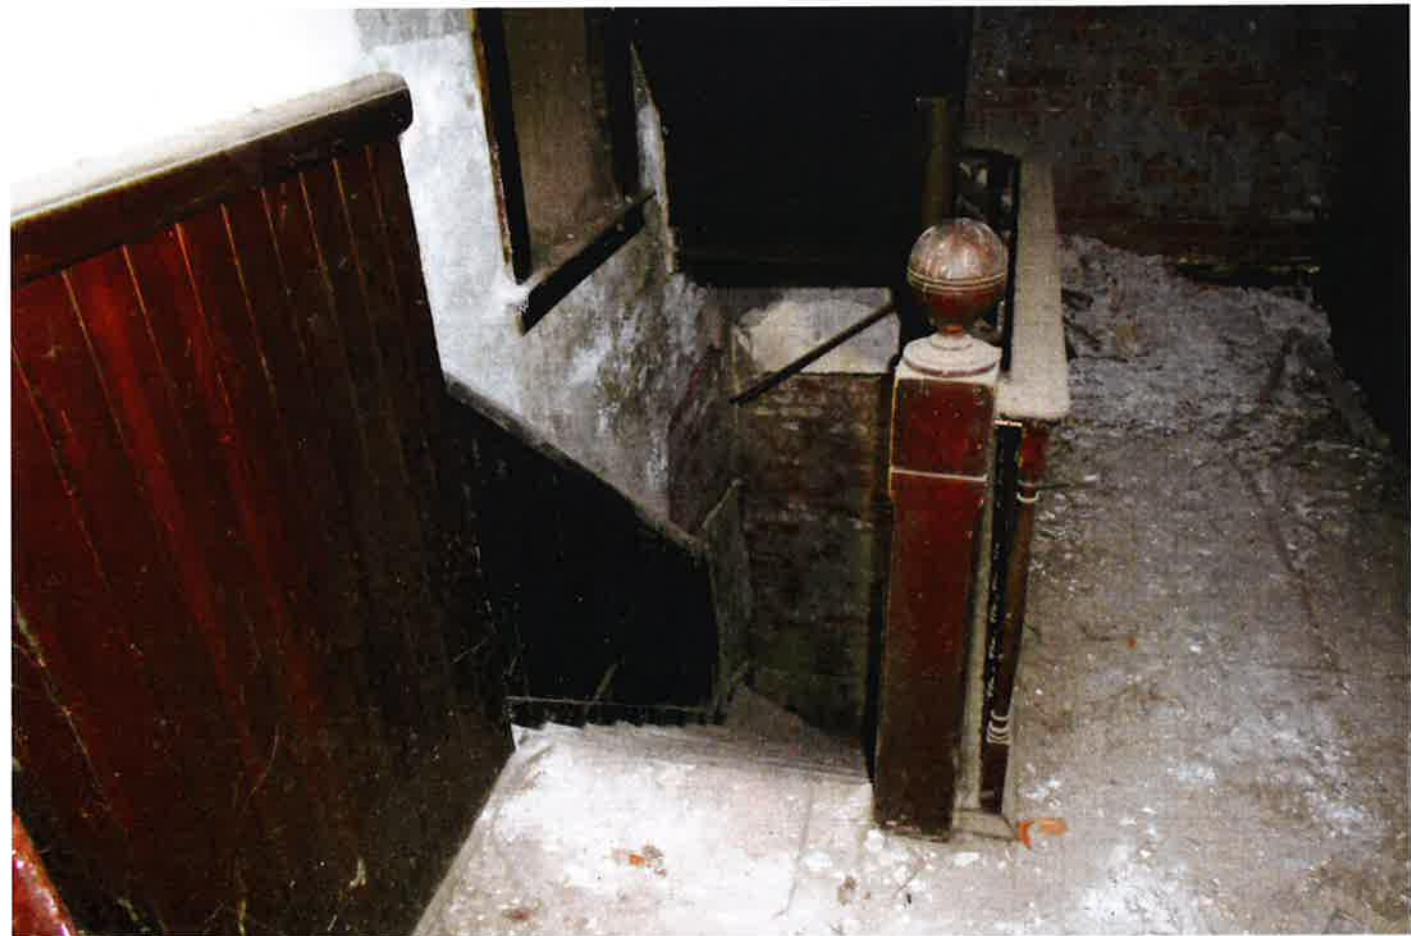
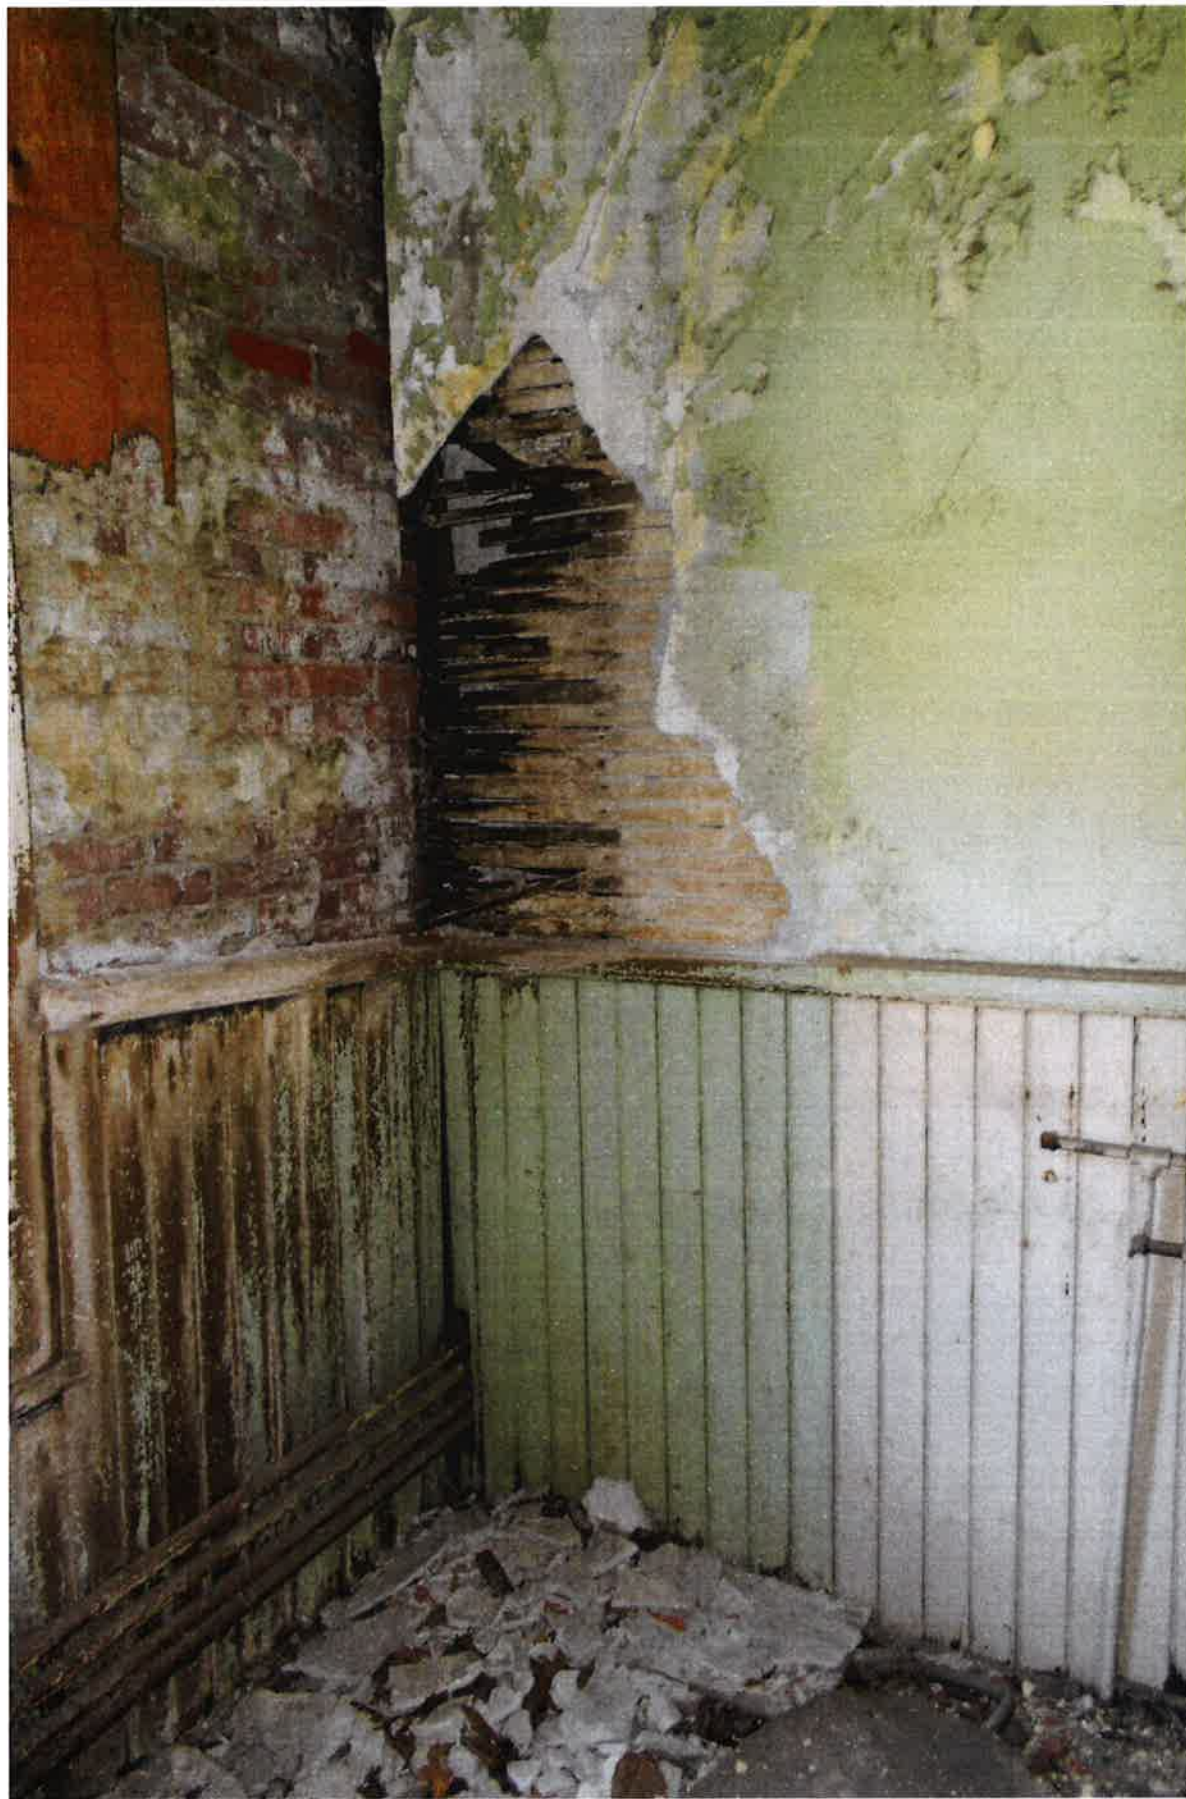
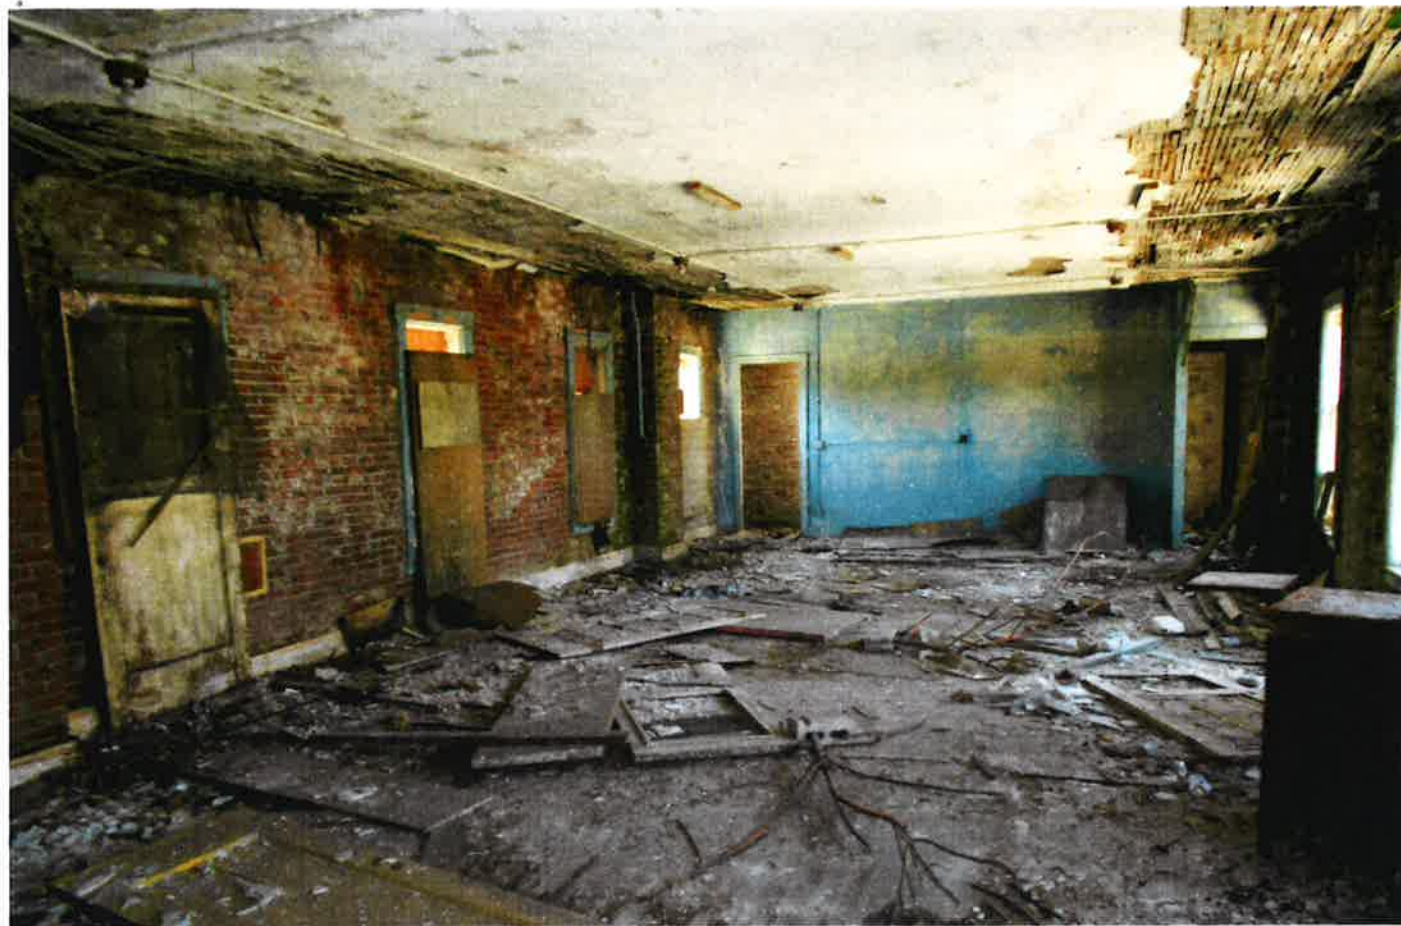
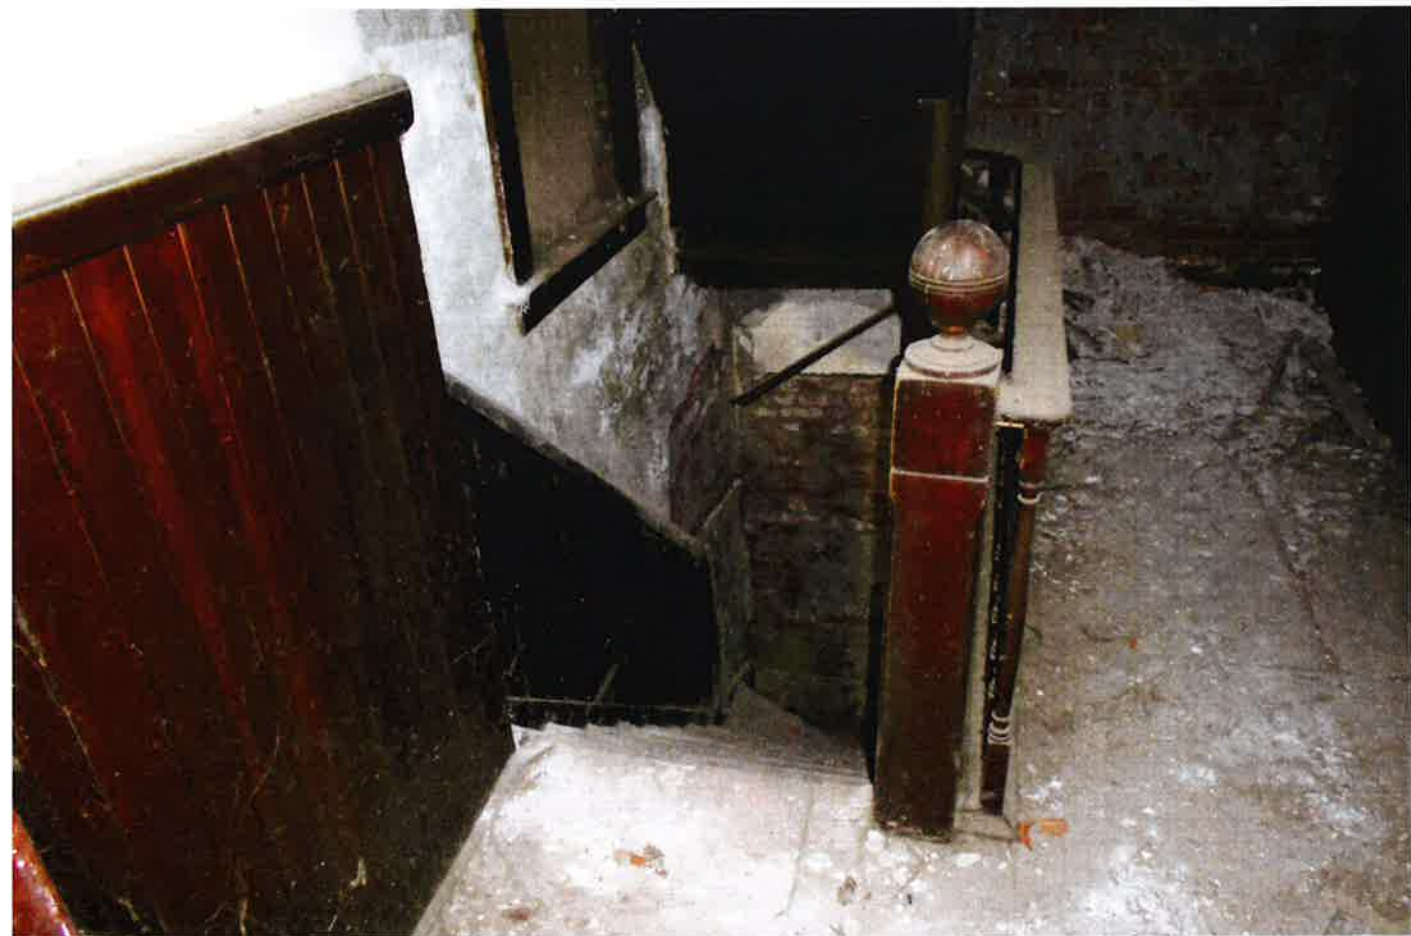
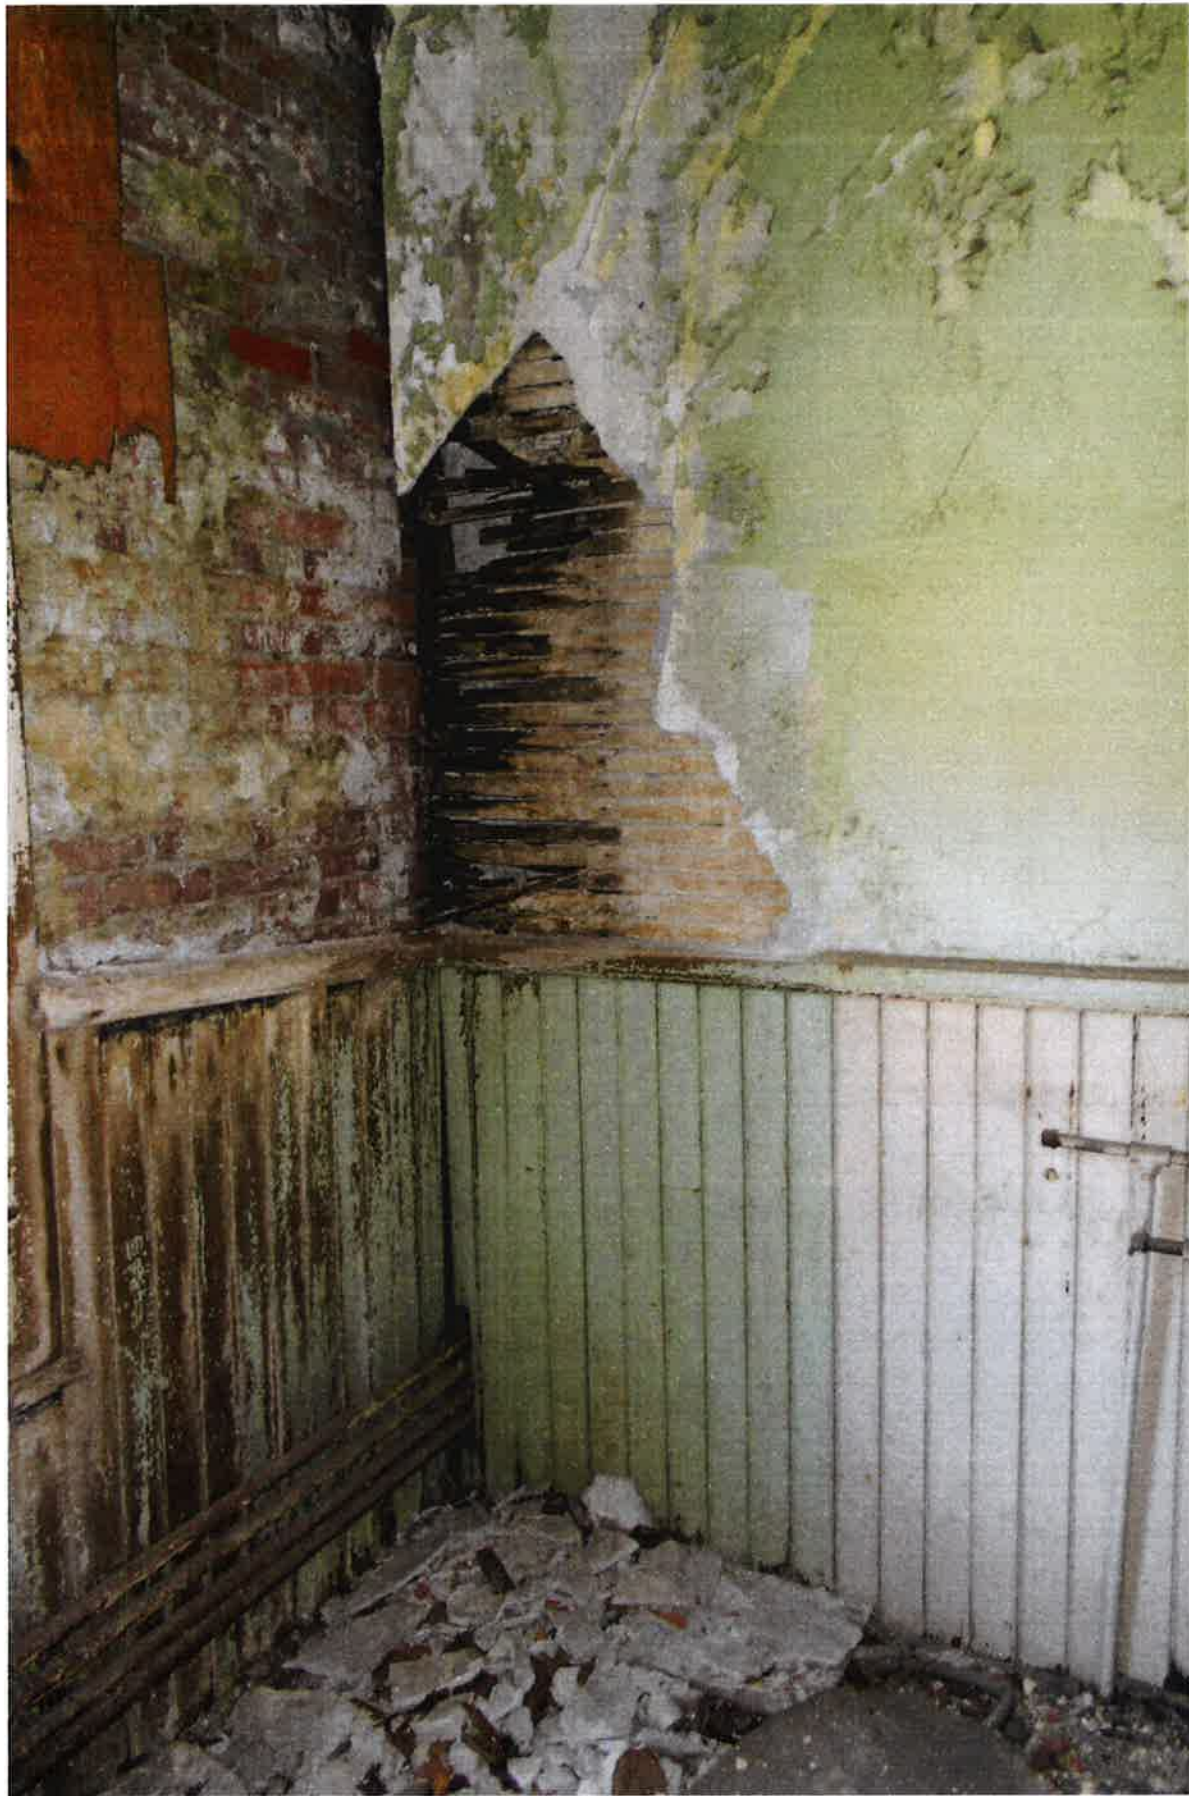
Laundry Building—Level 2 Interior

There are wooden stairs connecting to the upper levels against the north and south exterior walls. These stairs have failed in sections. The second floor is characterized by smaller tenant rooms in the northern half and two large open rooms in the southern half. Interior finishes include plaster on wood and brick, ranging in condition from poor to failed. The floor finishes include wood strip flooring as well as tile products. Moisture and debris have compromised most of these finishes beyond repair with some floor areas feeling soft and spongy.
