REQUEST FOR REVIEW AND COMMENT ON PROPOSED REMOVAL OF BUILDINGS AT THE HOUSE OF PROVIDENCE ACADEMY

The city received a request to demolish and remove demolish the Laundry and Boiler Buildings, Boiler Smokestack, and the El Presidente Restaurant on the House of Providence site at 400 East Evergreen Boulevard.

Laundry Building, Boiler Building, and Boiler Smokestack Description & Condition Assessment

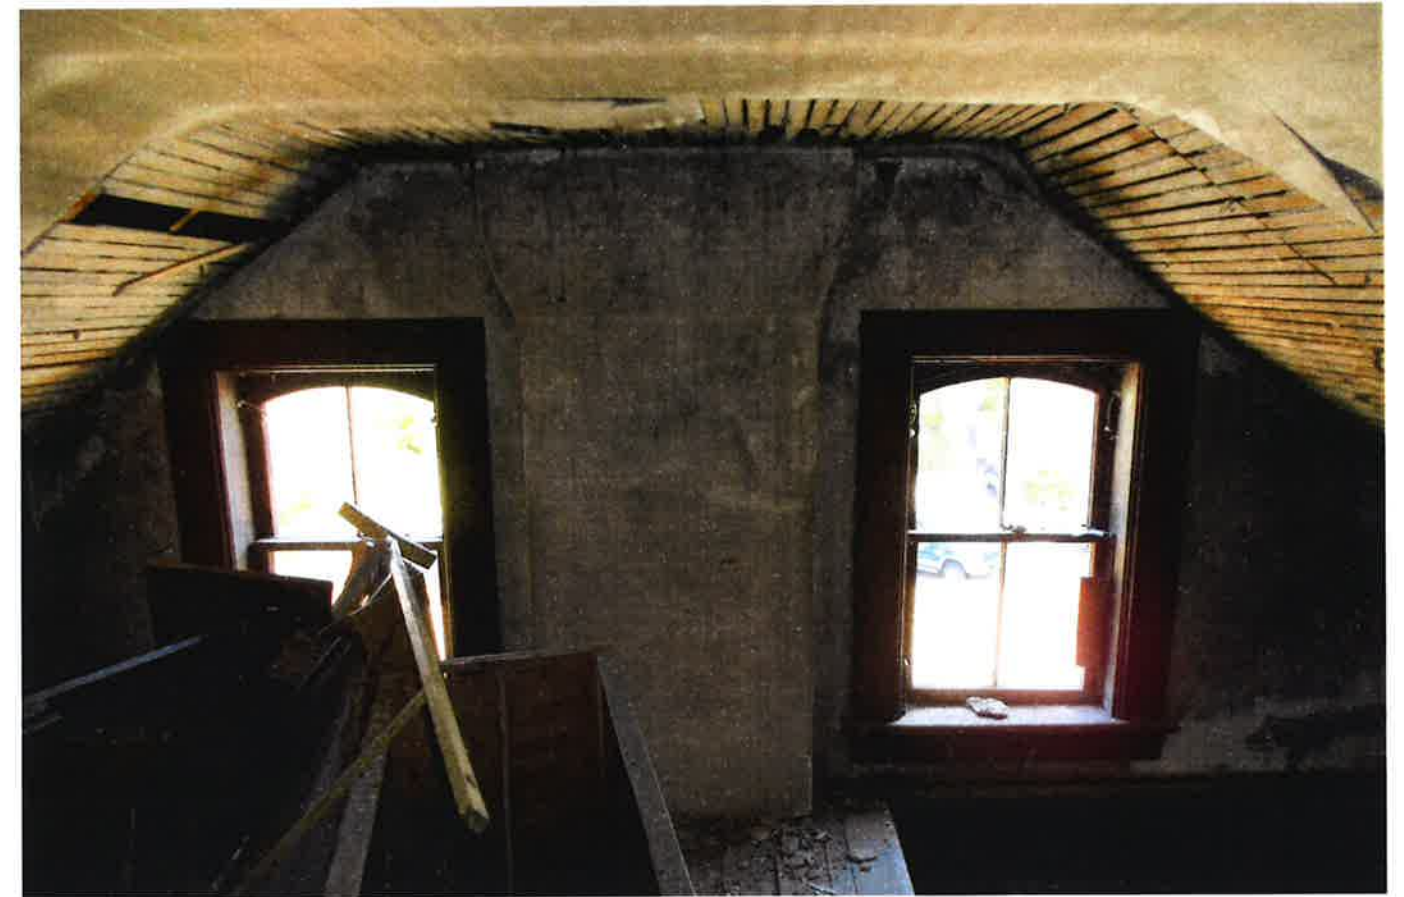
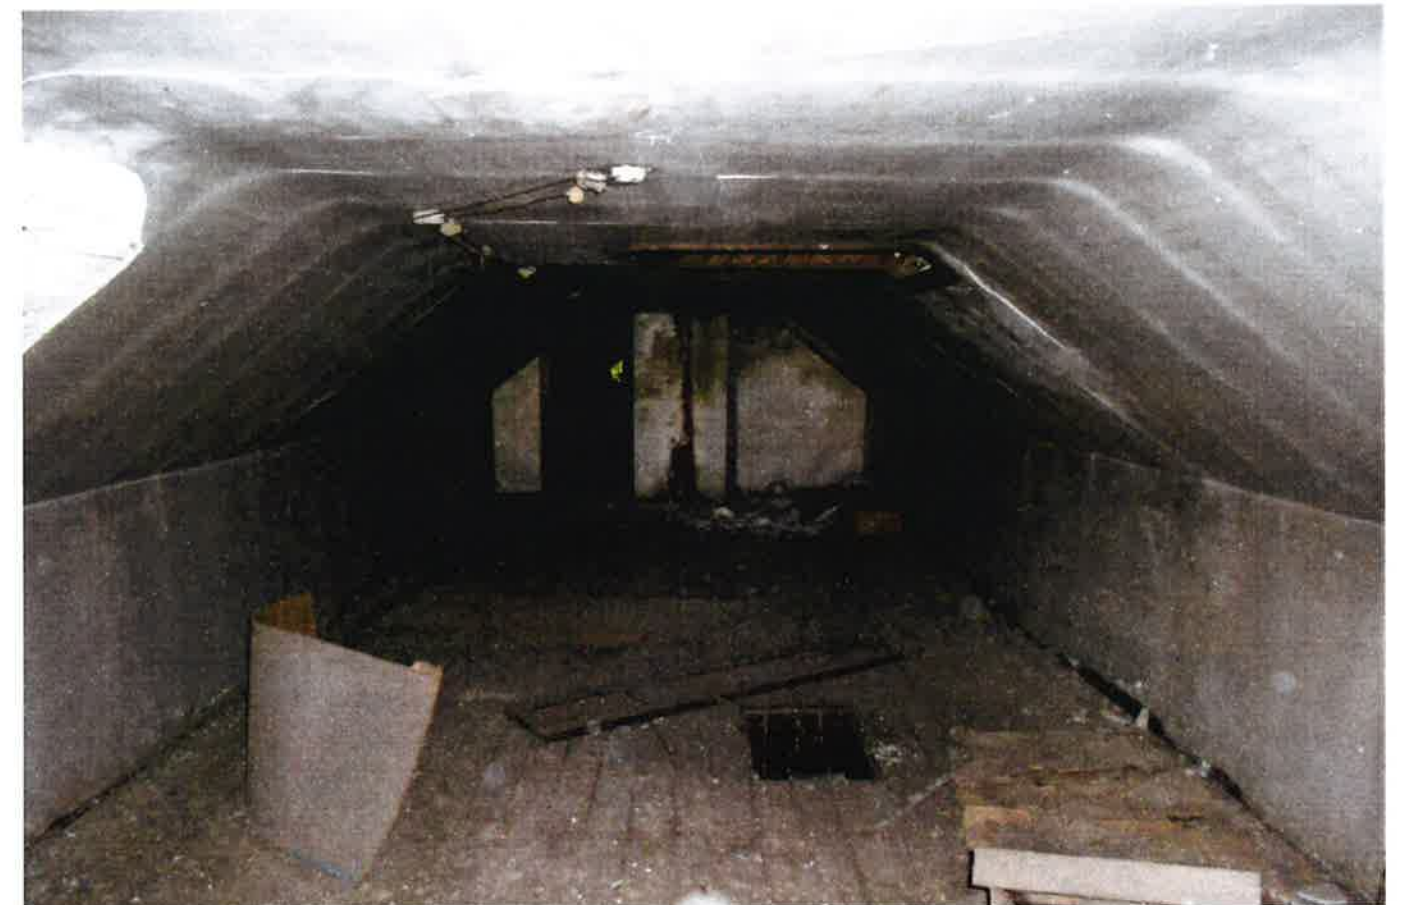
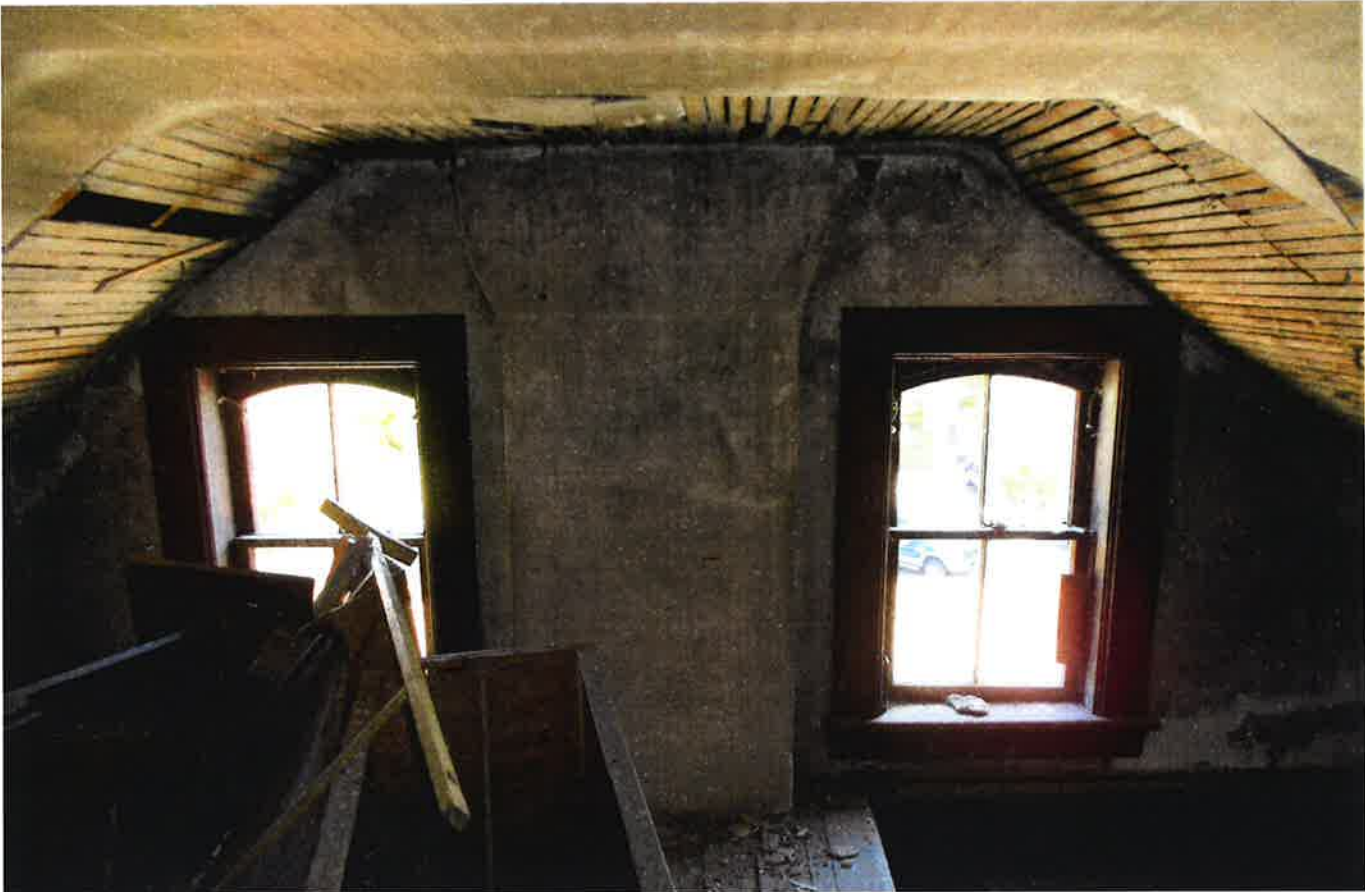
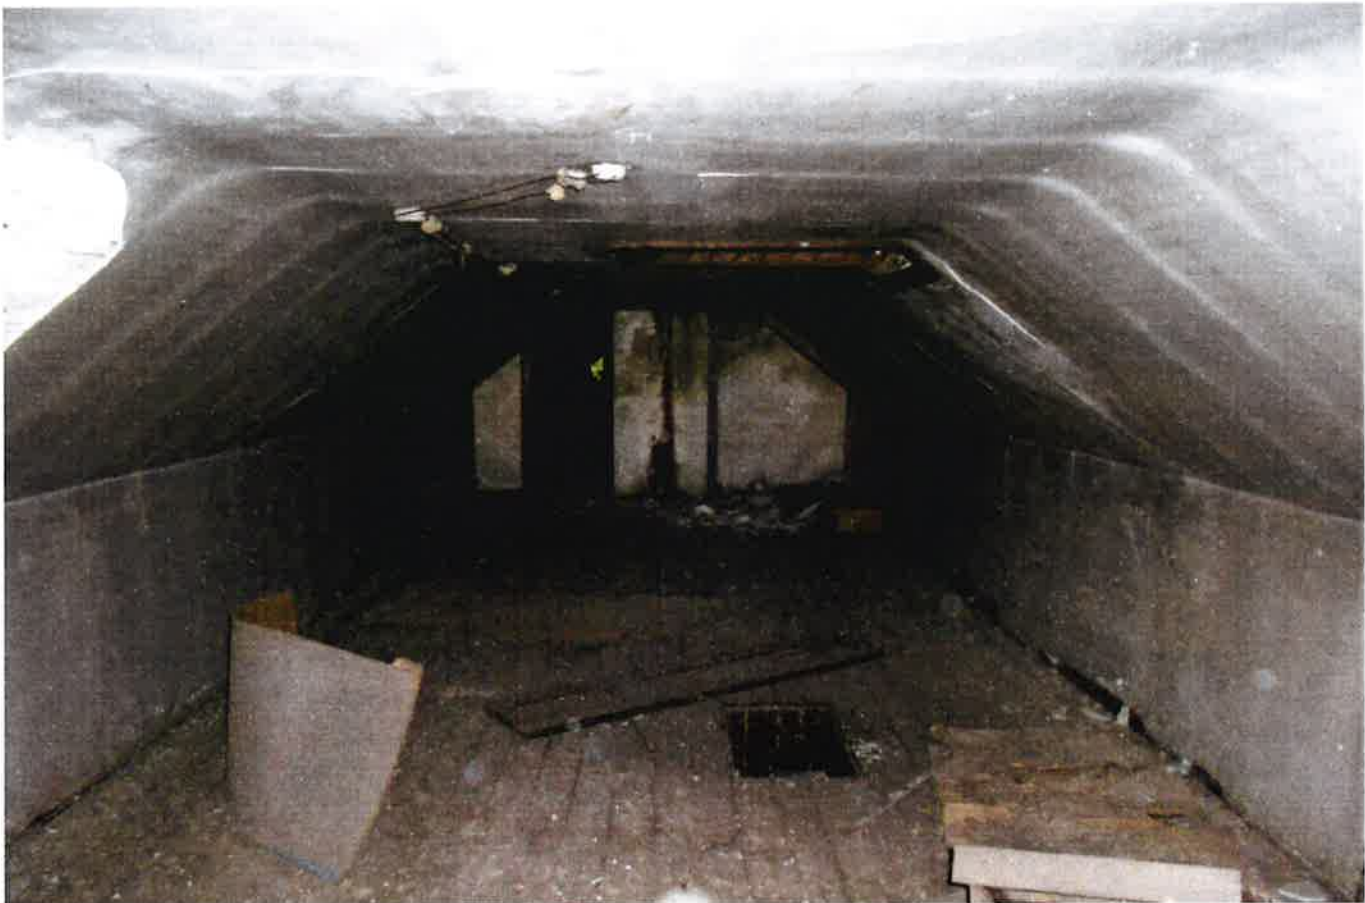
Laundry Building—Level 3 Interior

The attic condition is similar to that of the second floor. In addition, the potential for re-use is limited by the non-compliant ceiling height of approximately six feet.

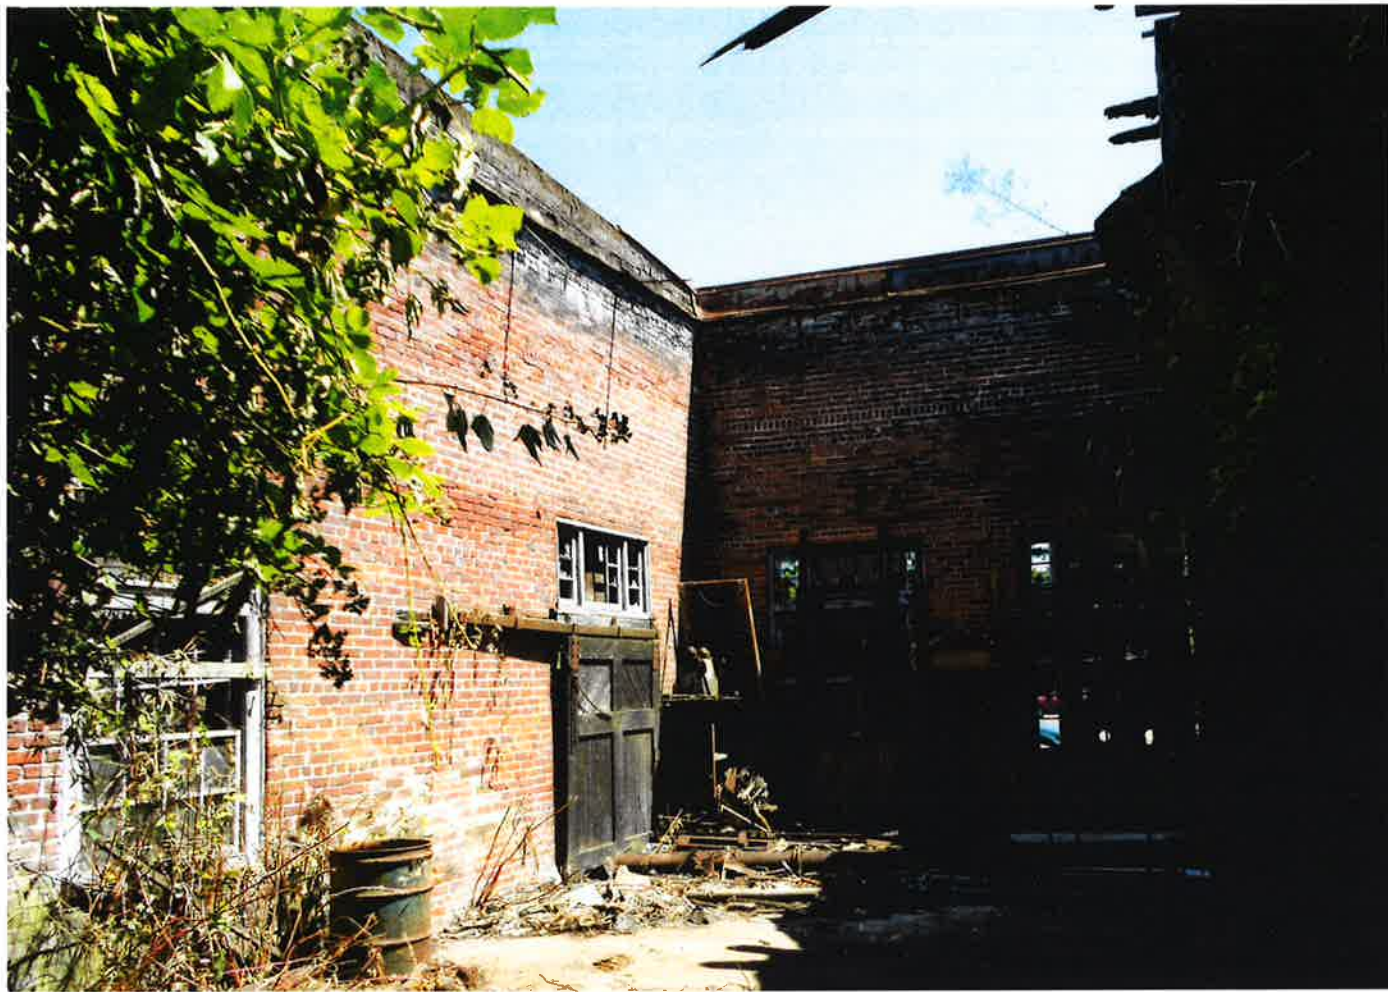
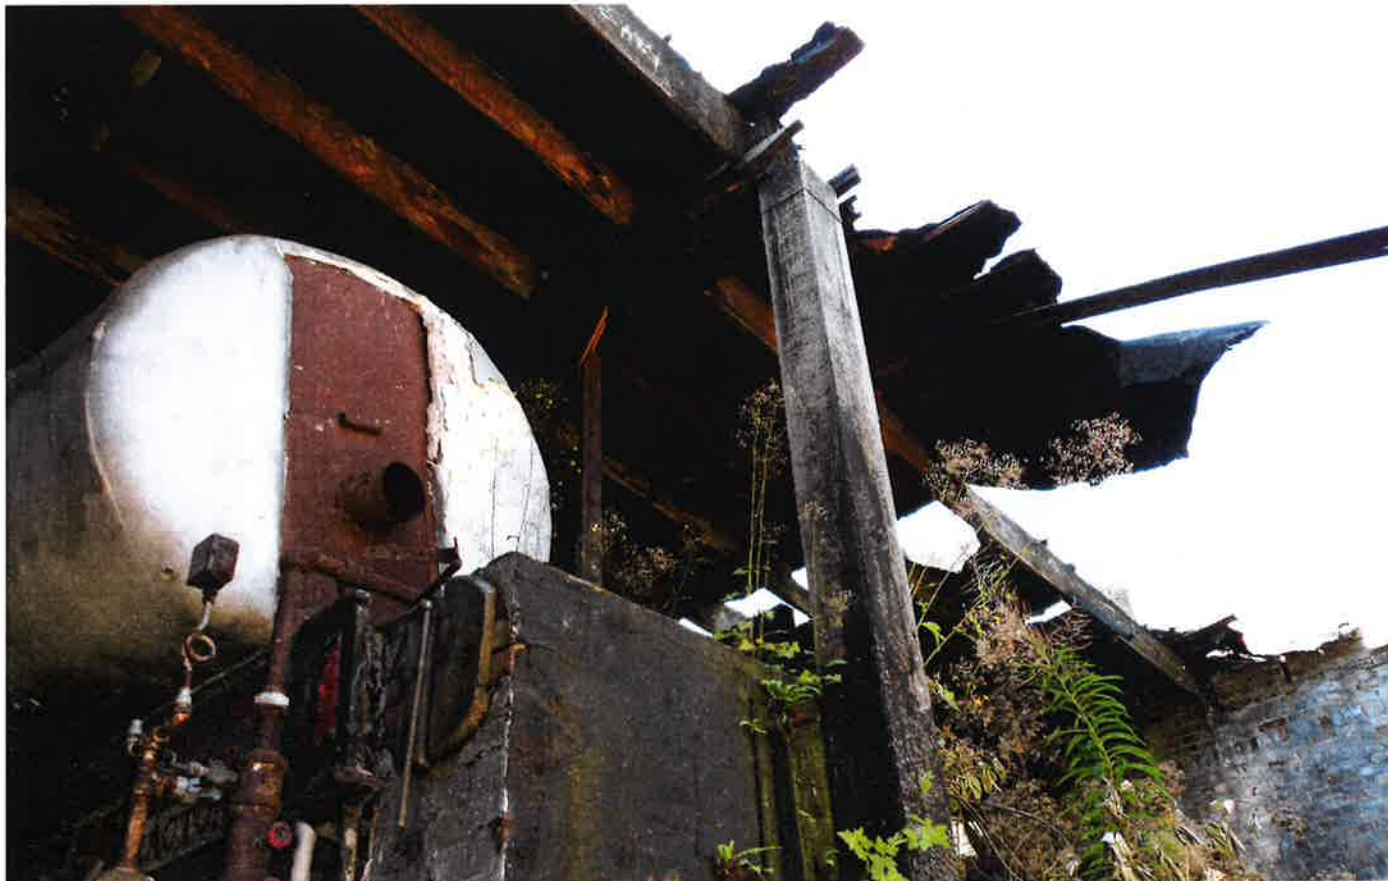
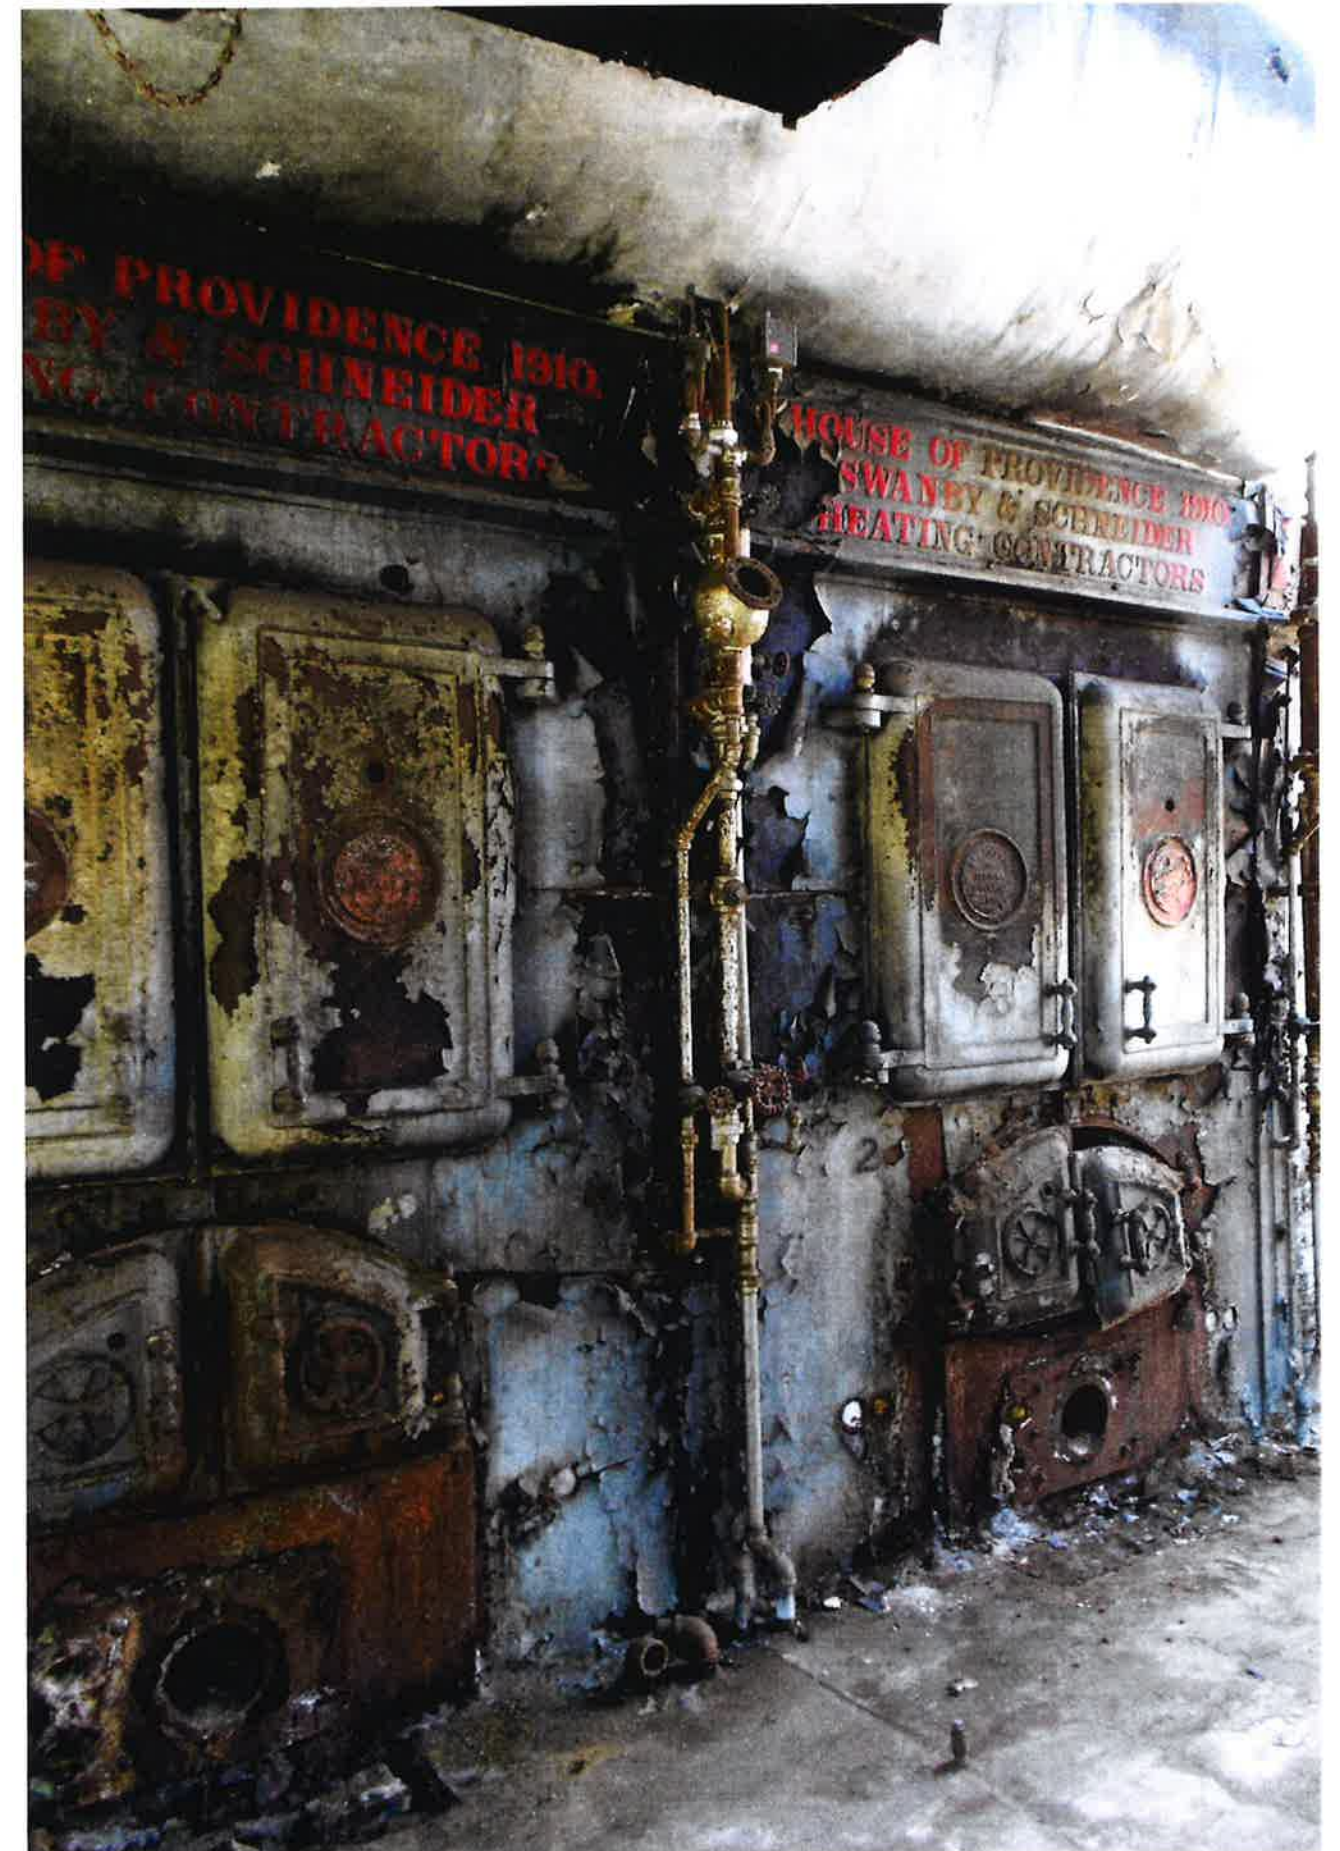
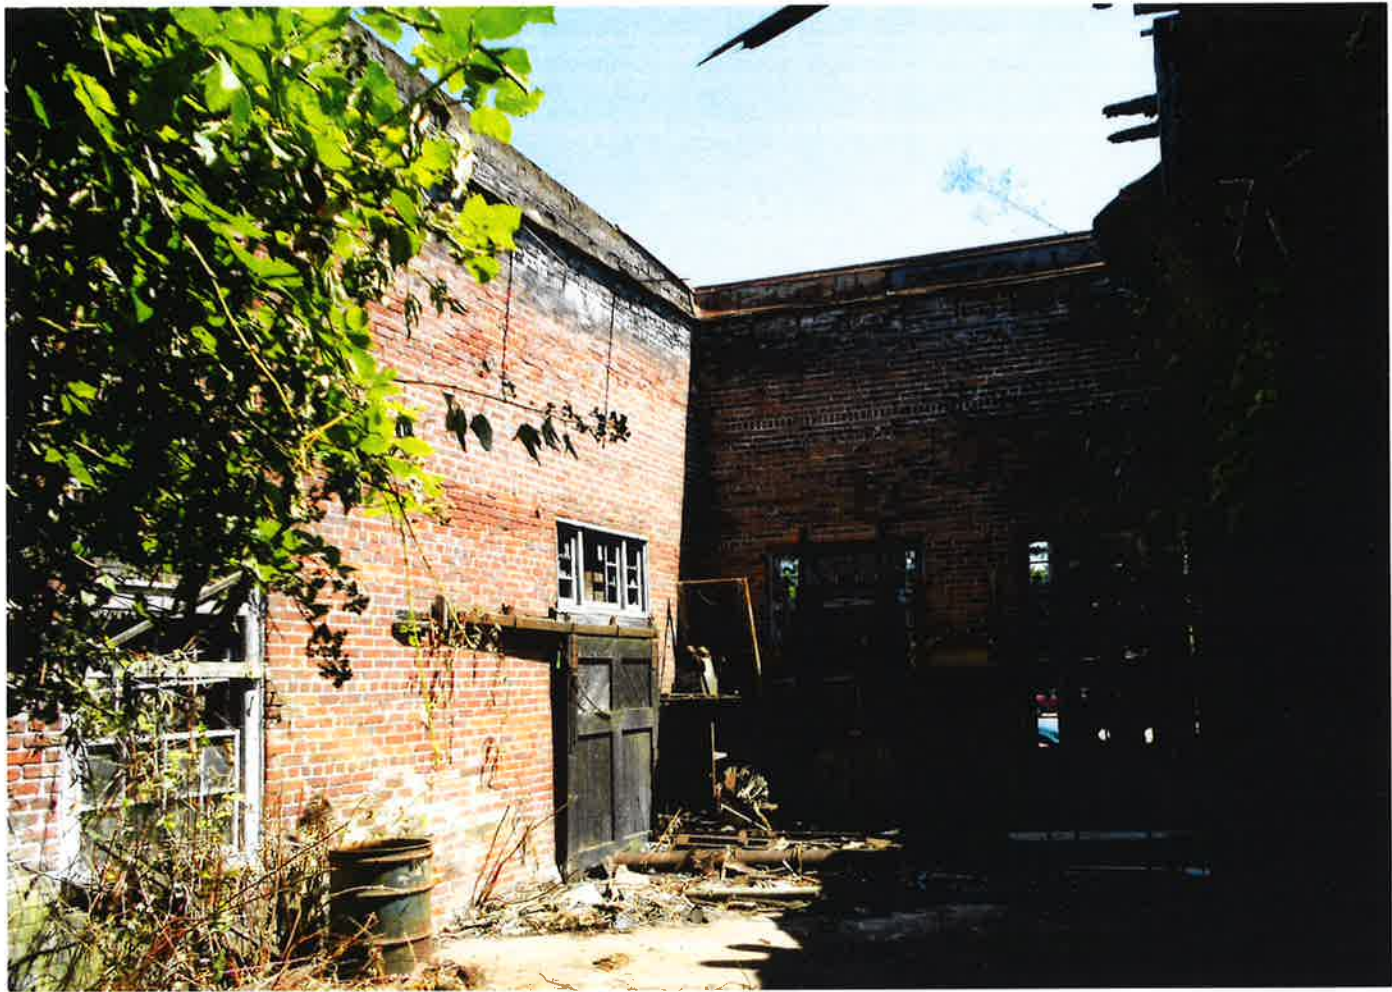
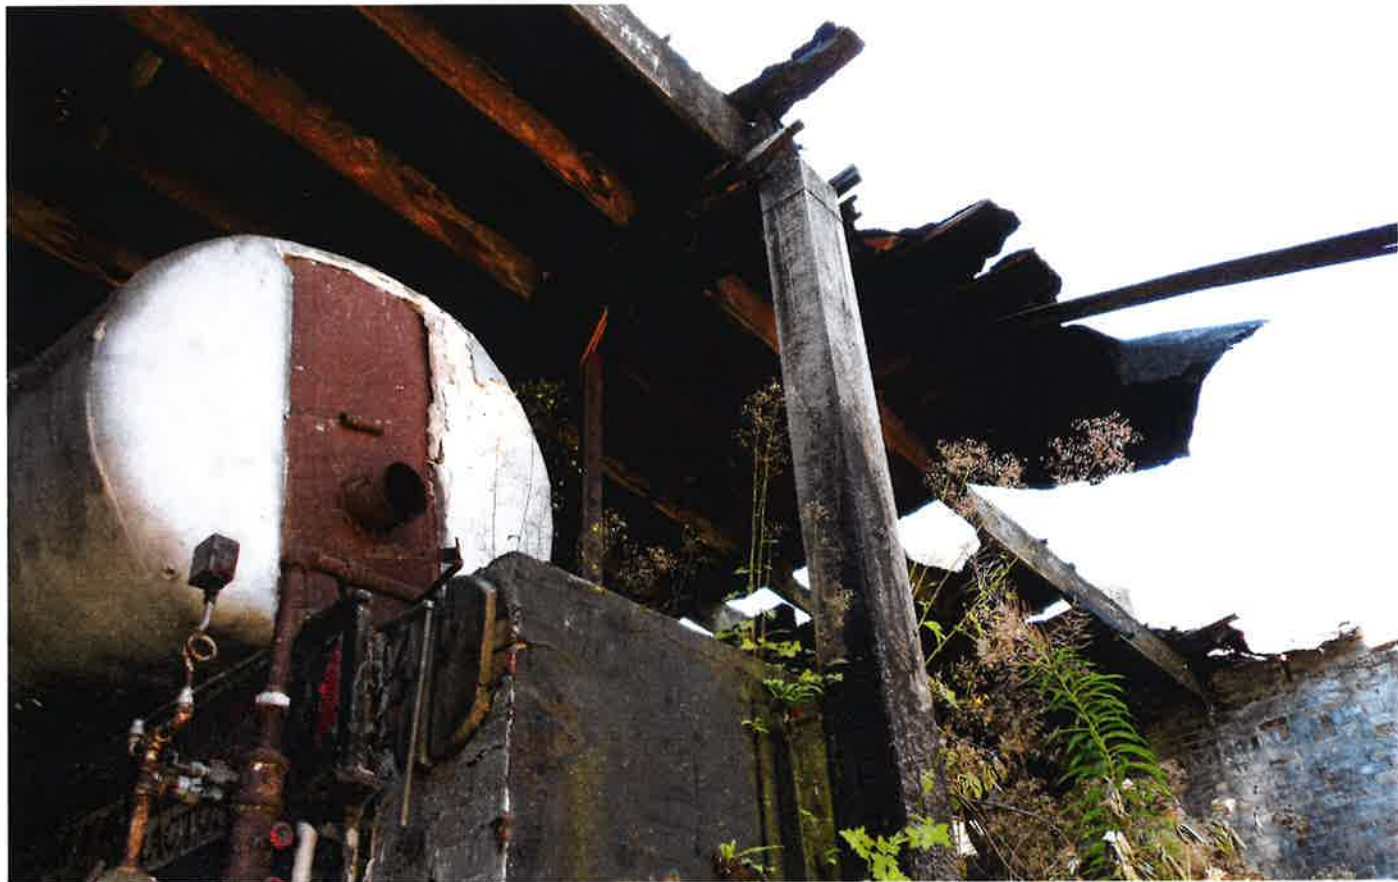
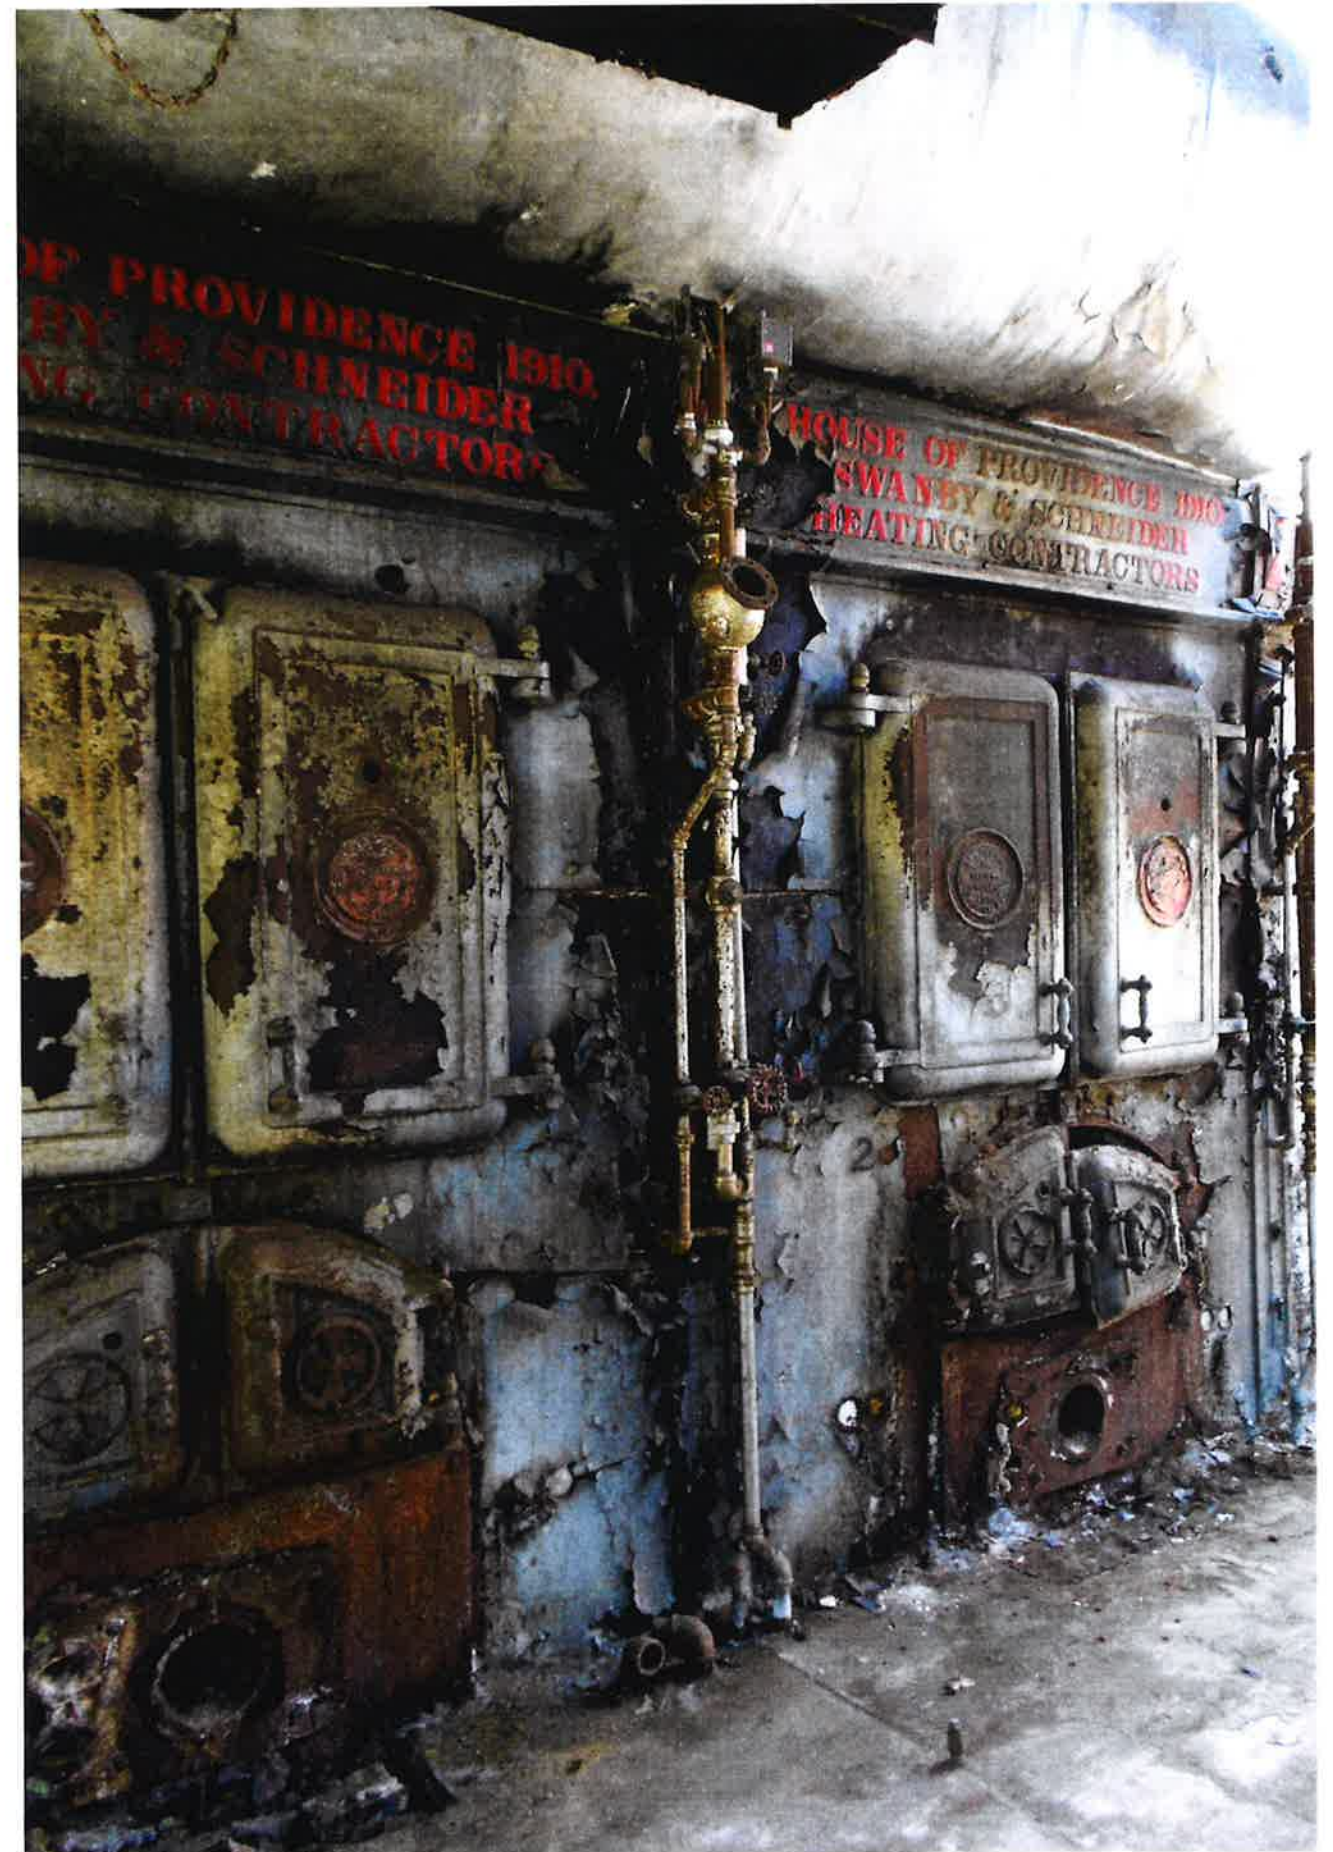
Boiler Building—Interior Photos

The Boiler Building is a one-story brick structure connected to the east side of the Laundry Building. The building is roughly square in plan with an unreinforced masonry smokestack sitting on a square base near the center of the south façade. The wood-frame roof has been substantially lost to fire leaving the interior of the building open to the elements. This condition represents a safety hazard. The roof is/was supported by the unreinforced masonry bearing walls at the perimeter. The floor is concrete slab-on-grade.

The dominant feature of the interior space is the historic boiler, which consists of a massive masonry furnace with a cast-iron front. There are no usable mechanical, electrical, plumbing, or fire sprinkler systems in the Boiler Building.

Like the Laundry, the Boiler Building would also require a change of use to "B" occupancy. A full seismic upgrade would be required, including the smokestack. The roof, windows, and doors would also have to be replaced. All new mechanical, electrical, plumbing (including ADA-accessible restrooms), fire sprinklers, and telecommunications systems would be required for this building. The building would also require abatement of hazardous materials.

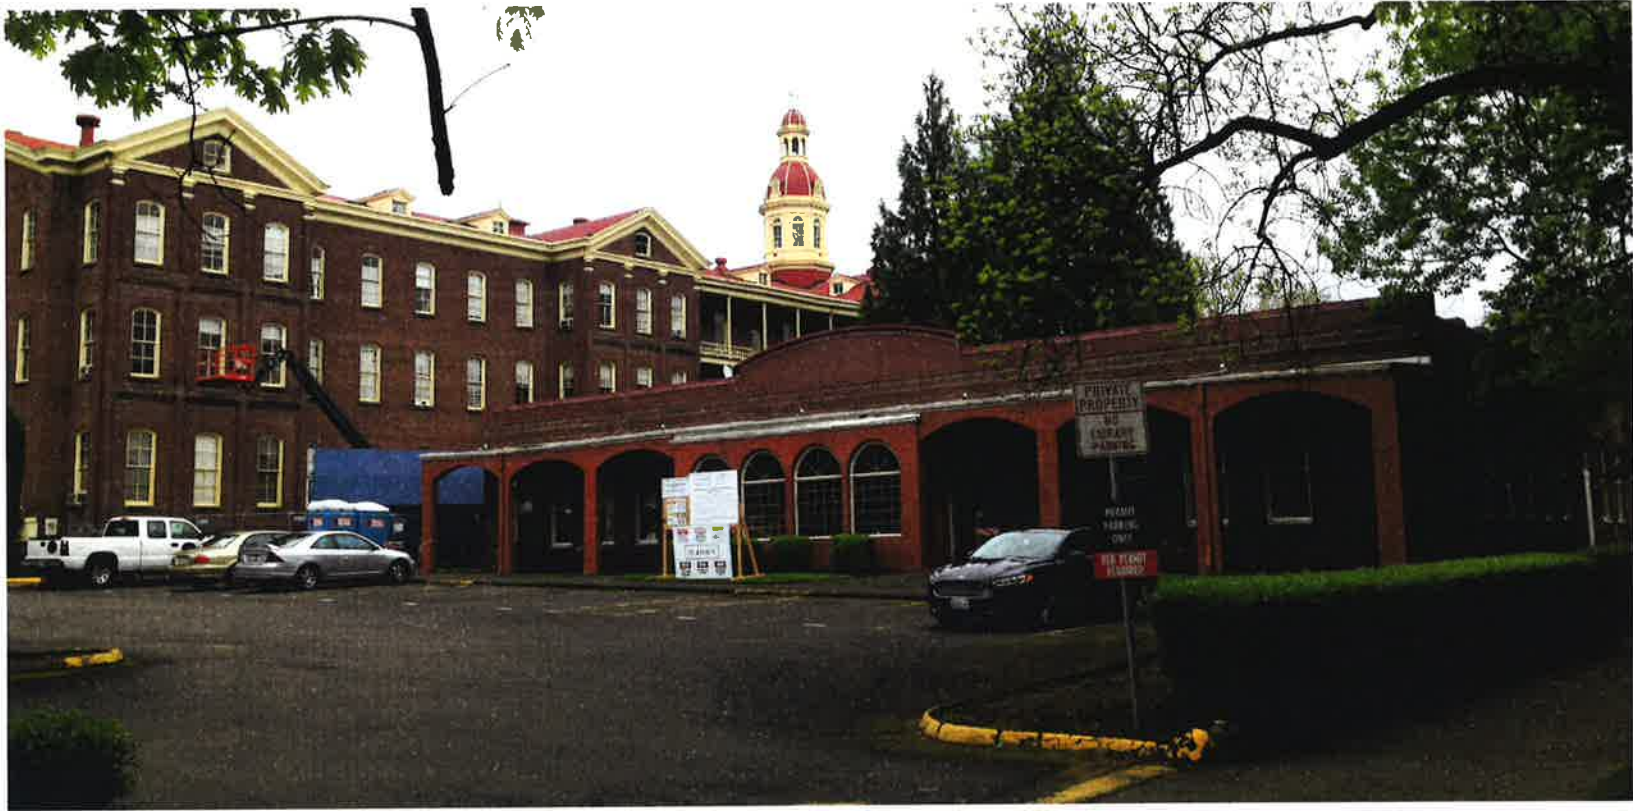
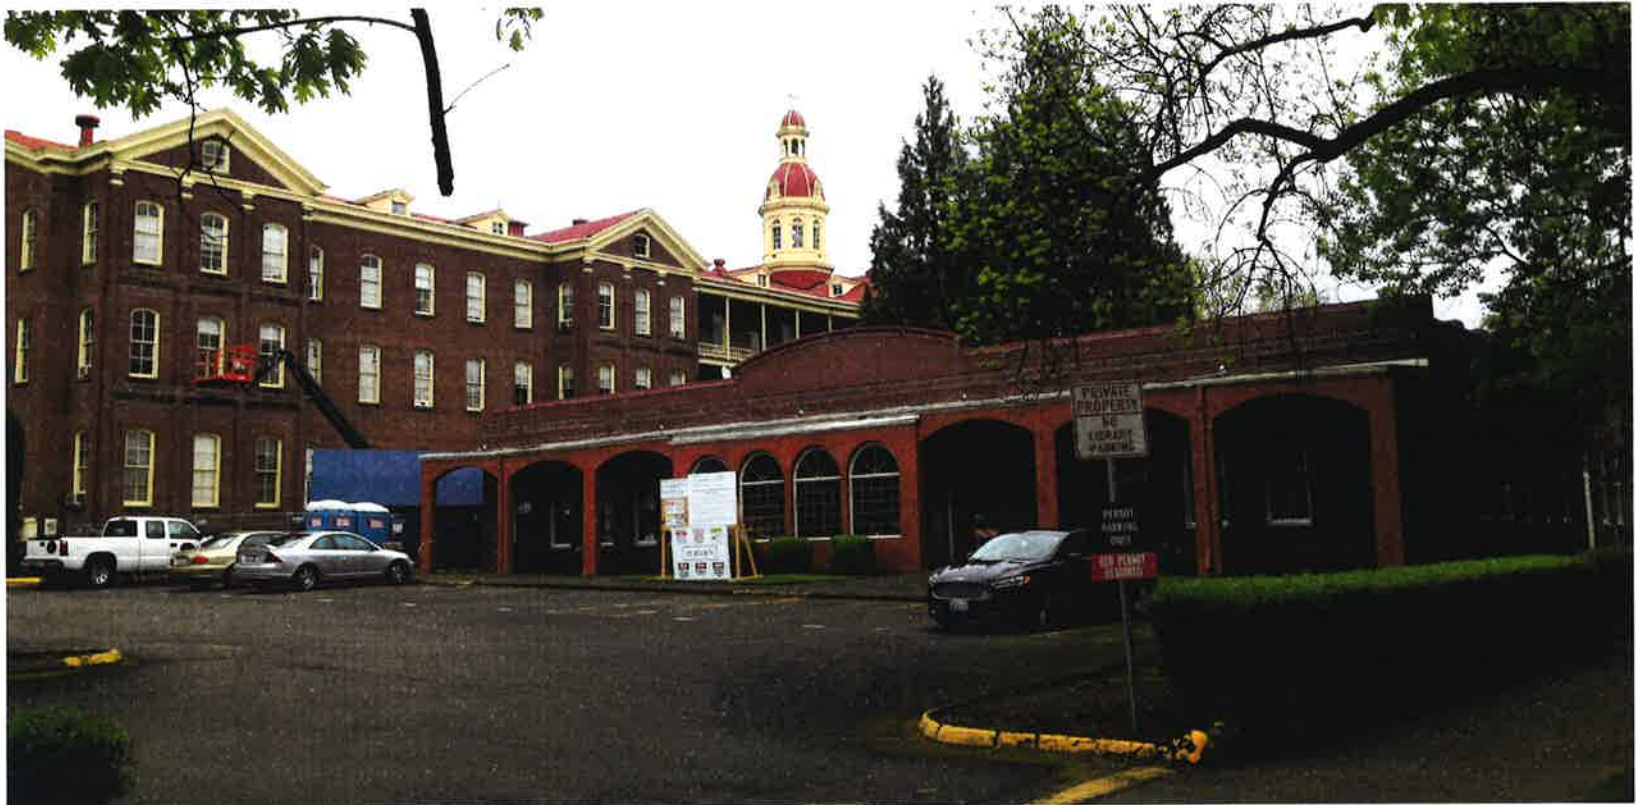
Providence Academy—Existing condition with El Presidente Restaurant

The restaurant is located directly in front of the Academy Building's west wing. Part of the building uses Hidden brick and fenestration similar to the Academy in an effort to be sympathetic to the Academy Building. The east side of the restaurant includes a solarium-type extension that is not compatible and detracts from the historic nature of the grounds.
