# TECHNICAL MEMO

To: Clark County Public Works  
From: Inter-Fluve, Inc.  
Date: May 18, 2006  
Subject: Technical assessment of the Whipple Creek Basin to support stormwater basin planning efforts in Clark County, WA.

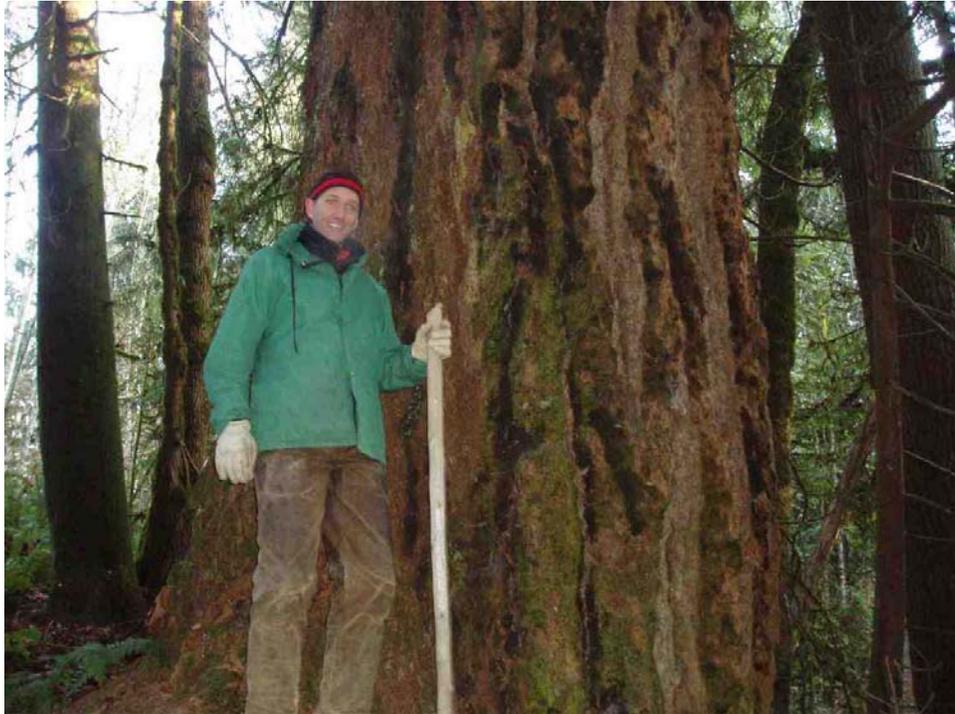
Figure 13. Old-growth fir snag in riparian area of Trib W8.36.

Although riparian corridors are mostly intact throughout the basin, intrusions have occurred over the years for various purposes, including utility corridors, transportation corridors, logging access, livestock access, and residential uses (e.g. lawns). Large trees that historically would have fallen into stream channels were removed years ago. Conifers on the order of several feet in diameter (see Figure 13) have been replaced by smaller hardwood species or invasive species. The removal of large wood that historically provided natural grade control has served to destabilize channels.

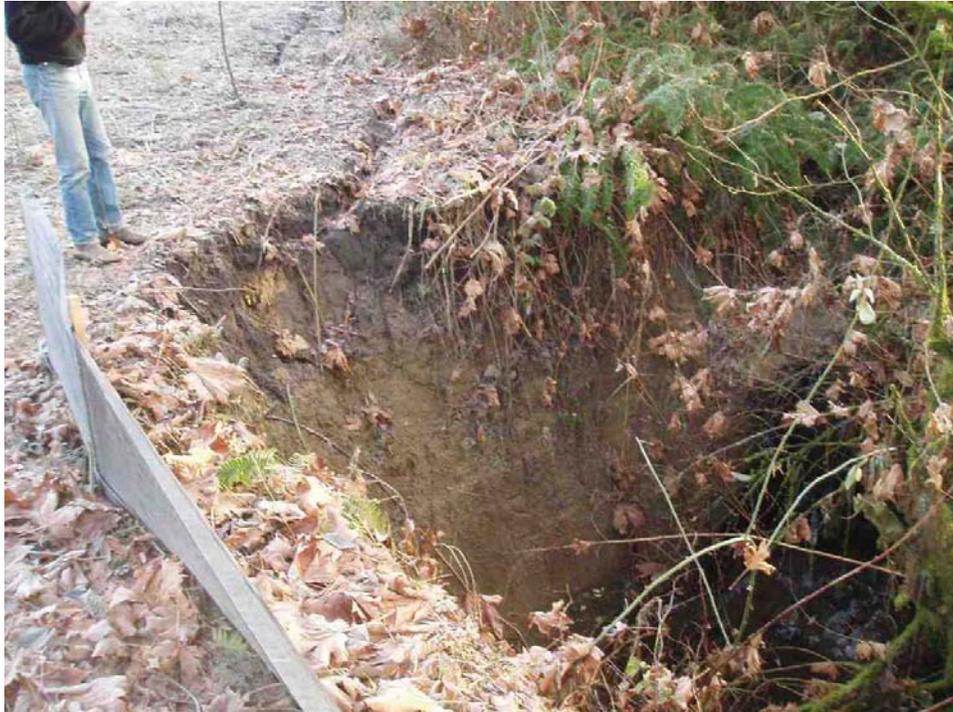
Figure 15. Photo of headcut just downstream of outlet of stormwater detention facility at headwaters of Trib W6.44 (Clark County Fairgrounds site). Approximate height of headcut is 12 feet.

Some of the most severe erosion has occurred near the outlets of stormwater detention facilities or other stormwater outfall locations, where large (up to 15 ft) headcuts have formed in small channels or on valley hillslopes leading to channels. These features are the result of improperly designed or maintained facilities that have failed to control for the effects of flow concentration at discharge locations. Example locations include detention facilities at the fairgrounds site (trib W6.44, Figure 15), Whipple Creek Place (trib W6.26), on trib W5.70 T0.49S, and on trib W8.36 (see Figure 16); and outfalls at the school property (trib W5.70) and on trib P1.06 T0.49W.

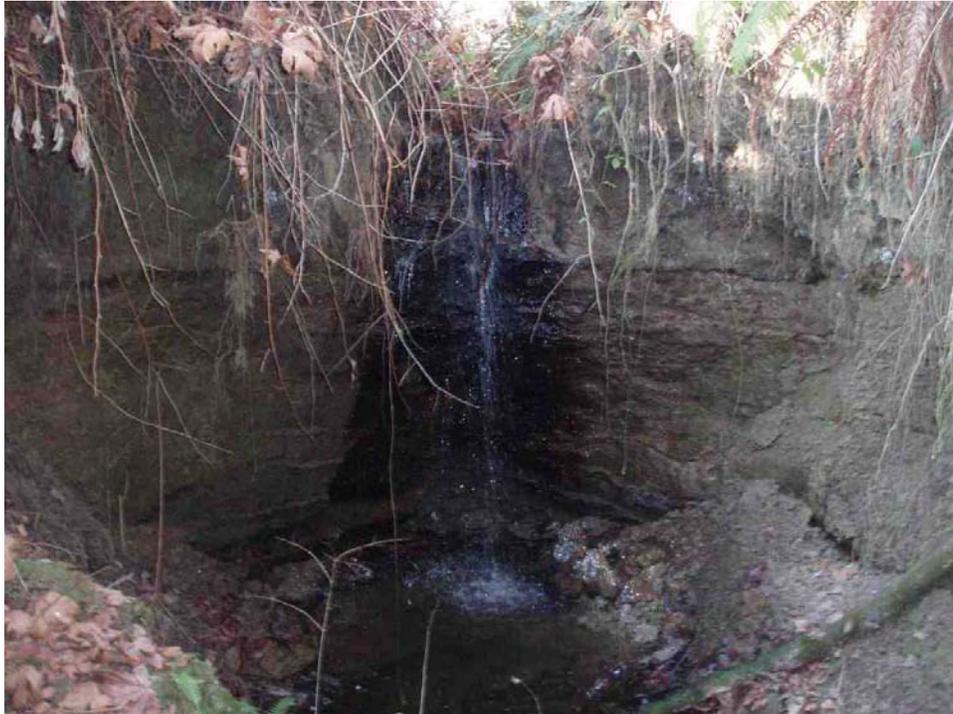
Figure 16. Photo of headcut just downstream of outlet of stormwater detention facility at headwaters of Trib W8.36. Approximate height of headcut is 6 feet.

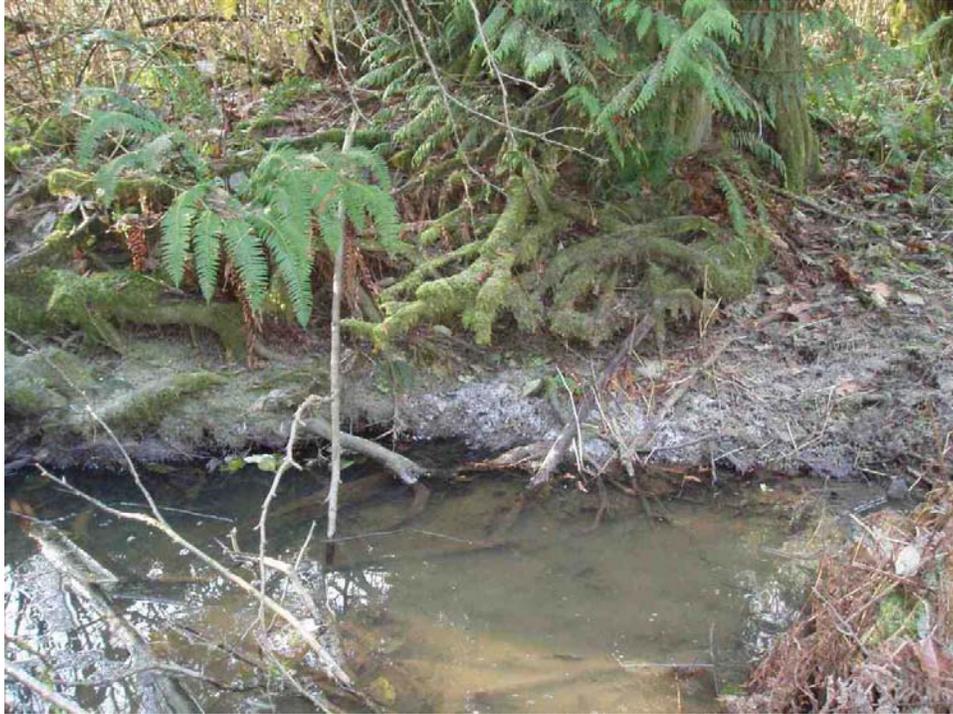
Figure 17. Photo of exposed root mass of Western Red Cedar (covered in moss) adjacent to Whipple Creek upstream of Union Road. Exposure of root mass suggests channel expansion (deepening) has occurred in this area.

The upper mainstem is defined here as the reach extending from Union Road upstream to approximately RM 8.4. This reach is a 3<sup>rd</sup> order channel with moderate gradient (approx. 1.5%). The reach contains a moderate amount of coarse material (gravels and small cobbles) and segments with pool-riffle sequences. In places, channel steps are formed by small woody debris. Banks are fairly stable throughout with both native and non-native vegetation (blackberries) and root masses providing stability. Large patches of dense blackberry thickets are located beneath openings in the riparian forest canopy. These patches are interspersed with healthier forest patches with native vegetation. A medium (approx. 4 ft) headcut is located at the top of this reach at approximately RM 8.3. Upstream of this location the stream is a slightly entrenched (high valley width to bankfull width ratio) channel with a low width/depth ratio. The stream is well connected with its floodplain and courses through floodplain wetlands thick with reed canary grass and beaver activity. Below this location, the stream is incised and appears to have drained former floodplain wetlands. Further downstream, the channel appears to be in a moderate-to-good condition. Several small headcuts (less than 3 feet in height) are located along the length of the lower reach with evidence of moderate channel expansion in places (see Figure 17).

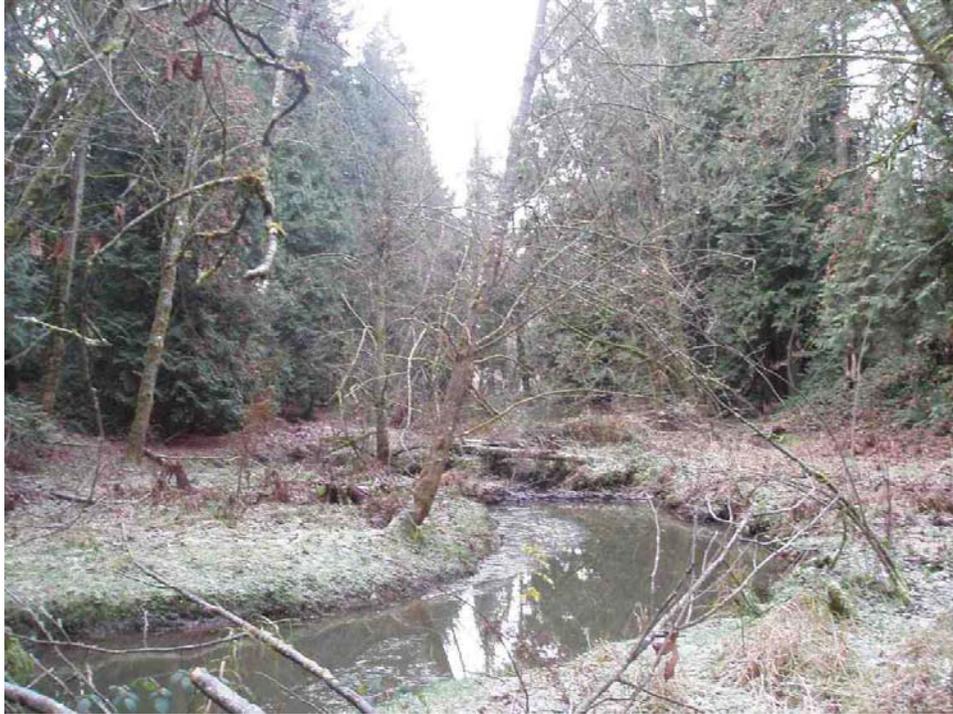
Figure 18. Characteristic middle mainstem reach at approximately RM 7.2.

The middle mainstem is defined here as mainstem Whipple Creek extending from the Packard Creek confluence upstream to Union Road. This segment consists of 3<sup>rd</sup> and 4<sup>th</sup> order reaches with very low gradient (<0.35%). These channels are primarily response reaches, with channel beds and banks made up of sands and silts. Figure 18 depicts a channel that is characteristic of the middle mainstem. Coarse material is scarce, with isolated pockets of gravels located at areas of high scour (i.e. culvert outlets) or at tributary confluences. The upper portion of this segment (upstream of 11<sup>th</sup> Ave.) alternates at times between a defined channel and long beaver dam complexes where standing water extends across the floodplain. The lower portion of this segment also contains beaver activity, but channels are more defined, with beaver dams and small log jams creating sequences of steps separating long, slow moving pools.

The entire segment contains broad floodplains, most of which appear to be moderately-well connected with the stream channel. During field visits following 2-year or greater flow events in winter 2005-06, there was evidence that flows were at or near top of banks, although substantial inundation of floodplains had not occurred. In some locations, it is probable that flows that would have historically been over-bank flows may now be contained within the channel.

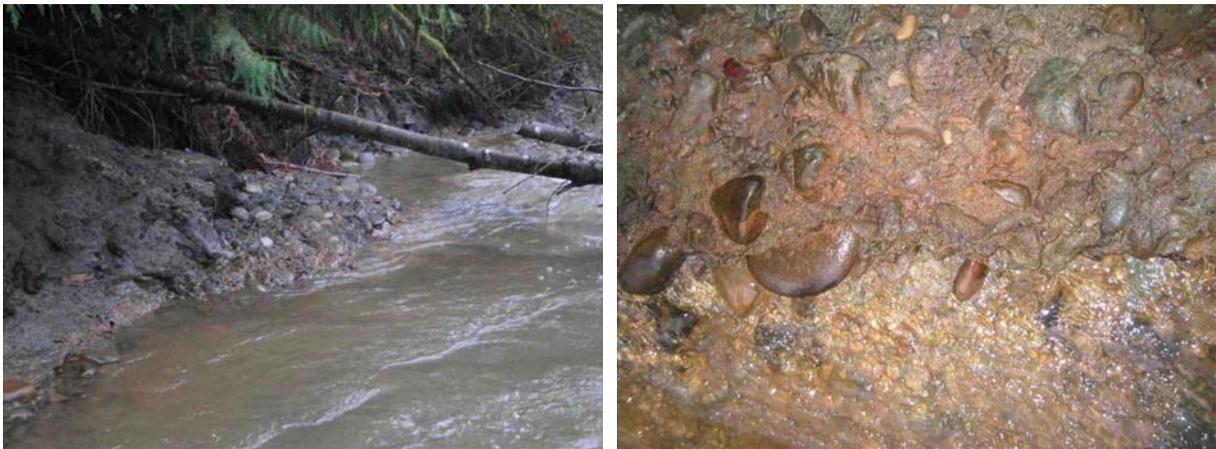
Figure 19. Outcrop of Troutdale Formation in the mainstem below Packard Creek (approx. RM 2.6).

This reach contains a significant quantity of coarse bed material in the form of gravels and cobbles up to 12cm median diameter. Coarse material is sourced from the underlying Troutdale Formation, which can be seen in channel banks as coarse gravels and cobbles in a sandy matrix (see Figure 19). The gradient and flow volume through this reach is sufficient to mobilize this sediment, maintaining good sorting and cleaning of the substrate. Consequently, this reach contains the greatest quality salmonid habitat in the basin.

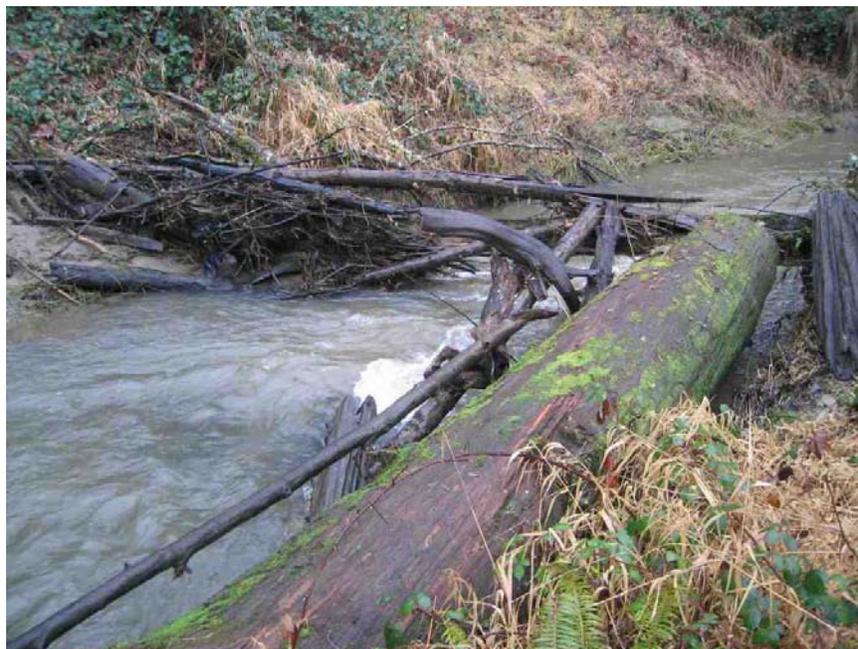
Figure 20. Log jam with large key piece at approximately RM 2.8.

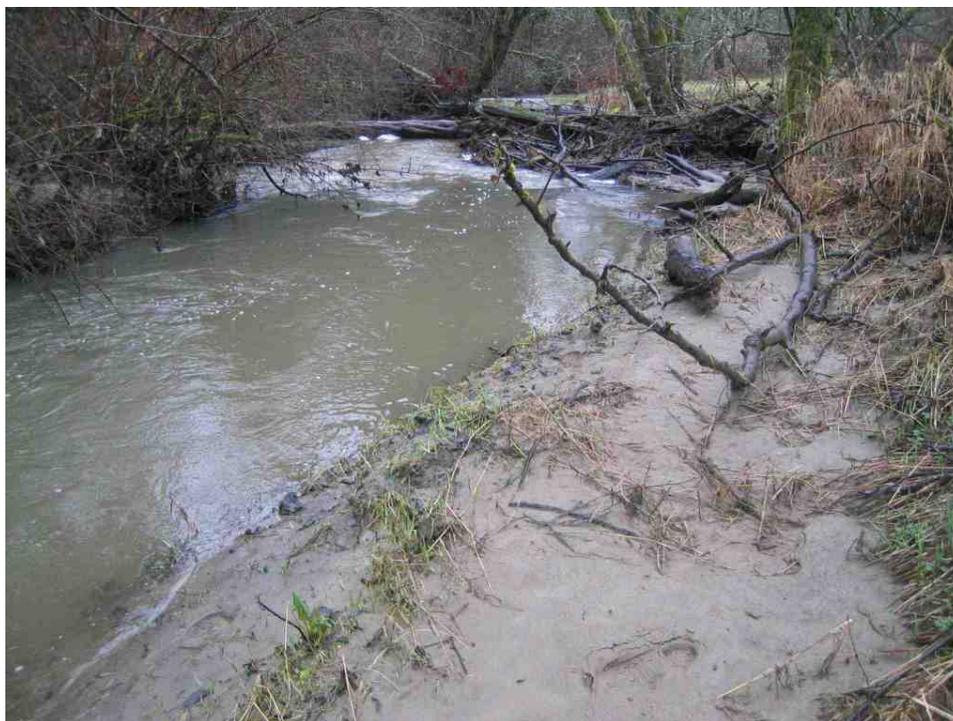
Figure 21. Accumulation of fine sediment as a result of backwater effects of log jam at approximately RM 2.9.

Log jams in this reach are providing important channel functions. Field observations following flood events indicate that jams are trapping fine sediments downstream, within, and upstream of the jams (Figure 21). Overflow channels scour floodplains, increasing floodplain connectivity. Channel adjustments discourage invasive riparian vegetation and create soil conditions favorable to colonization by native vegetation. Figure 22 depicts an area where backwater effects from an upstream log jam created floodplain overflow and subsequent scour and fill of material, allowing for young alders to colonize the site. This is the only location observed in the entire basin where there is any significant new growth of young riparian trees.

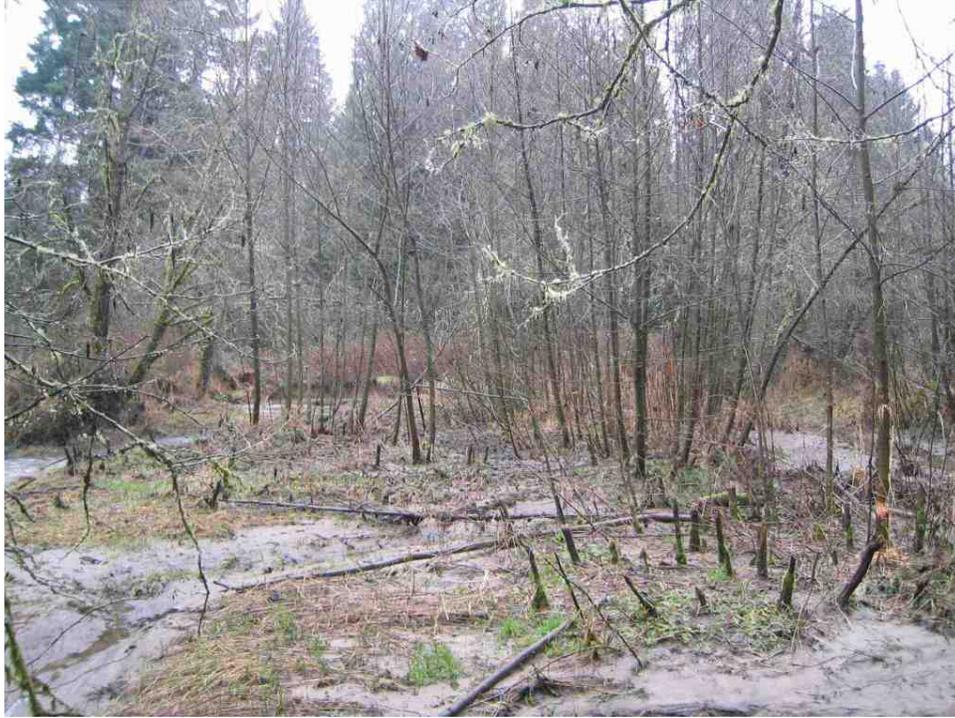
Figure 22. Young alders colonizing fine sediments recently deposited as a result of channel adjustment due to an upstream log jam (approx. RM 2.4).

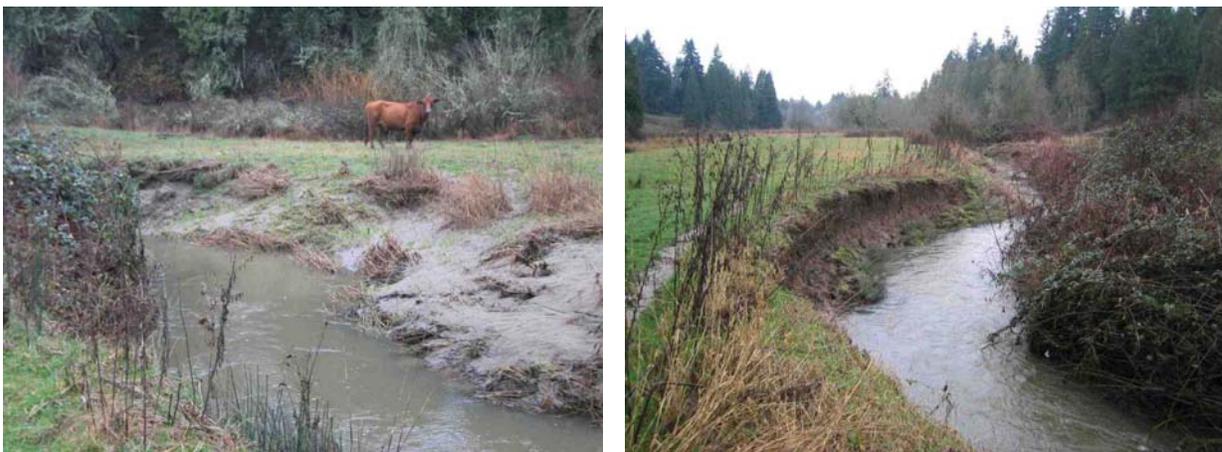
Figure 23. Whipple Creek in pasture area (near RM 2.2). Removal of riparian vegetation, colonization by invasive plants, and cattle access to the stream has resulted in a severely eroding and incised channel.

Below approximately river mile 2.4, conditions change dramatically. The gradient lowers and the stream enters a disturbed area. The upstream portion is within a maintained residential lawn, where lack of riparian vegetation and mowing up to the stream edge has caused severe bank instability. Below this, the stream enters a large pasture that extends to the stream edge, with cattle access to the stream channel. The channel here is severely incised and overwidened, with no woody riparian vegetation, and blackberry thickets along the channel (Figure 23). The channel bed is sand and silt.

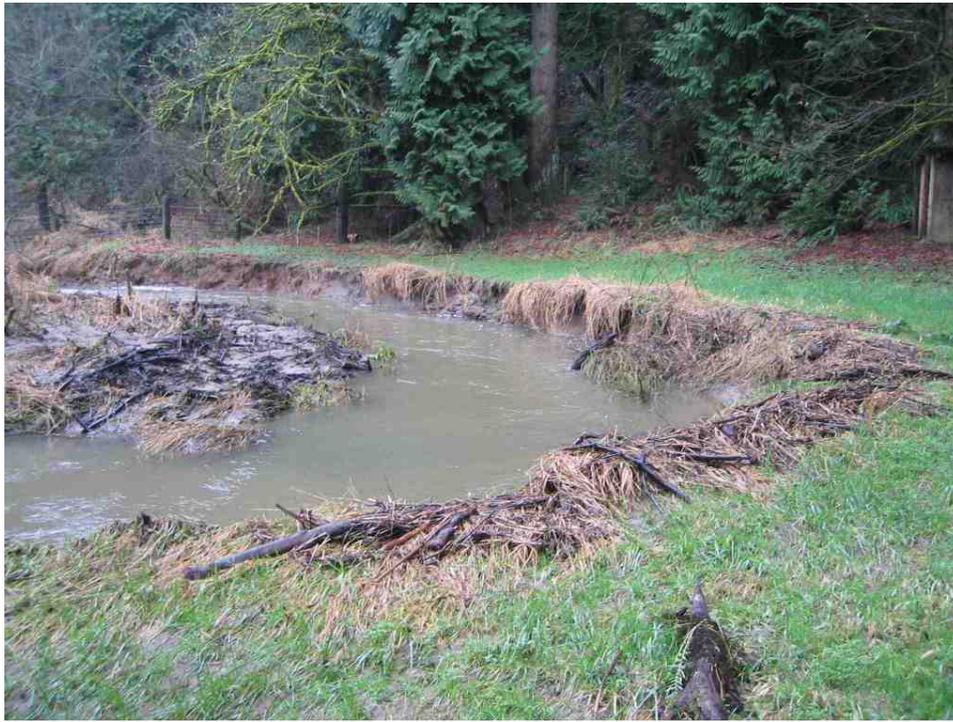
Figure 24. Evidence of recent over-bank flows at lawn area near RM 2.3.

During field surveys following 2-year plus flood events in winter 2005-6, overbank flows were evident at the lawn at the upper end of this disturbed reach (Figure 24), but did not occur in the incised channels in the pasture. These channels have over-enlarged beyond what is needed to convey the dominant discharge and have therefore lost their connection with floodplains. It is probable that meander patterns and channel geometries have changed dramatically in this area. Sinuous channels were likely straightened either through avulsions or direct human alteration. Incision then followed, lowering gradients and simplifying channels. There is currently very little suitable habitat in this area. Channel restoration at the upper end of this pasture area could potentially create sufficient gradient and channel structure to maintain suitable spawning gravels.

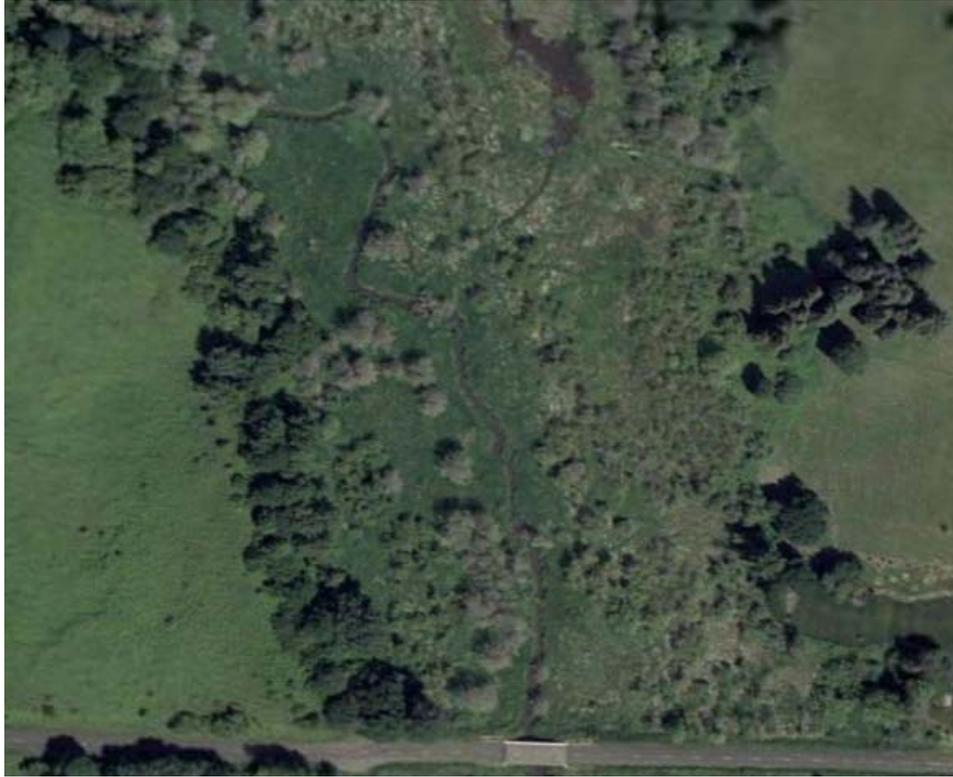
Figure 25. Aerial photograph of lower Whipple Creek just upstream of NW Krieger Road crossing near the mouth.

The lower mainstem below river mile 2 was not surveyed. Given the gradient profile and field observations from the road crossing near the mouth, it is assumed this reach would be similar to the middle mainstem, only with broader floodplain wetlands with less woody riparian vegetation (Figure 25). Channels near the mouth are very low gradient response channels with bed and banks comprised of silty material. Tidal backwater effects appear to extend some distance upstream. Floodplains are wide (approx. 800 feet), have high water tables, and are dominated by reed canary grass. The only trees are sparsely distributed Oregon Ash.

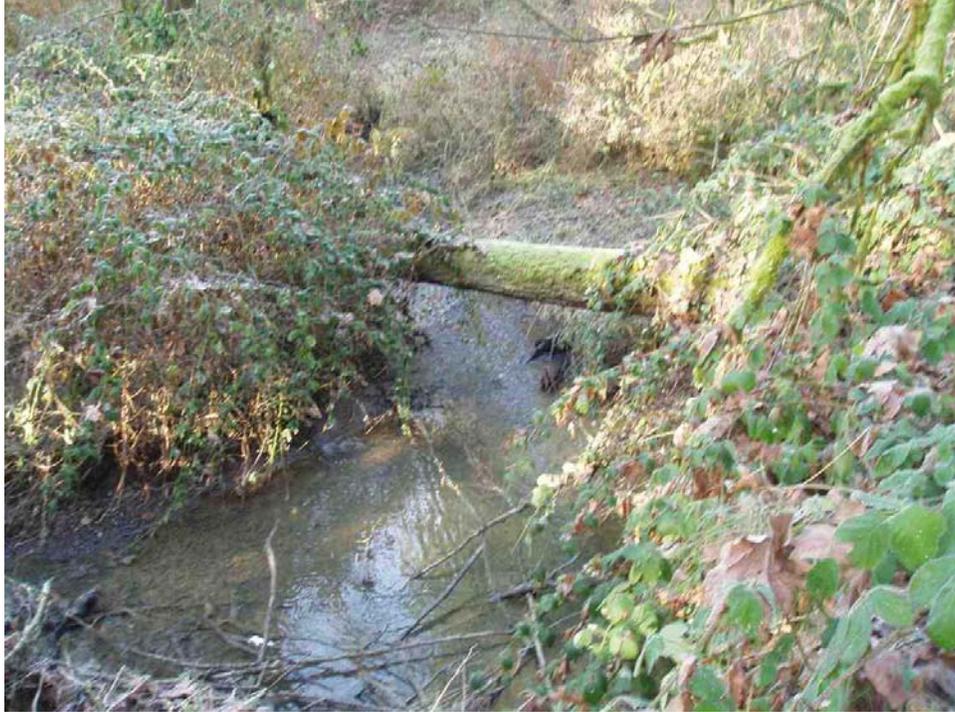
Figure 26. Photo of wood spanning above channel in Packard Creek. This is a common occurrence in Packard Creek and other incised channels.

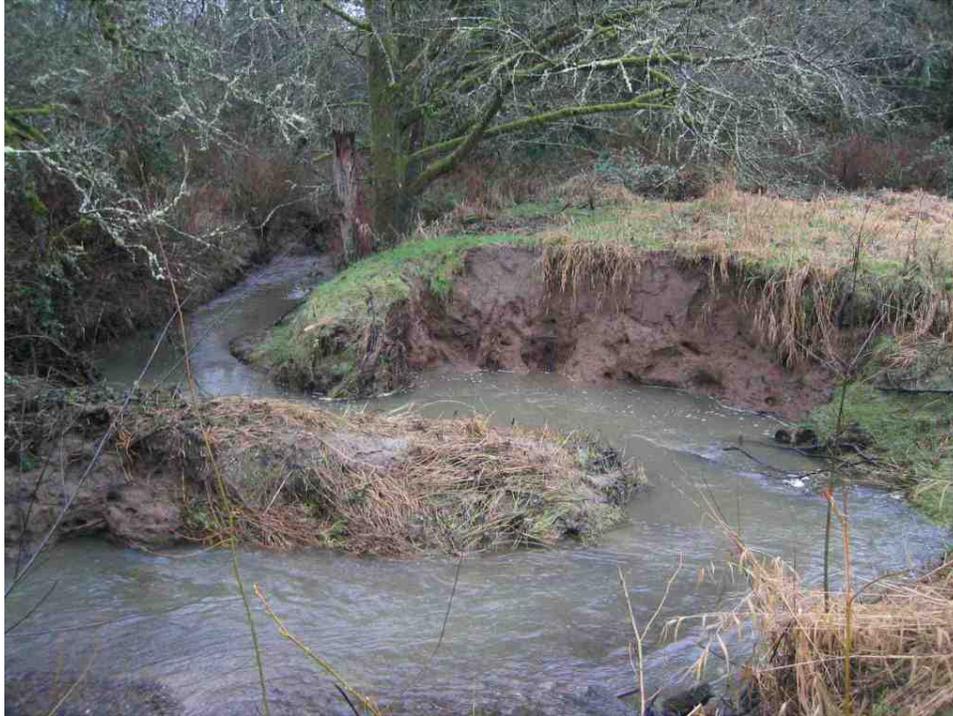
Figure 27. Streambank erosion at lower Packard Creek just upstream of the confluence with mainstem Whipple Creek.

Where Packard Creek courses through the floodplain of mainstem Whipple Creek, significant bank erosion has developed (Figure 27). An actively eroding 8 foot cut-bank has been caused by downcutting of Packard Creek to meet the grade of mainstem Whipple, which is incised into its floodplain at this location. The large amount of material contributed from bank slumping has further directed flow to the eroding bank. This process will continue until either channel roughness increases to slow velocity, the slope is reduced sufficiently to reduce shear stress, or bank resistance is increased.

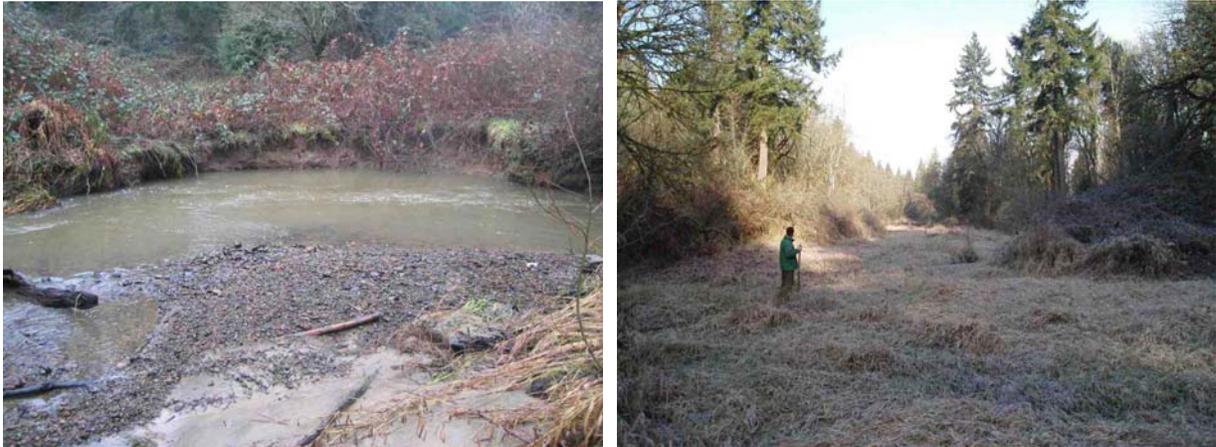
Figure 28. Typical riparian conditions now found in the basin (Left photo: blackberry dominated; Right photo: reed canary grass dominated).

In contrast to the pattern described above, we see a different process of succession that has followed the harvest of riparian timber in the early-to-mid 1900s. Essentially, natural forest succession has been interrupted by invasive species. Alders were able to re-colonize following harvest, but invasive species have prevented subsequent conifer growth. As a result, most riparian areas now contain sparse collections of alders at the tail end of their lifespan, with no young recruits of conifers or deciduous tree species. Blackberries or English Ivy have prevented the re-establishment of new seedlings and invasive species now form dense mats on the forest floor. Reed canary grass takes over in moister areas where

vegetation such as bull rushes and Oregon Ash would have dominated. See Figure 28 for typical riparian conditions now found in the basin.

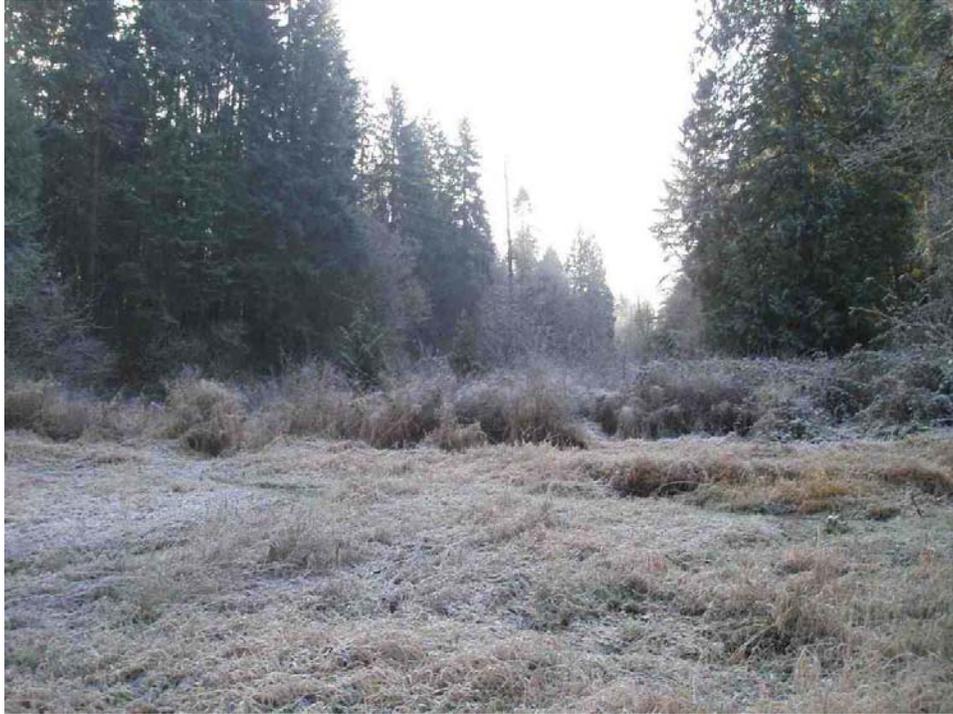
Figure 29. Reed Canary Grass (in foreground) dominates this riverine wetland area. Himalayan blackberry becomes the dominant vegetation as one moves downstream as a result of incision that has drained the floodplain terrace. A headcut is located near the transition from Reed Canary Grass to blackberry.

The interruption of natural forest succession is exacerbated by channel incision. Incision reduces overbank flooding and channel migration; processes that are necessary to scour new surfaces for native seed germination. Incision also drains floodplain soils, which may allow blackberries to take over in place of wetland vegetation. Wetland vegetation, however, is dominated by reed canary grass in most areas. There are several examples where floodplain wetlands dominated by reed canary grass have been drained due to channel incision and are now dominated by blackberries (Figure 29). Blackberries also dominate where there have been intrusions into the riparian corridor (e.g. roadways, utility corridors).

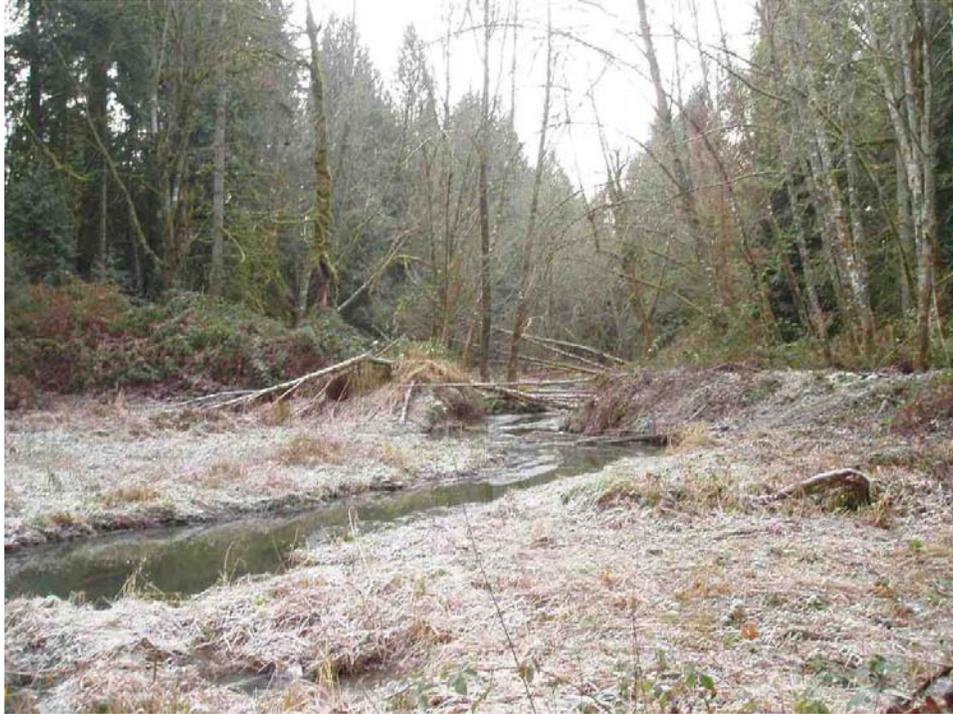
Figure 30. Remnant floodplain fill spanning the floodplain near RM 7.3. The creek currently flows through a break in the fill.

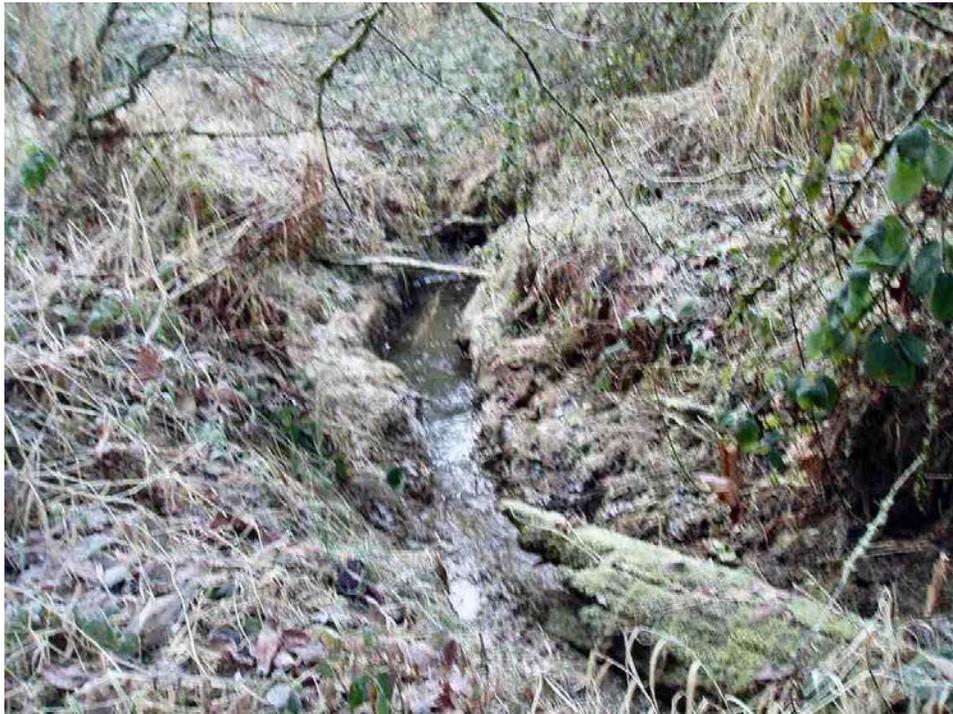
Figure 31. View of incised channel downstream of headcut near RM 8.3.

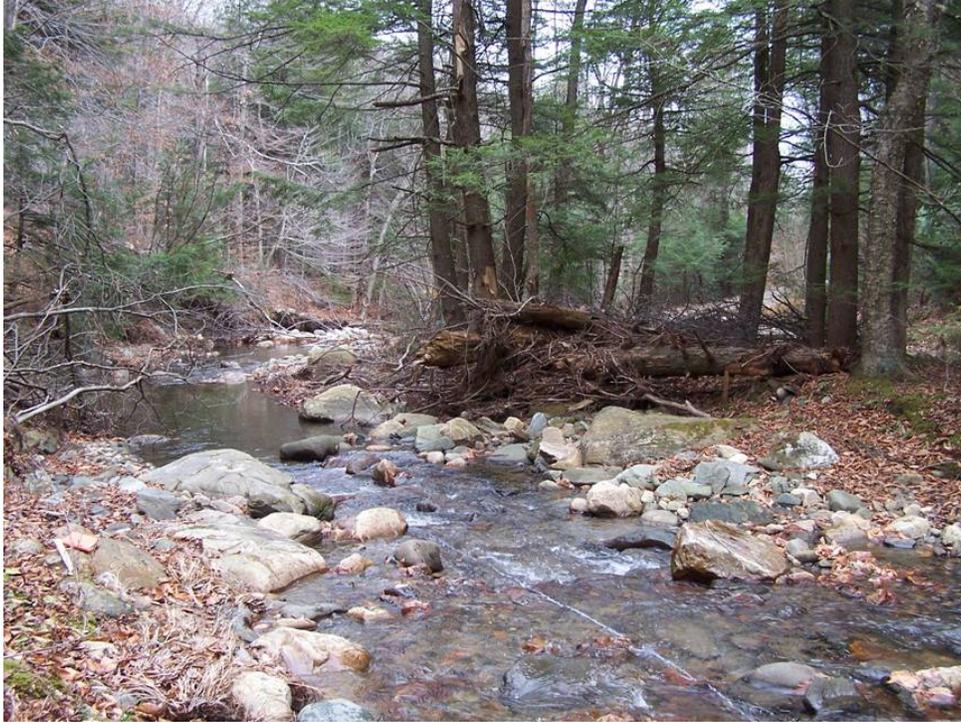
Figure 37. Series of rock steps installed for channel grade control, Tower Brook, Chesterfield, MA.

- See Figure 37 for an example photograph

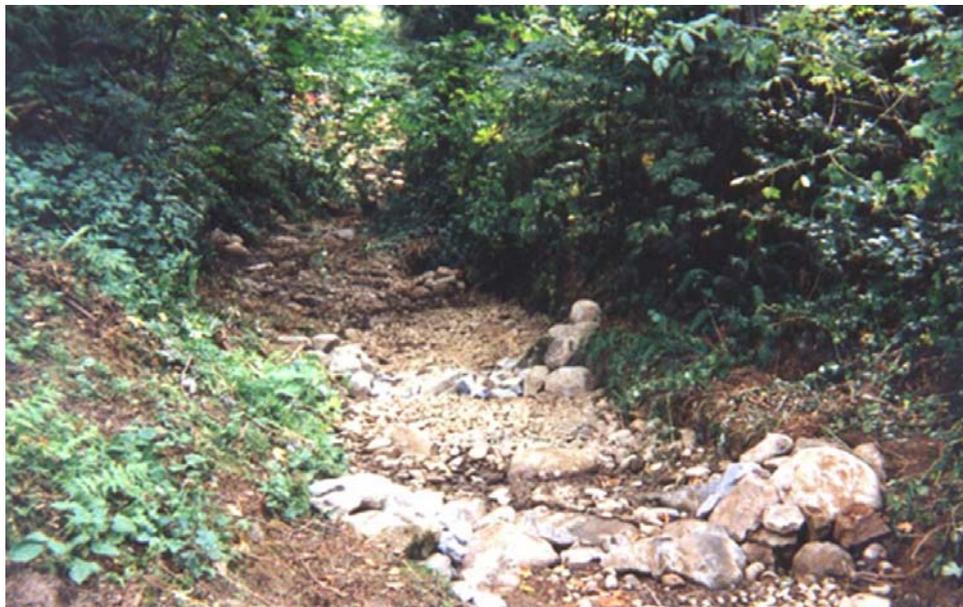
Figure 38. Series of rock grade control/headcut revetment structures placed in Oak Creek, Portland, OR

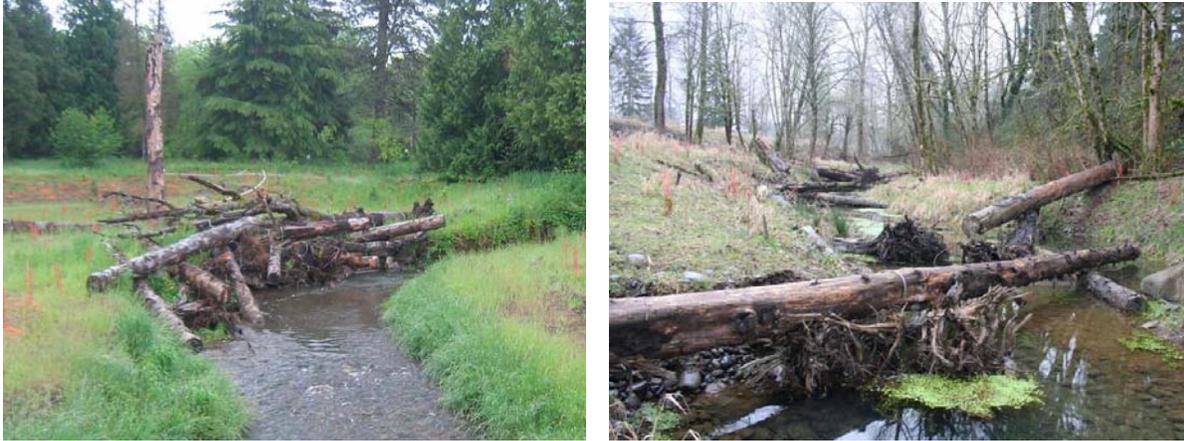
Figure 39. Large wood complexes installed for streambank protection (left, Kelley Creek, Portland, OR) and for habitat enhancement (right, side-channel of Clackamas River, OR).

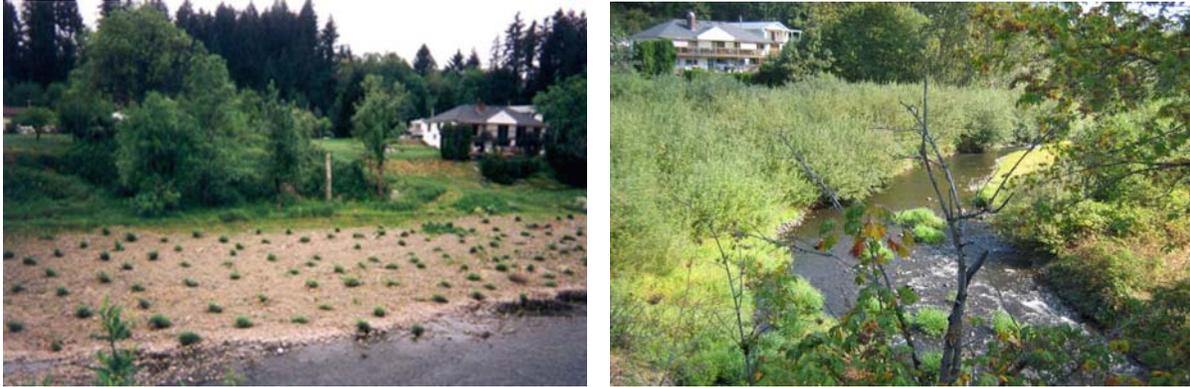
Figure 40. Riparian revegetation on Salmon Creek, WA. Photo taken 6 months after planting (left) and 10 years after planting (right).

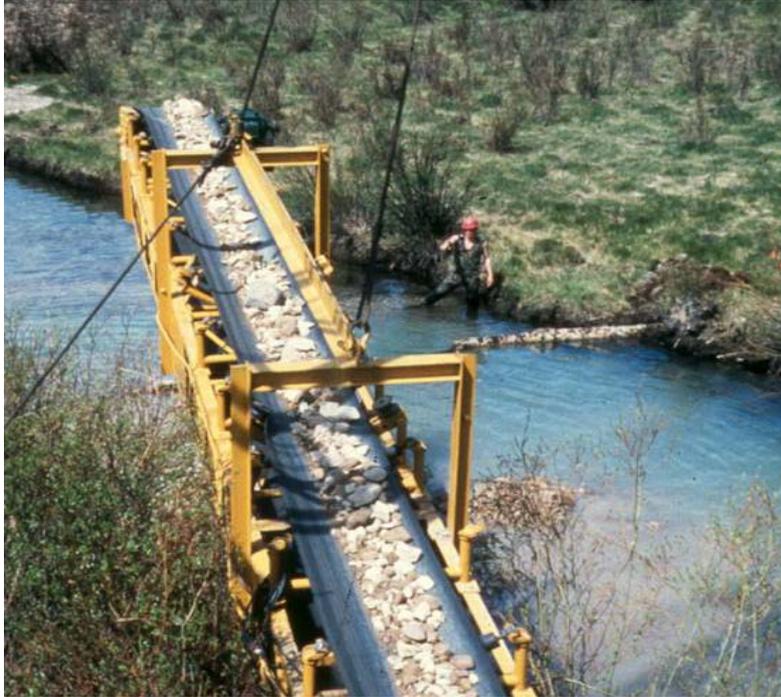
Figure 41. Conveyor placing substrate (cobbles and gravels), Ruby River, Montana.

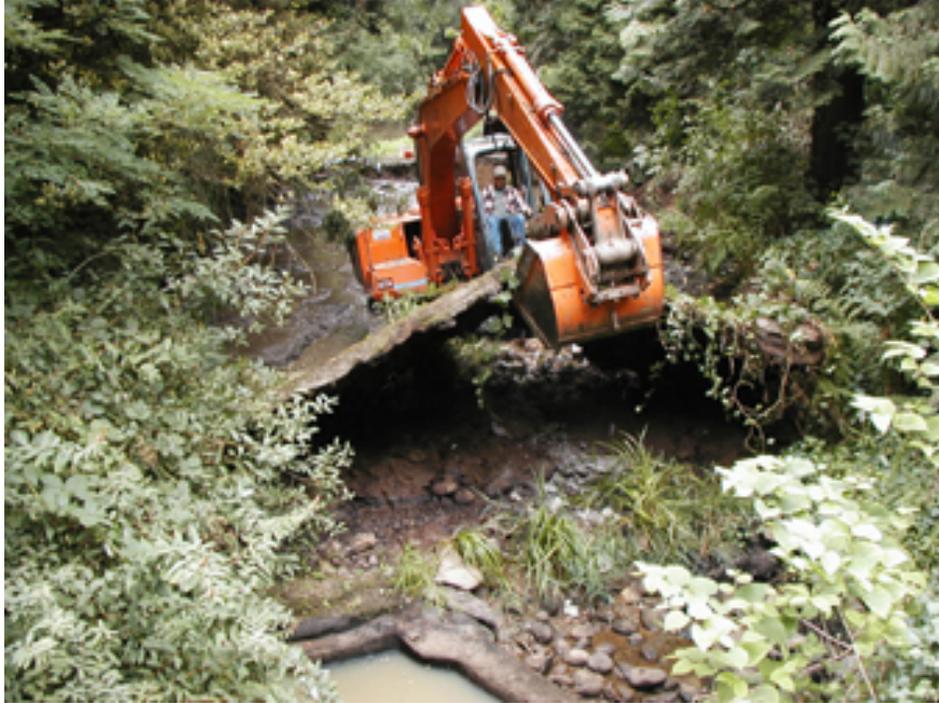
Figure 42. Removal of concrete weir in Johnson Creek, Portland, OR.
