Clark County  
Historic Preservation  
Commission

## Certificate of Appropriateness Application

Name of Property: Clark County Poor Farm

**78<sup>th</sup> Street Heritage Farm**  
**Poor Farm Cemetery Fence – Certificate of Appropriateness Application**  
**Supporting Materials**

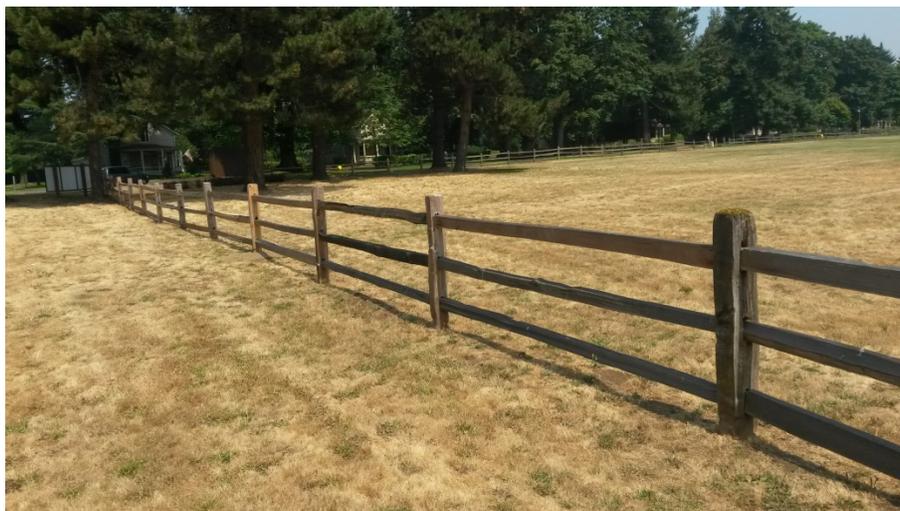
Standard Split Rail: This is the proposed style. Cost estimates for the grant were based on construction of this style fence. Advantages include low cost, high visibility to demarcate the cemetery boundary, easy maintenance and it should last for at least 15 years.

1. Standard split rail fence.

Primary disadvantage is posts would be installed to a depth of two feet. Even though typical burial practices were to dig grave sites to a depth of six feet, some of the remote sensing work identified some ground disturbance anomalies within the cemetery between two and four feet depth.

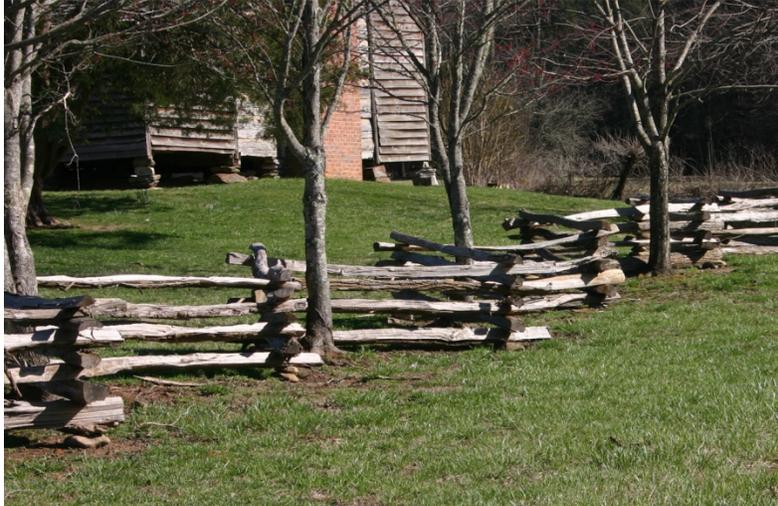
Z-style split rail: Materials are similar to the standard split rail fence with similar longevity. Primary advantage is that shallow footings could be used. Disadvantages are that the z-pattern is typically completed at 90 degree angles per fence segment for stability. This doubles materials and installation costs. Maintenance would also be more time consuming and expensive.

2. Z-style split rail

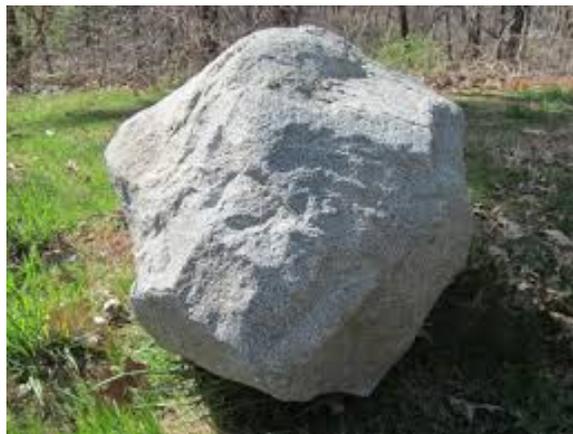
Placed boulders: Three to four foot diameter boulders could be placed at the corners of the cemetery and, on either side of the maintenance access road and along the perimeter of the cemetery. Primary advantage is that material and maintenance costs would be less for this approach. Footings to secure the rocks could be limited to 18 inches. Disadvantages include demarcation of the cemetery boundary would not be as clear as with a split rail fence. Access to the cemetery would also be open, increasing chances of desecration.

3. Placed boulders

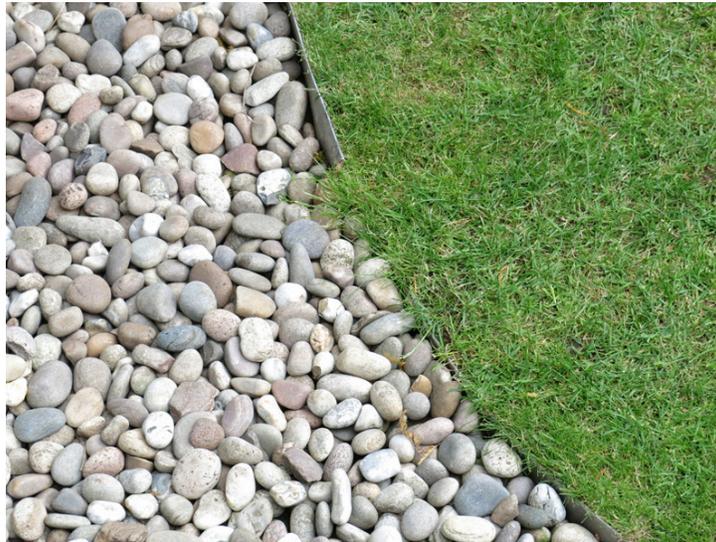
Pebble border: A four-foot wide border filled with river rock is another option. Primary advantage is that excavation of the ground surface could be limited to about six or seven inches. Disadvantages include significant maintenance costs. With ongoing mowing of tall grass and other agricultural activities, it will be easy for the border to become obscured and rocks dislodged. Weeding of the border is also problematic. Access to the cemetery would be open, increasing chances of desecration.

4. Pebble border

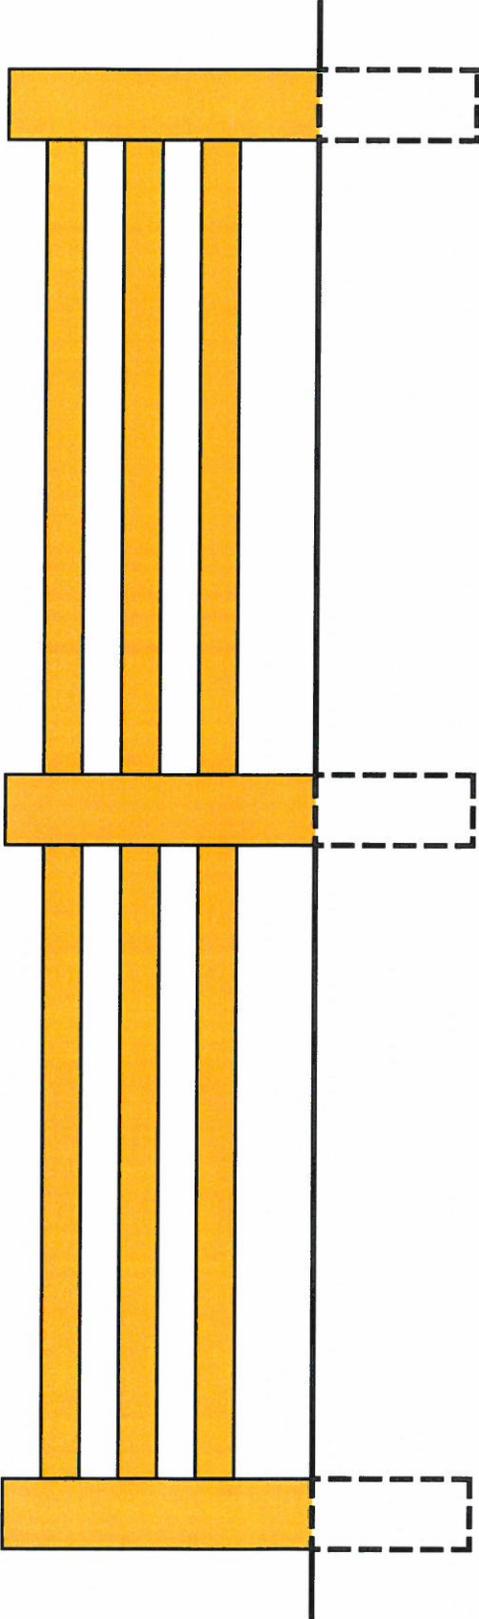
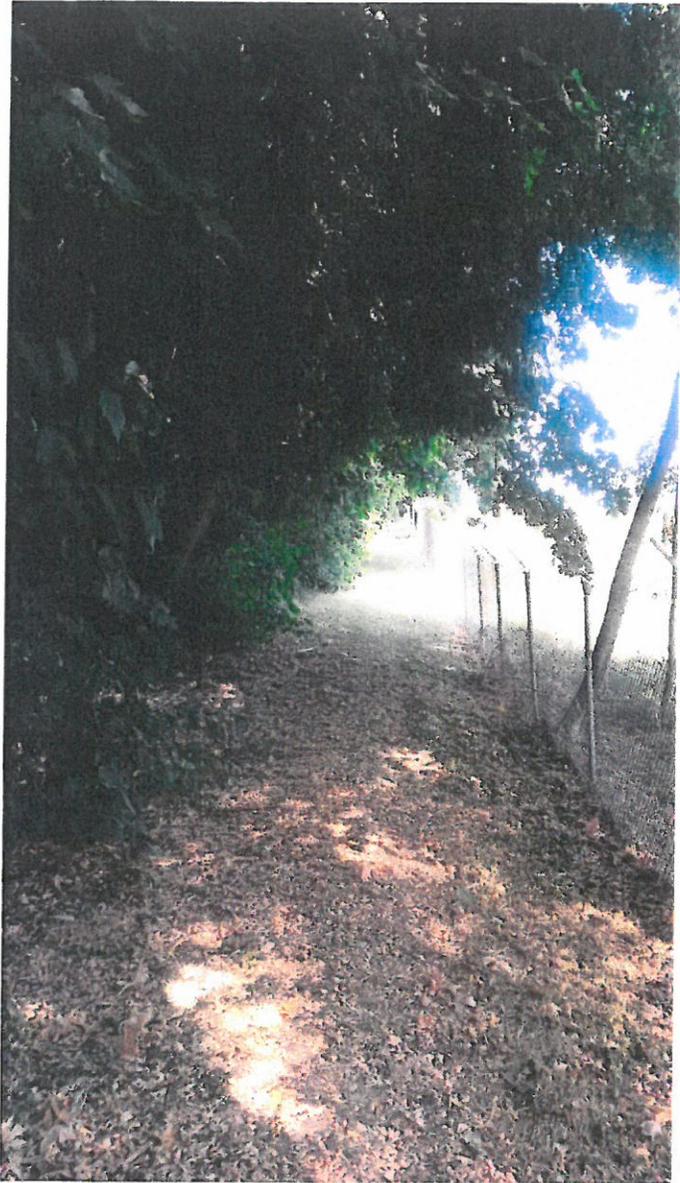
# Poor Farm Cemetery Cedar Split Rail Fence: Typical Section

Six foot posts spaced ten feet apart connected with four inch rails

Posts installed to a depth of two feet

Six foot long cedar posts six inches wide will be spaced every ten feet and buried to a depth of two feet for stability. These will be connected by four inch wide cedar rails, three rails between the posts.

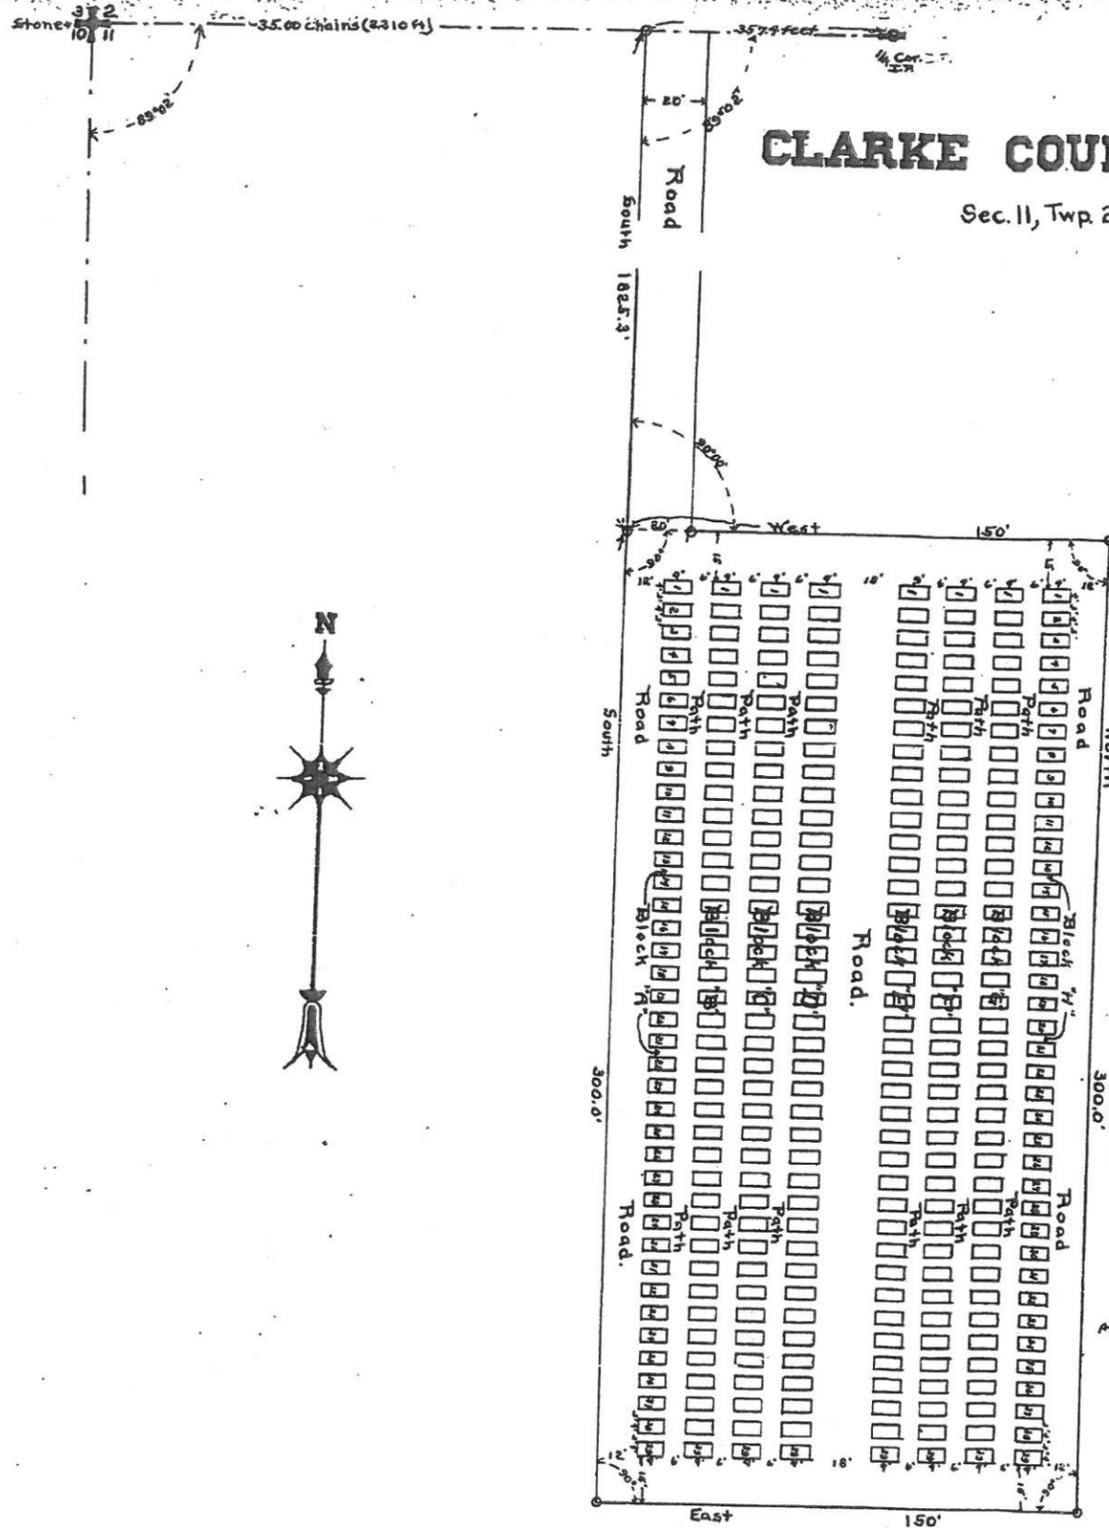
# CLARKE COUNTY CEMETERY

Graves are 4'x9' and 39 in each Block.  
 Paths are 3' wide running East & West  
 and 6' wide running North & South.  
 Roads are as designated.

The cemetery is platted as 150 feet (west to east) by 300 feet long (north to south). Both on the north and the south, within the plat, there are fifteen foot wide vacant corridors between the cemetery boundary and where the gravesites begin. On the west and east, there are twelve foot wide vacant corridors between the cemetery boundary and where gravesites begin.

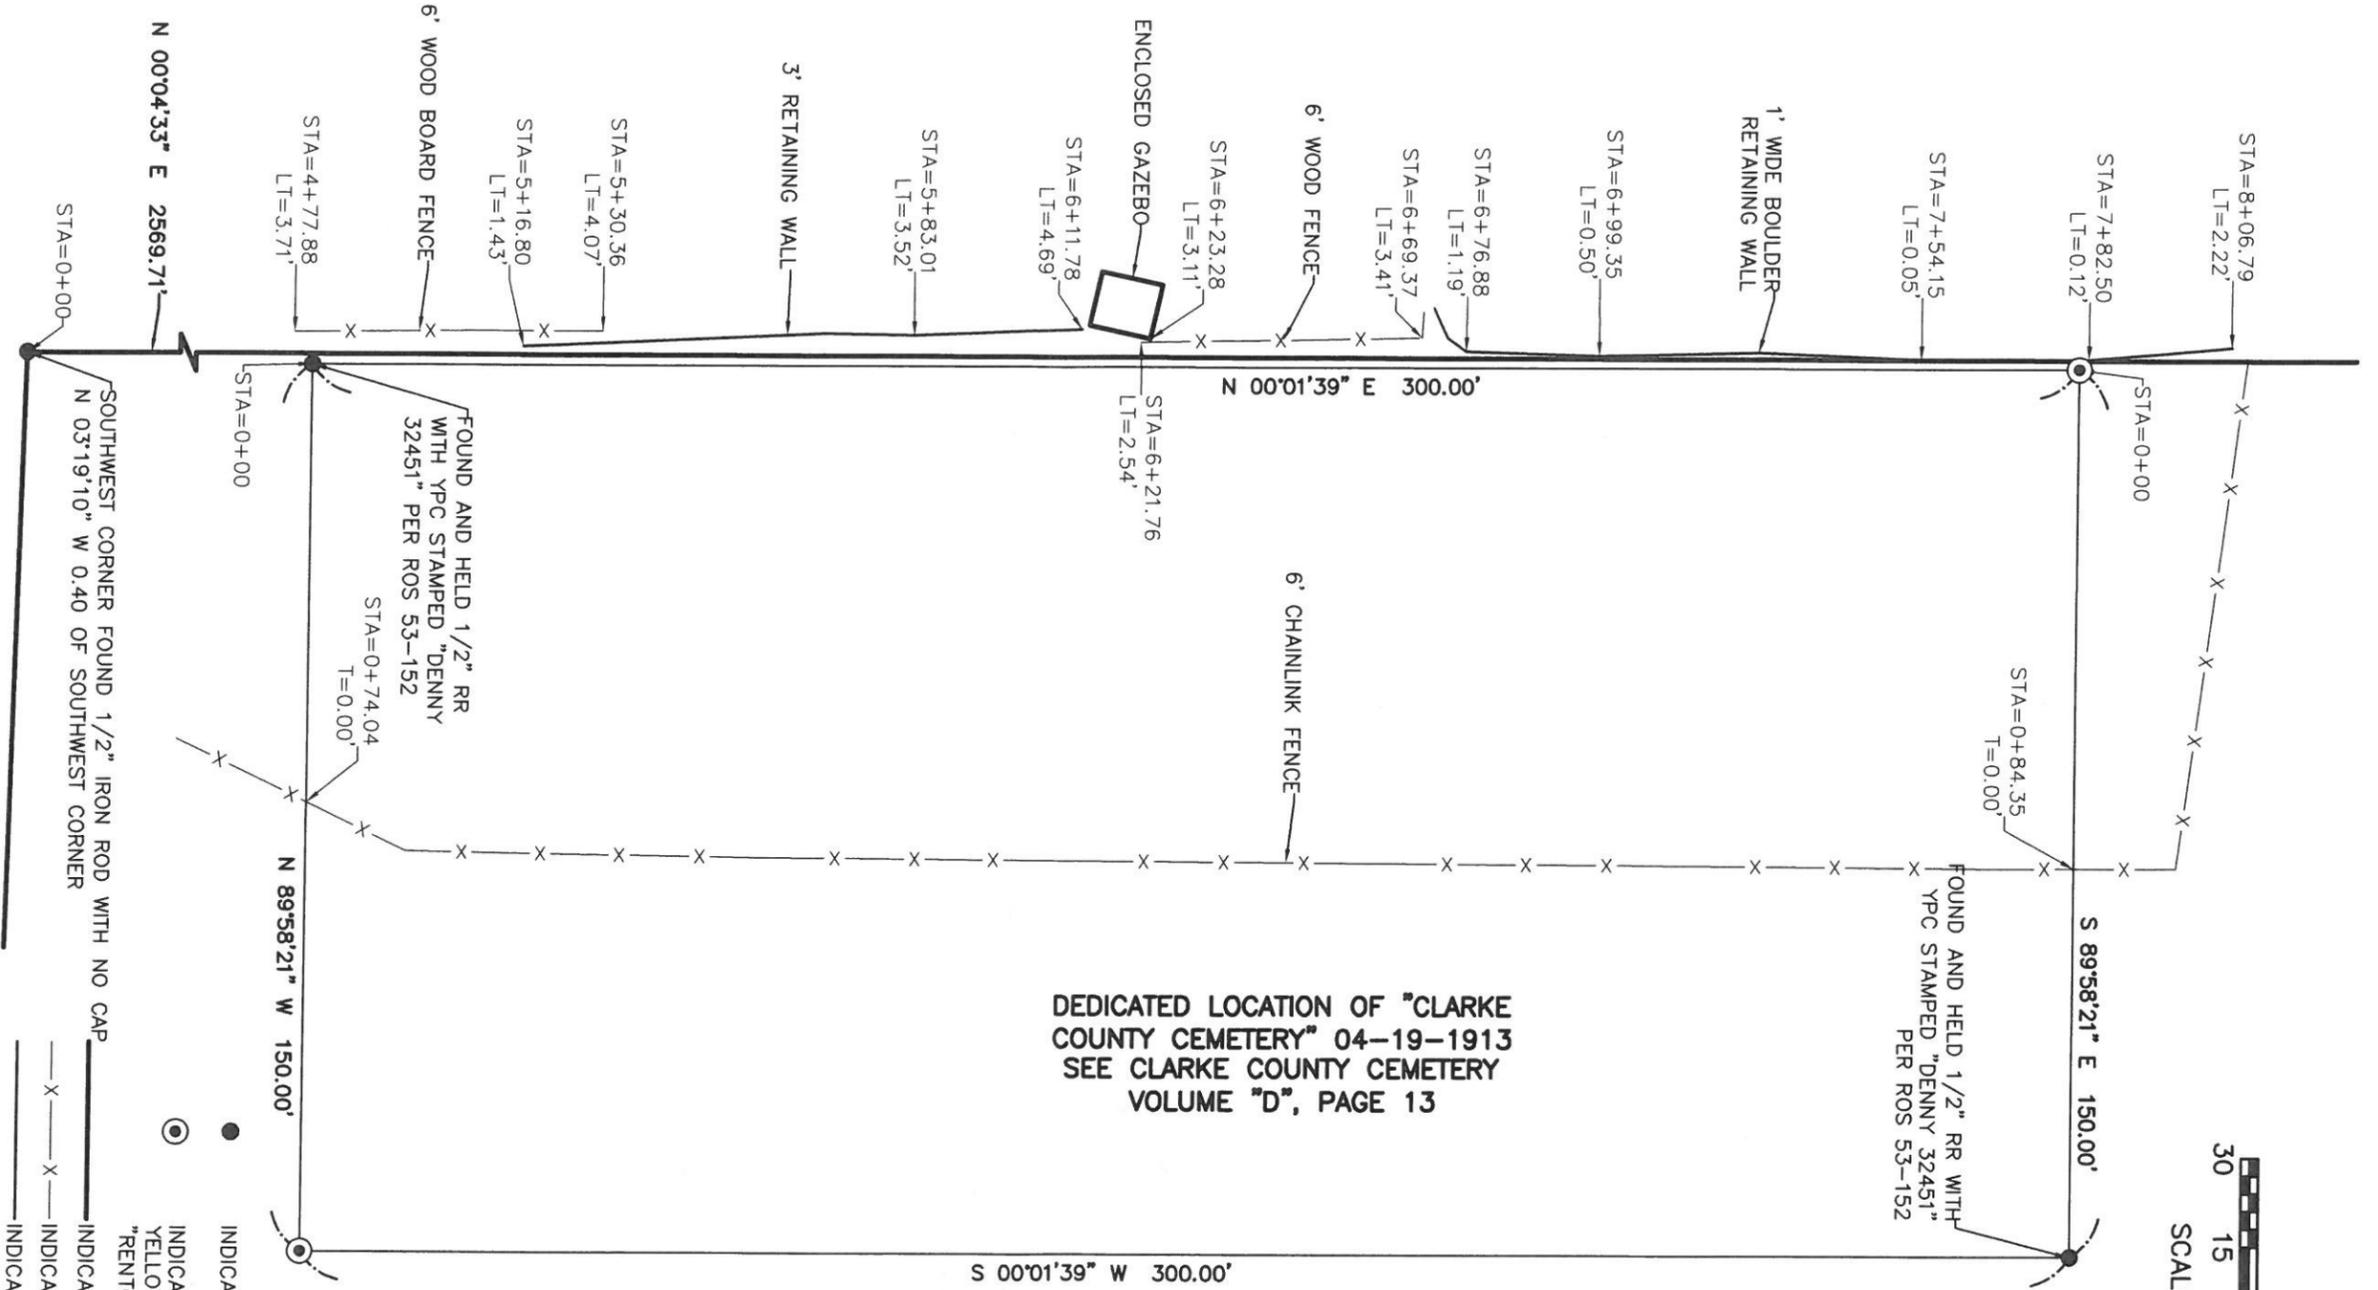
**EXHIBIT**  
 CLARK COUNTY  
 POOR FARM CEMETERY

DEDICATED LOCATION OF "CLARKE COUNTY CEMETERY" 04-19-1913  
 SEE CLARKE COUNTY CEMETERY VOLUME "D", PAGE 13

Enclosed are the original plat dated April 11, 1913, an updated survey dated March 29, 2017 and an aerial photograph with the boundaries outlined in red.
