# Clark County Heritage Register Nomination Form

Historic name The Kapus Granary  
Other names/site number Formerly at 27225 NW 11<sup>th</sup> Avenue, Ridgefield

PROPERTY NAME: KAPUS GRANARY  
CLARK COUNTY, WASHINGTON

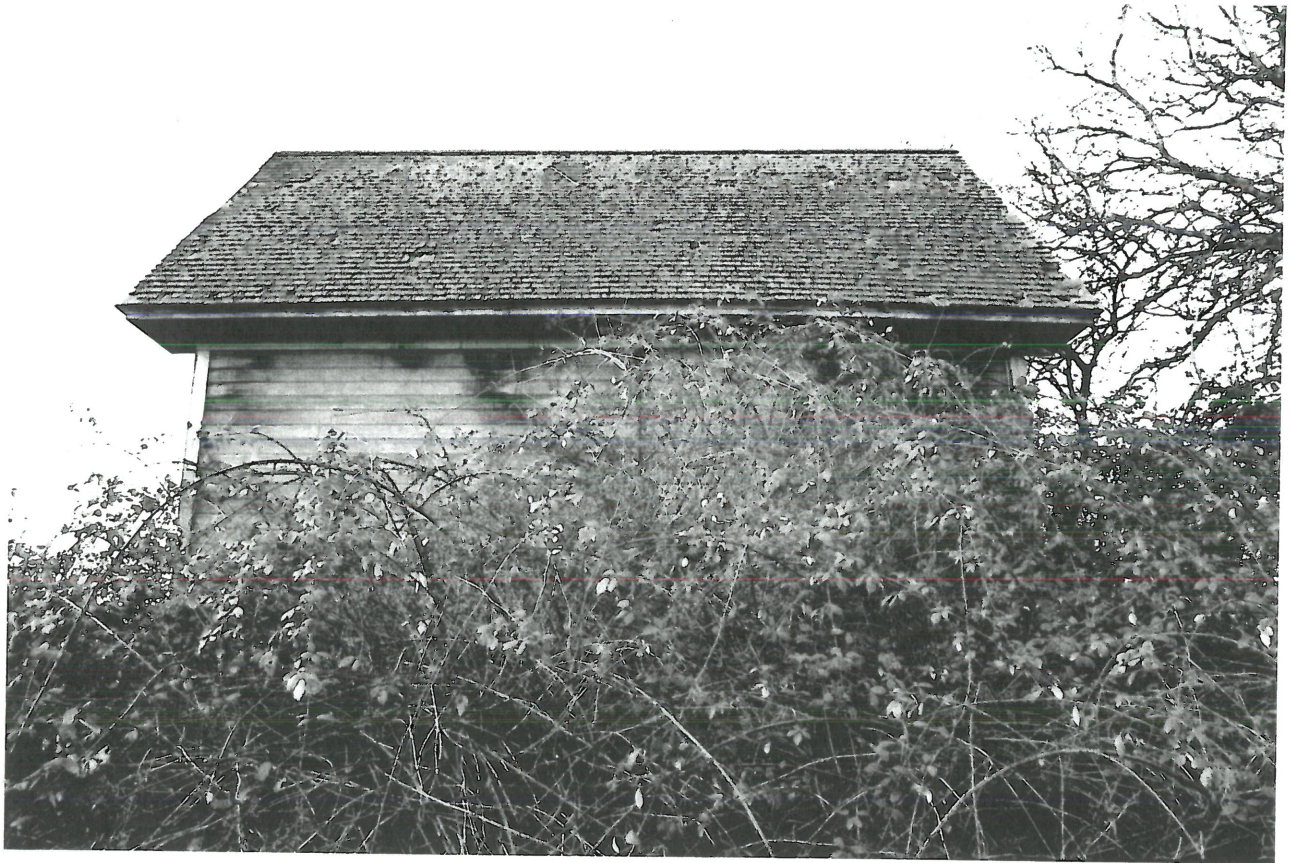
PHOTO 9

- Photo 9 The east elevation of the granary. The view is to the west
- Photo 10 The south and east elevations of the granary. The view is to the northwest. The windows are on the second floor of the south elevation. Note the top of the door on the west side of the south elevation visible behind blackberry overgrowth.

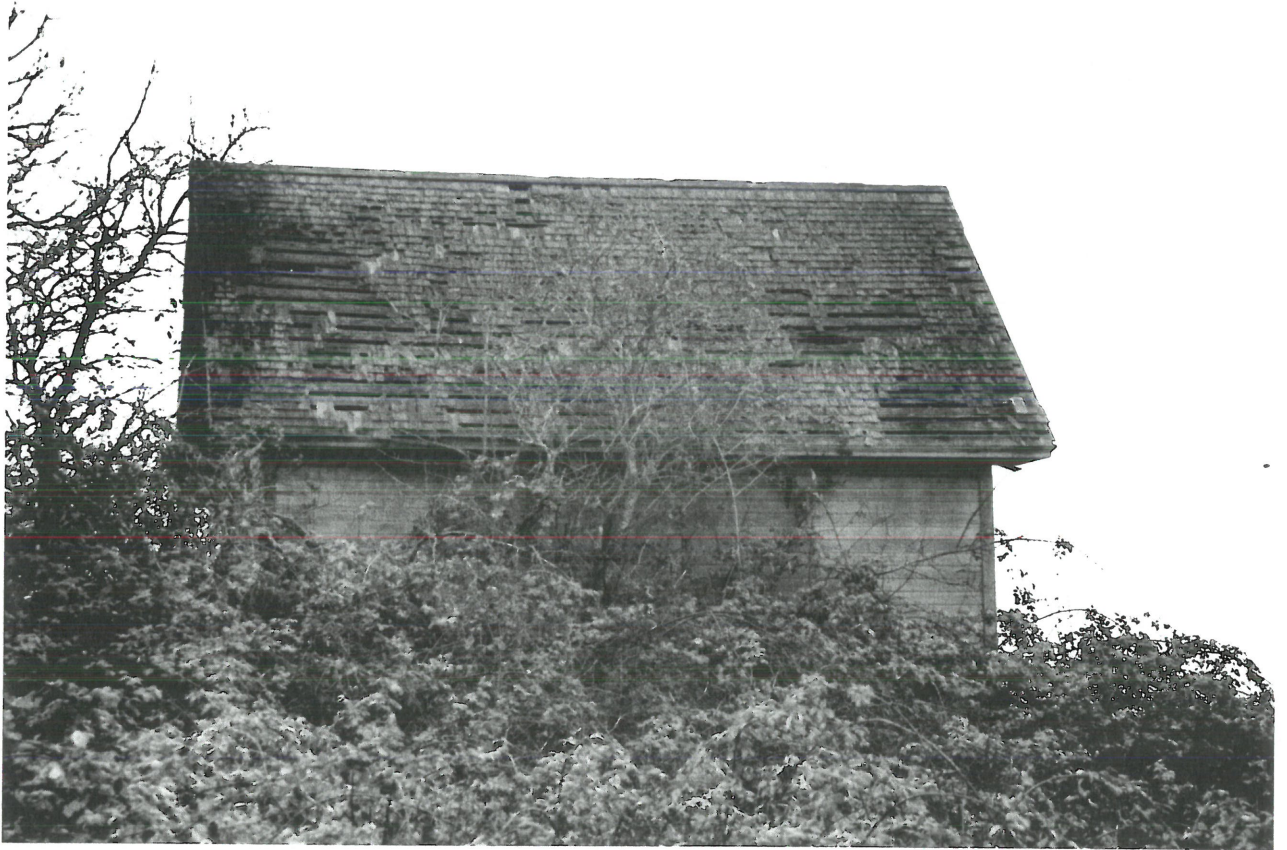
PHOTO 11

- Photo 11 The west elevation of the granary. The view is to the east.
- Photo 12 The north elevation of the granary. The view is to the southwest.
- Photo 13 The north elevation of the granary. The view is to the south.

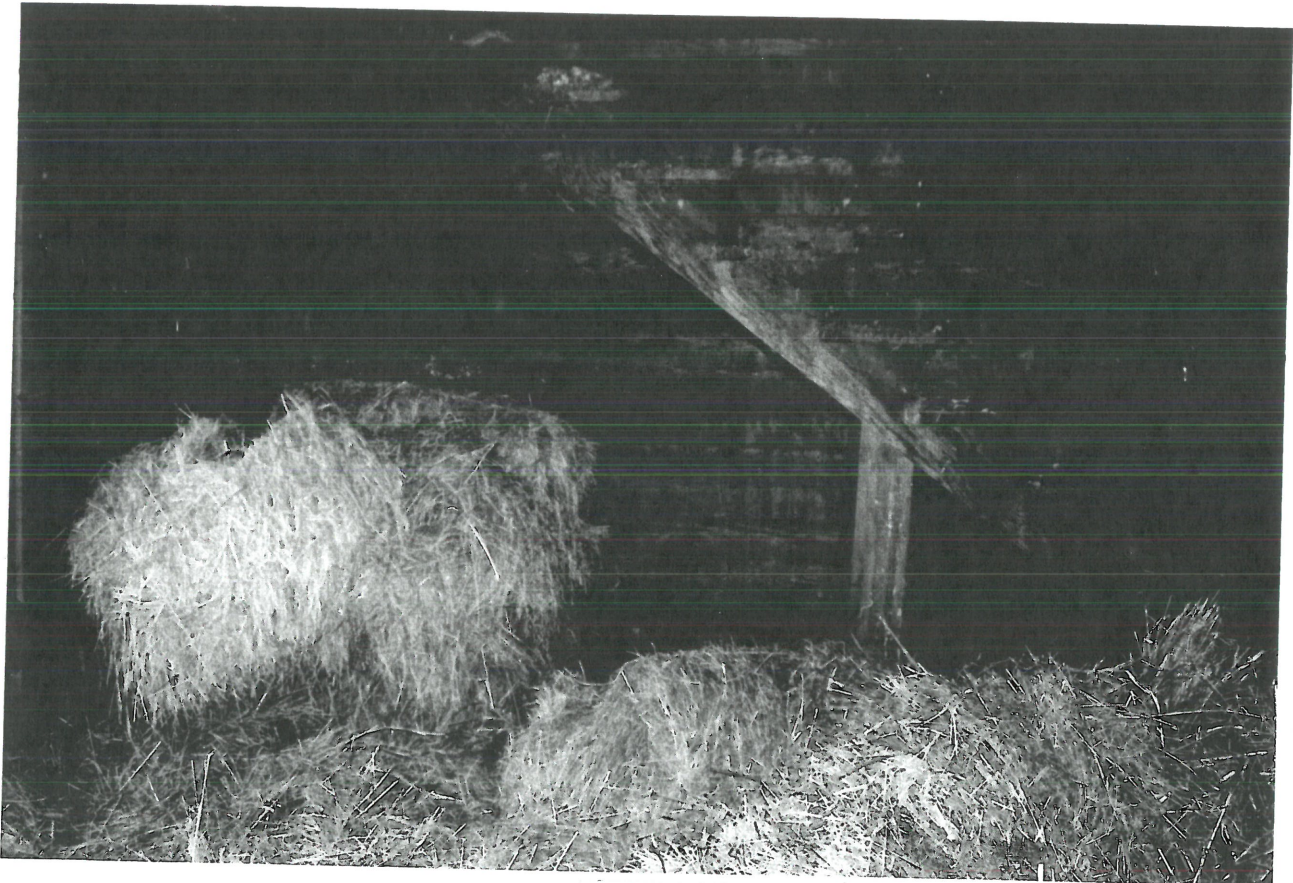
PHOTO 16

- Photo 16 The interior, first floor of the granary. The view is to the south. The stairs lead from the first to the second floors and rise from west to east.

The interior of the first floor features two large stalls for grain storage. The stalls are located along the east and west walls and run from the north wall southward. Each is 7 feet wide. The eastern stall is 10 feet long and the western stall is 14 ½ feet long. They are divided by a walkway approximately 3 feet wide, running to the north wall. The walls of these stalls are approximately 4 feet tall and have slots on the interiors of their east and west for receiving the dividing walls. Chutes in the ceiling of the first floor correspond to the individual sections of the stalls. The walls of this story are finished with tongue-and-groove boards from floor to ceiling. The flooring is also of tongue-and-groove boards.

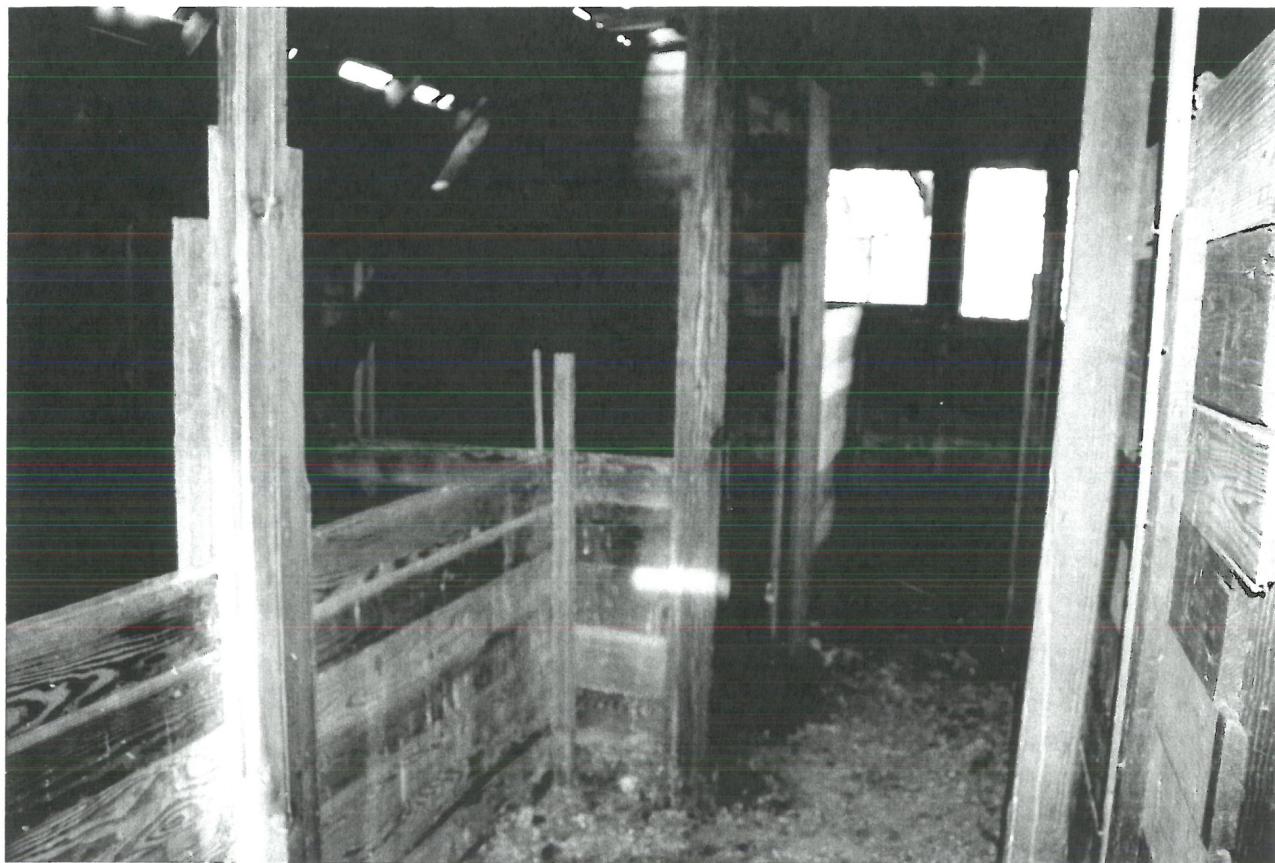
PHOTO 17

- Photo 17 The interior, second floor of the granary. The view is to the north-northwest.
- Photo 18 The interior, second floor of the granary. The view is to the northeast. Note the original 1929 electrical wiring.

The second floor of the granary is characterized by three large stalls for grain storage. These stalls also have slots for the insertion of dividing walls. The holes in the floor corresponding to the chutes attached to the ceiling of the first floor are still extant. Two of the stalls occupy the western wall. The northern of the two is approximately 7 feet wide and 10 feet long. The southern stall is approximately 5 ½ feet wide and 14 feet long. At the south end of the second floor is a short flight of four steps with open risers ascending towards the south to a quarter landing. From that quarter landing, a steep set of ladder steps ascends towards the east, leading to the attic storage space. The walls and ceiling of the second floor are clad in tongue-and-groove boards. The ceiling on this floor measures 9 ¼ feet, although the slope of the gable roof begins at a height of 6 ½ feet. The floor of the second story is tongue-and-groove board.

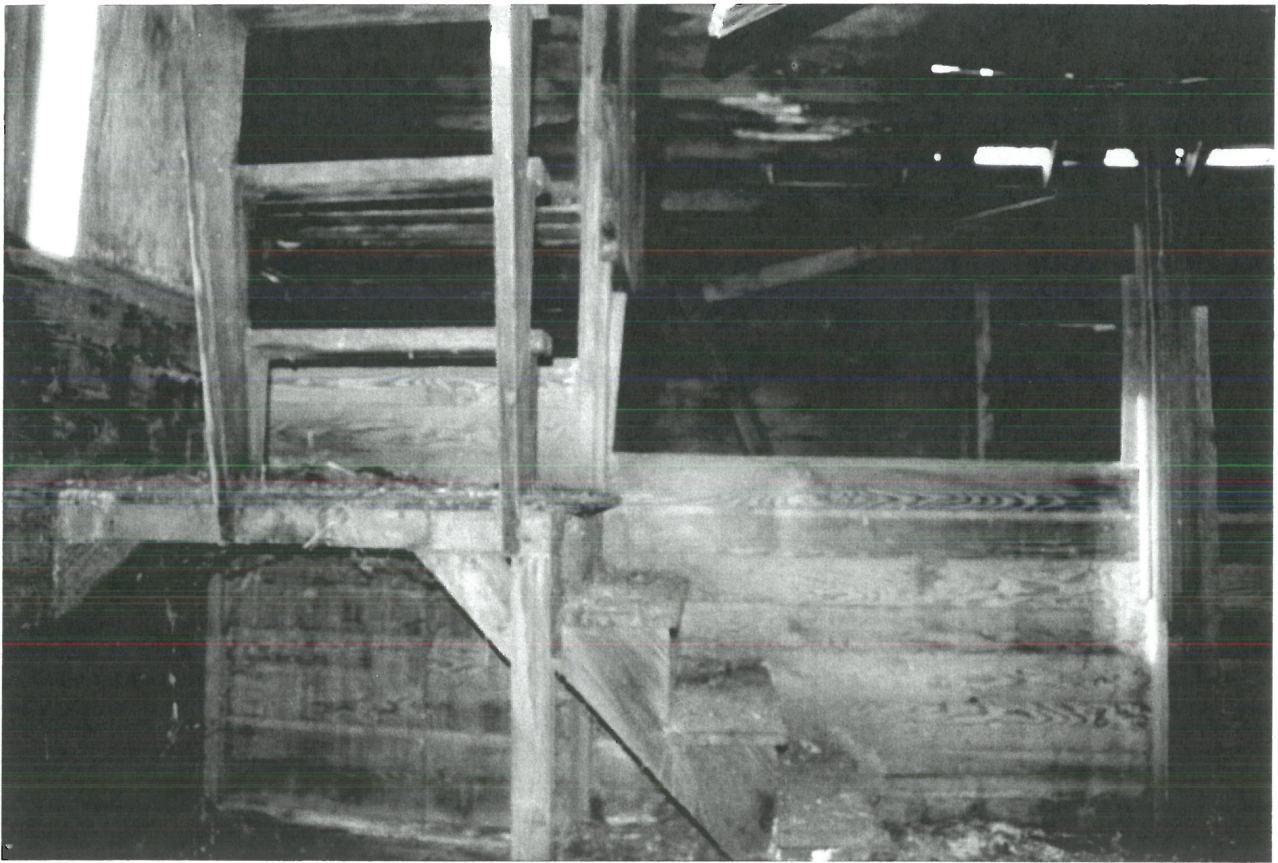
PHOTO 19

- Photo 19 The interior, second floor of the granary. The view is of the steps, quarter landing, and ladder steps leading to the attic space at the south end of the second floor. The view is to the west.

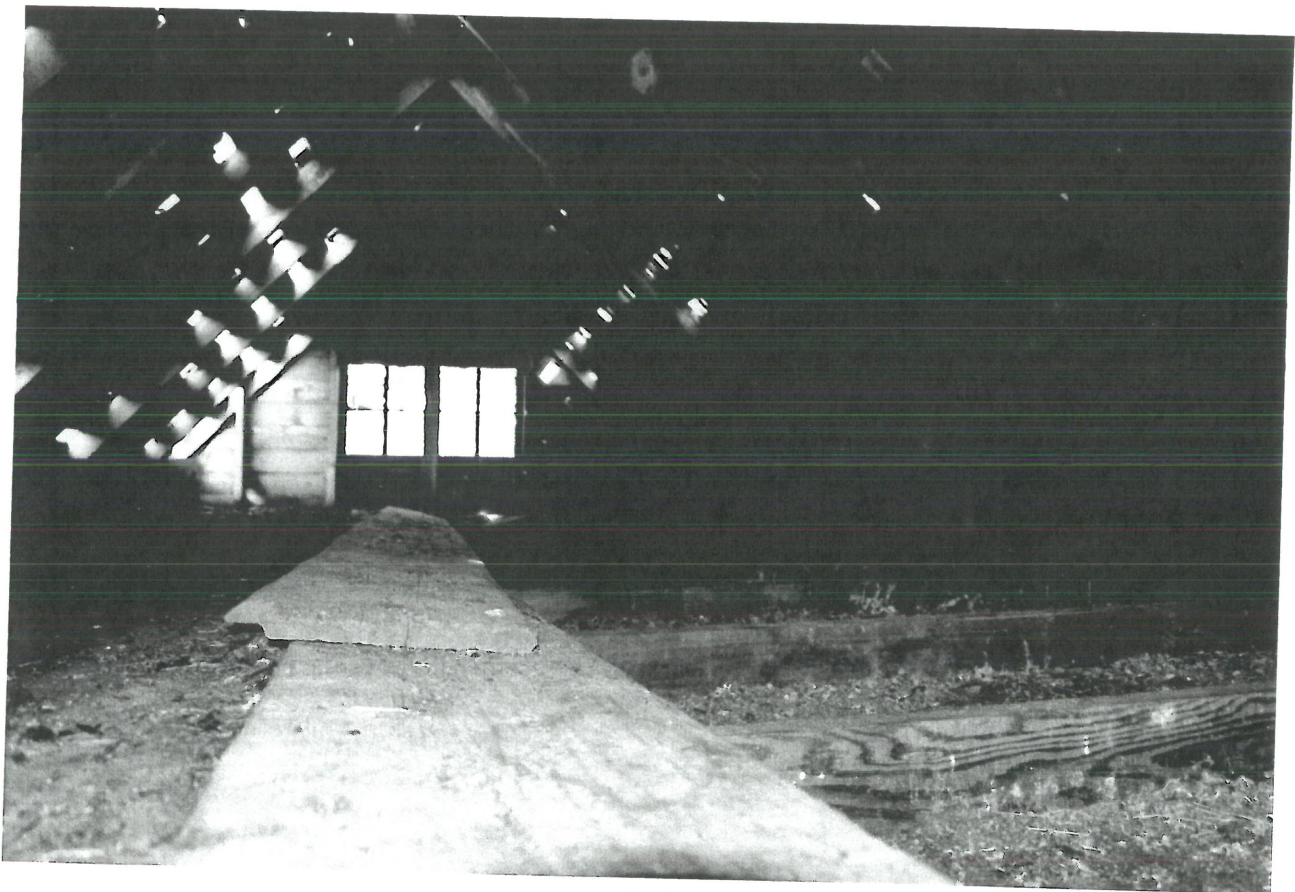
PHOTO 20

- Photo 20 The interior, attic space of the granary. The view is to the north.
- Photo 21 Detail of the eave and eave return of the granary. The view is of the southeast eave return. The view is to the northwest.

The attic which was minimally finished historically, has been finished with fir flooring and shiplap siding. The historically fixed attic windows have been hinged to tilt out from the bottom.

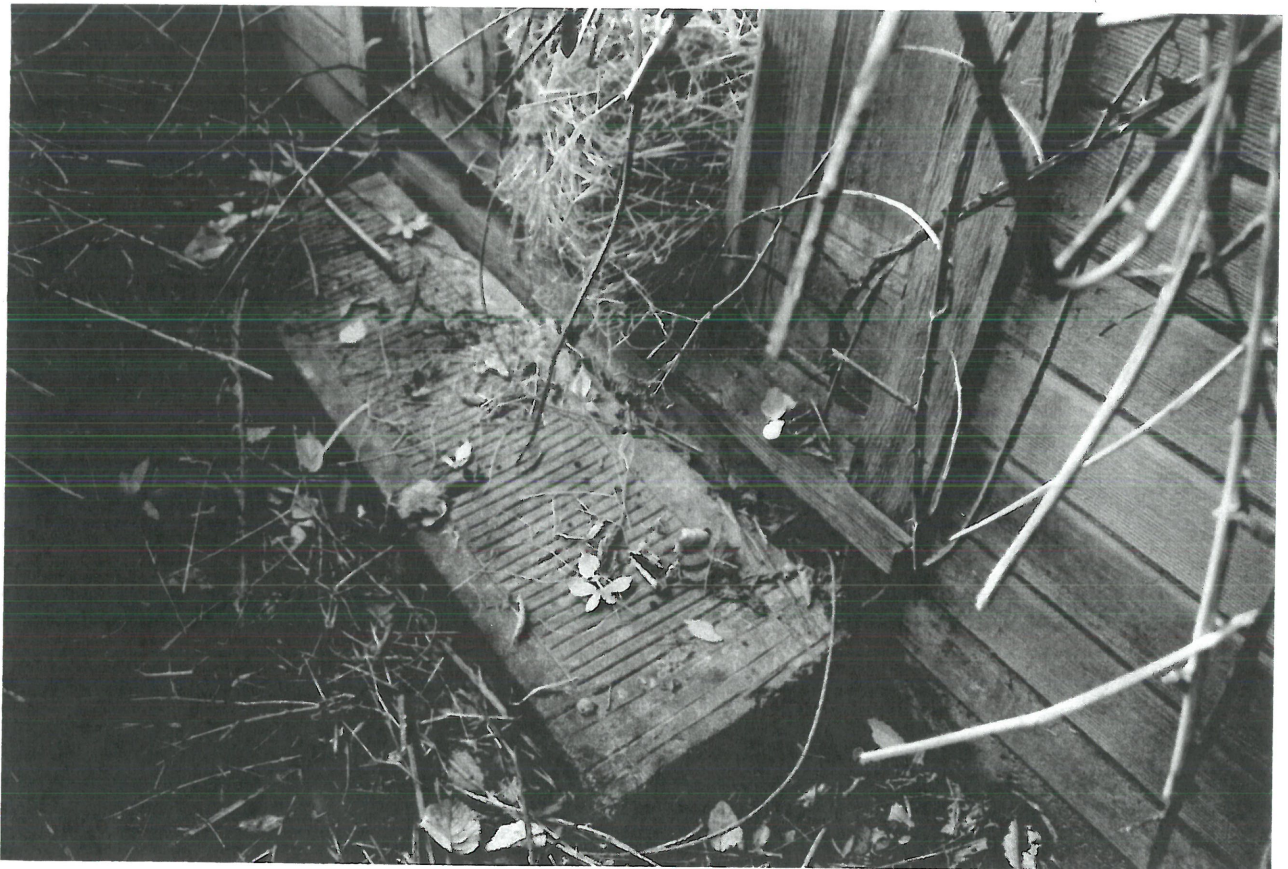
PHOTO 22

- Photo 22 View of the concrete step in front of the pocket doors on the south elevation of the granary. The view is to the southwest. Note the drain in the concrete foundation at the lower right of the frame.

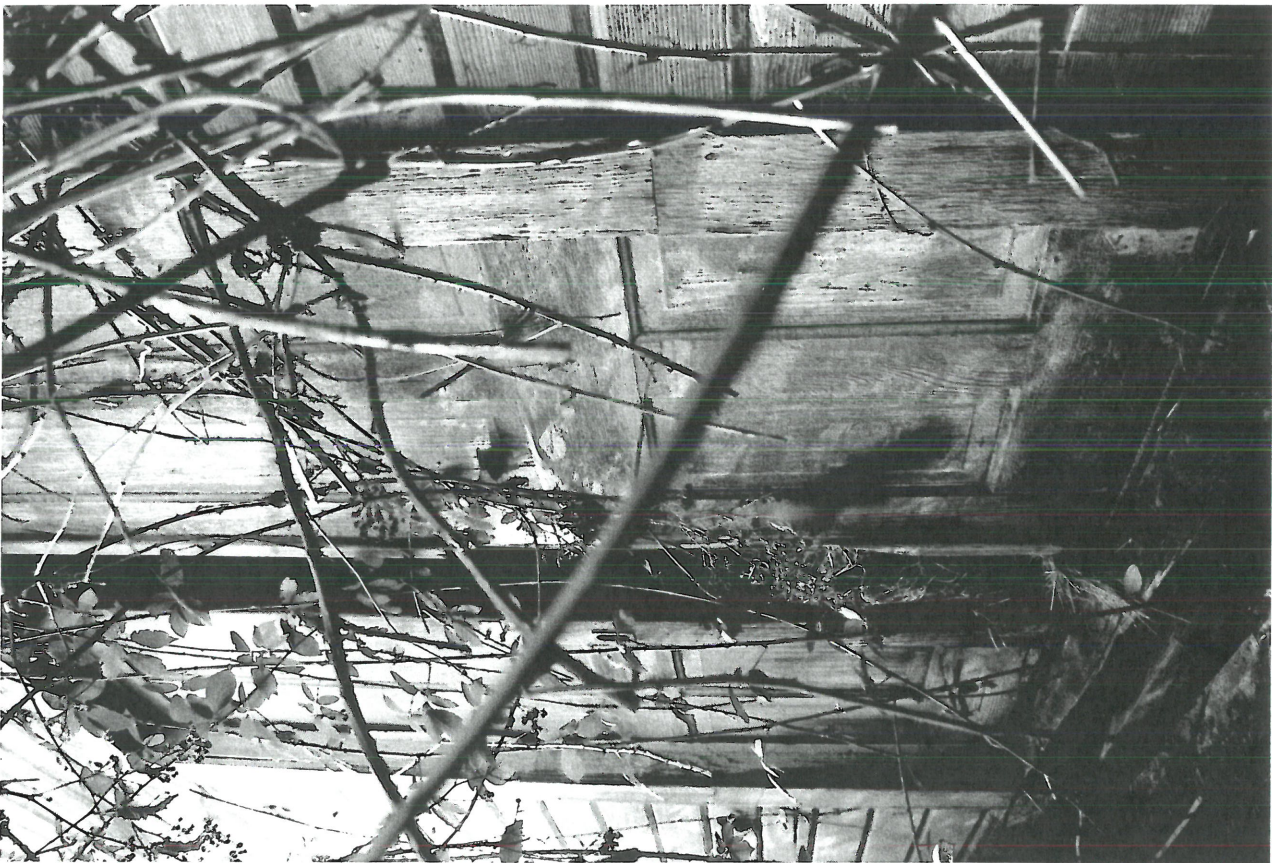
PHOTO 24

- Photo 24 View of the pocket doors on the east elevation of the granary. The view is to the south-southwest.
- Photo 31 View of the Kapus Farm ensemble. The view is to the northeast.

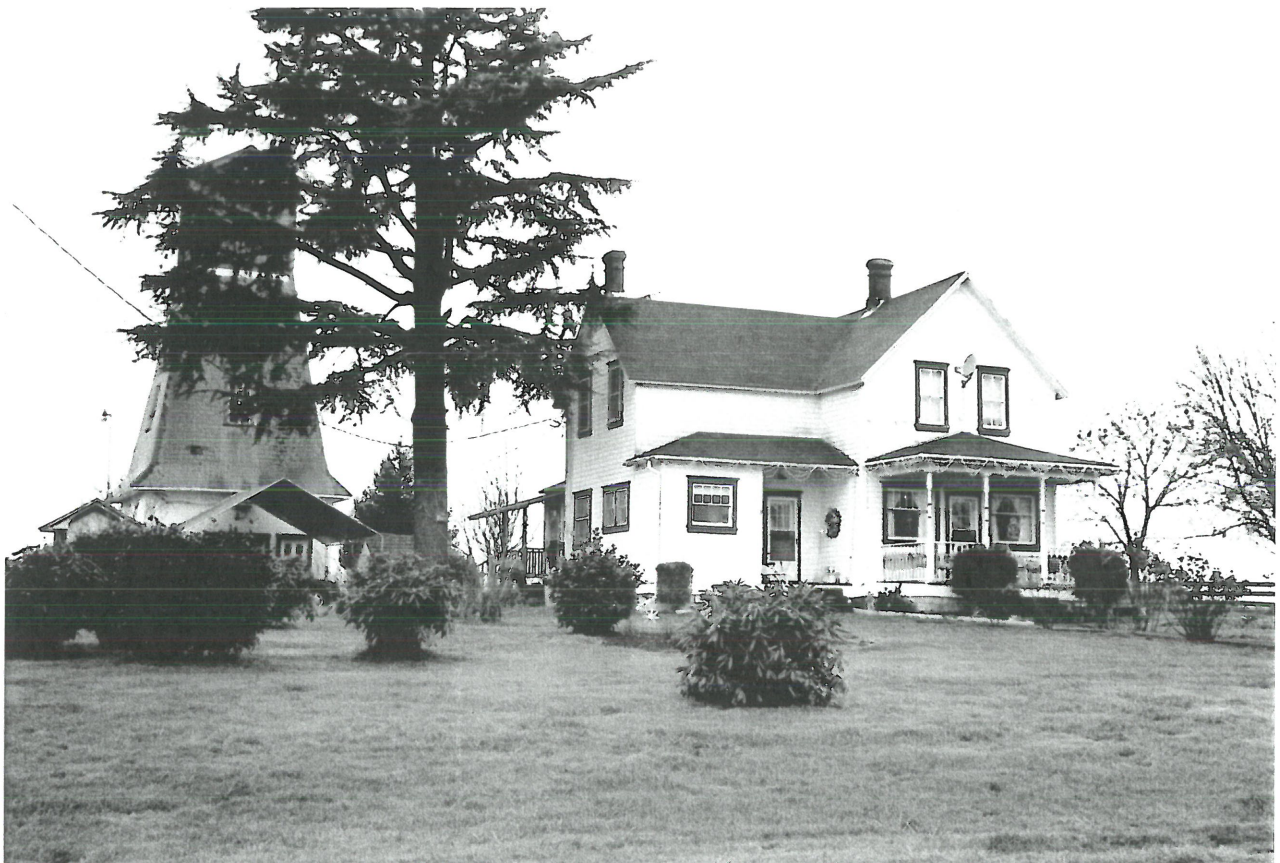
PHOTO 32

- Photo 32 View of the Kapus farm house and water tower. The view is to the west-northwest. The roof of the outhouse is visible behind the bush at the left of the frame.

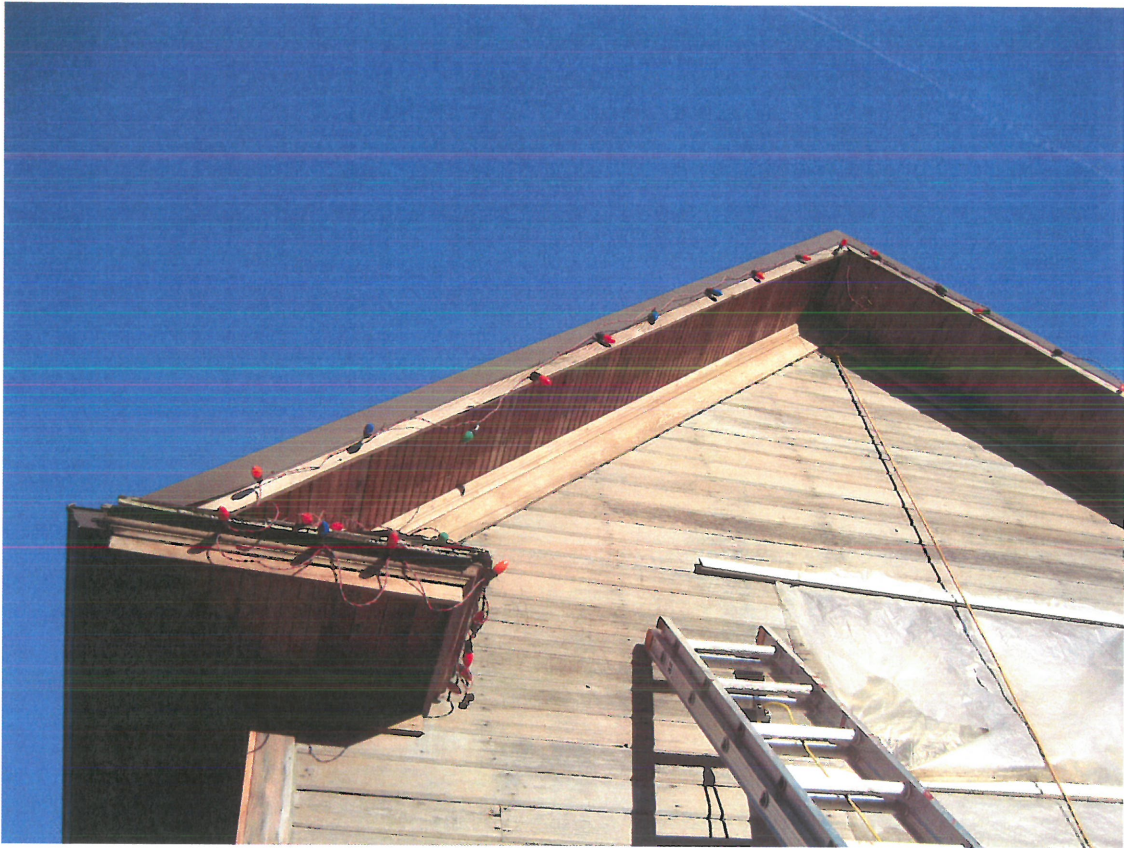
**Photo 33**

- Photo 33      The west roof elevation of the granary.
- Photo 34      The south and west elevations of the granary.
- Photo 35      The east elevation of the granary. The view is to the west.

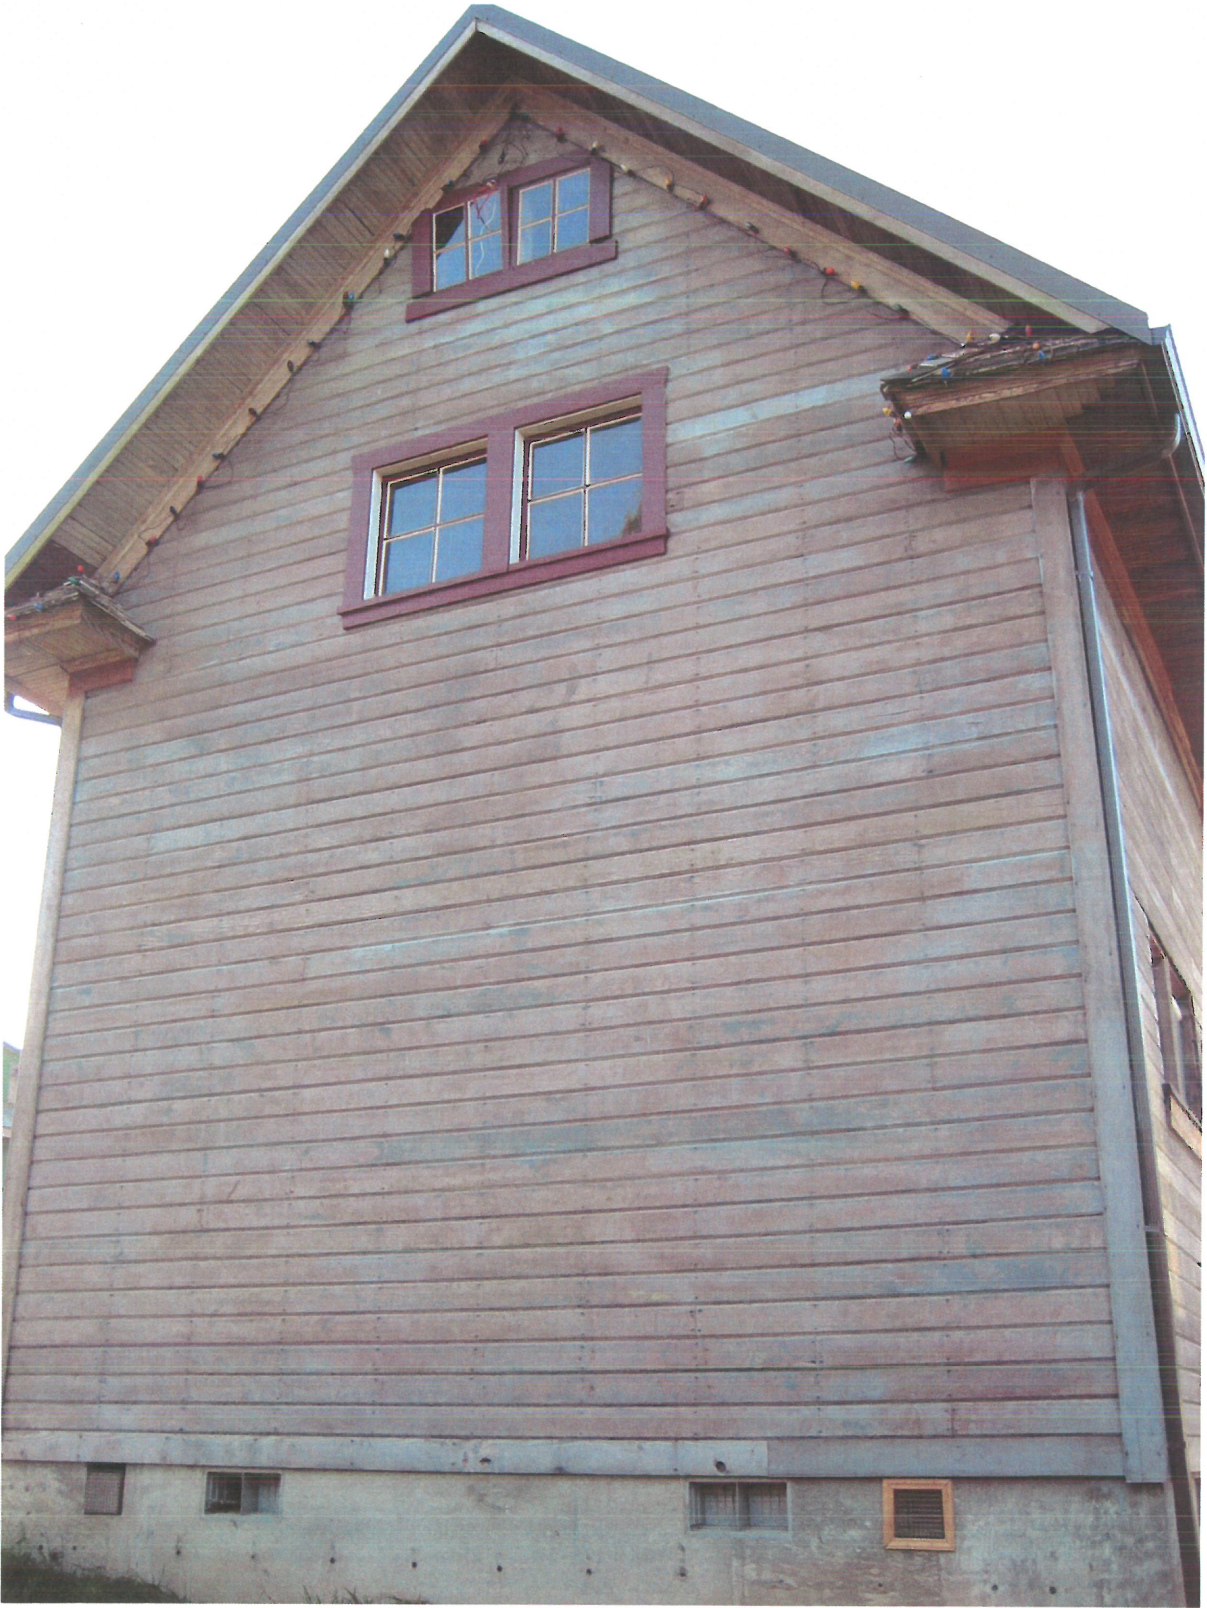
**Photo 36**

- Photo 36      Closer view of the east elevation.
- Photo 37      The east and north elevation.
- Photo 38      Closer view of east elevation and roof.
- Photo 39      The interior, first floor of the granary. Note the stalls for grain storage.

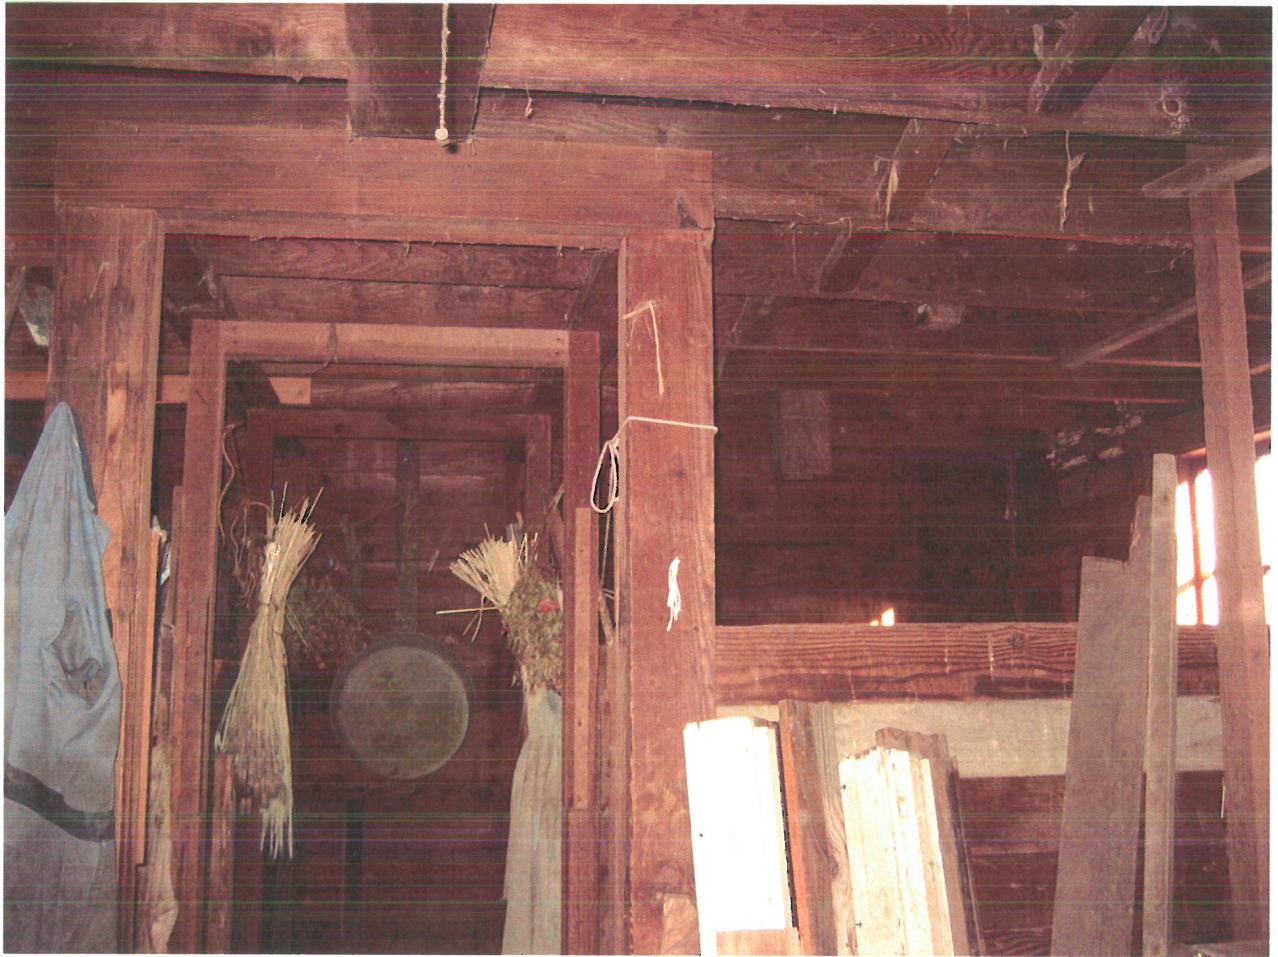
**Photo 39**

**Stalls for grain storage**

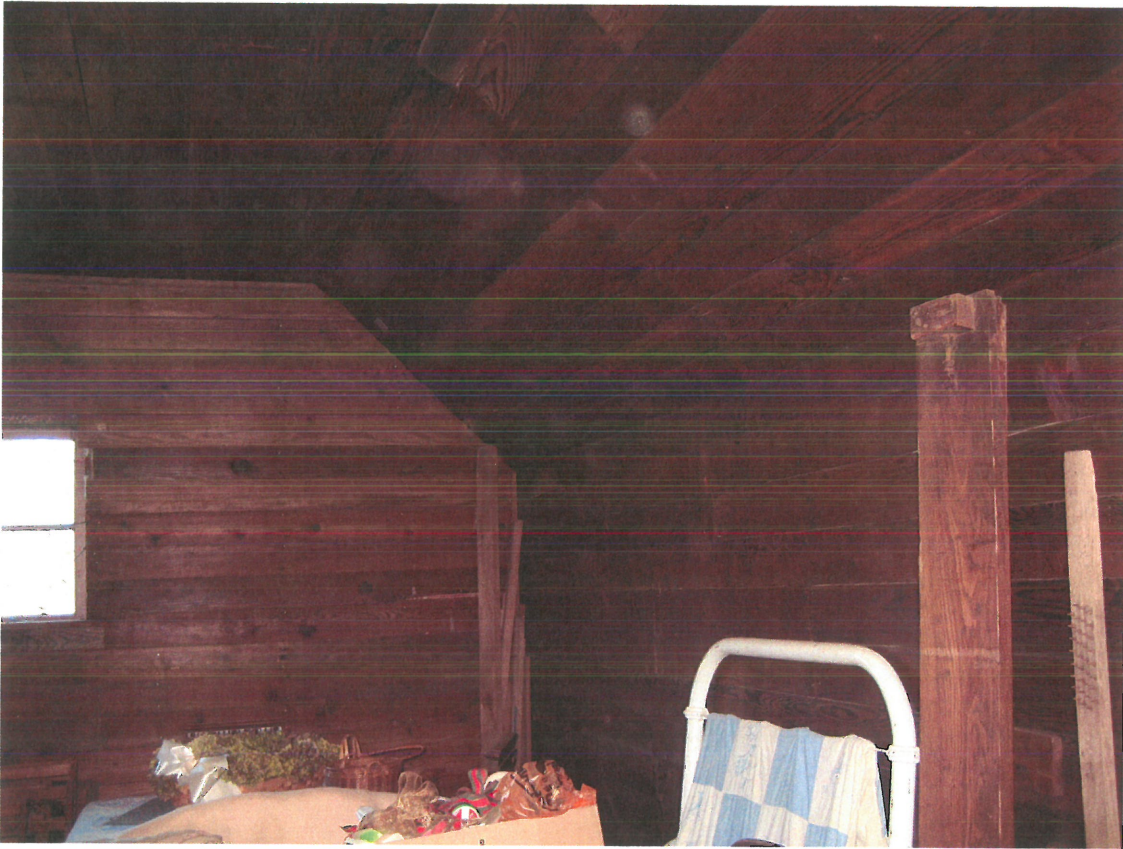
- Photo 40      The interior, first floor of the granary. The view is to the south. Note the still existent grain shoots.
- Photo 41      The interior, second floor of the granary. The view is to the east.

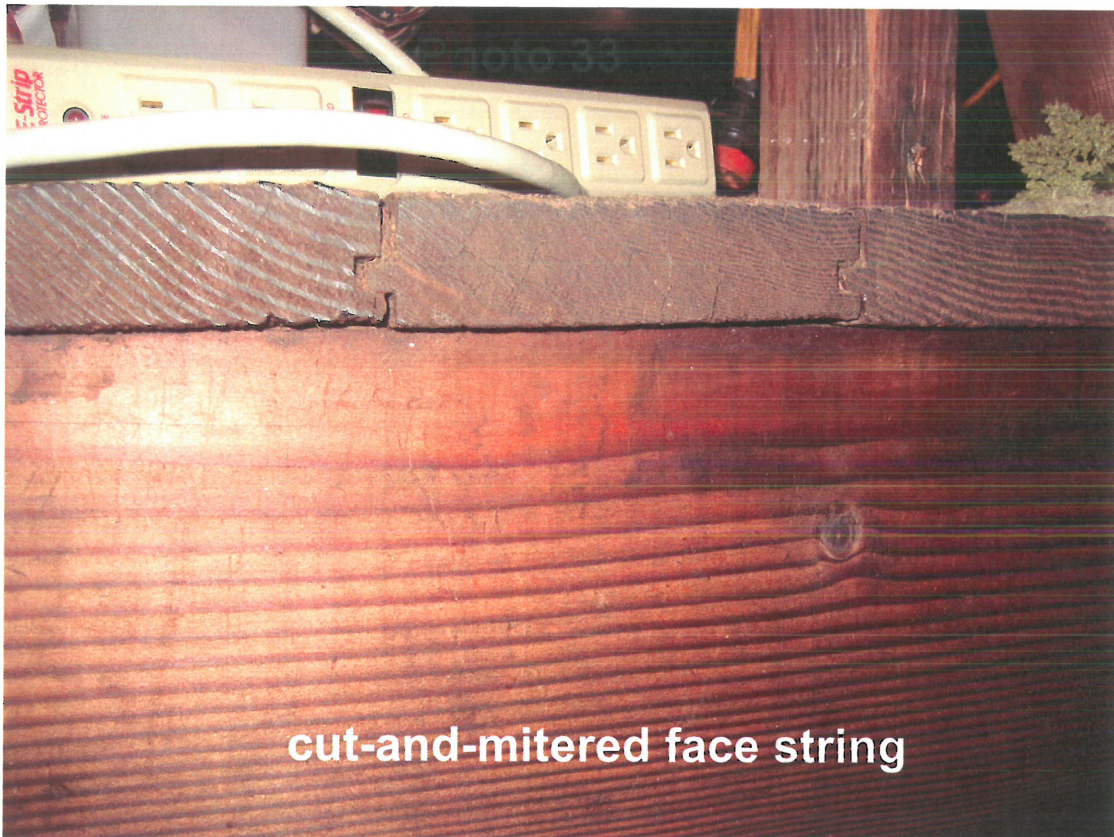
- Photo 42      The interior, second floor of the granary. Note the cut-and-mitered face string of the stairs.
- Photo 43      The interior, third floor (attic) of the granary. The view is to the east.

cut-and-mitered face string

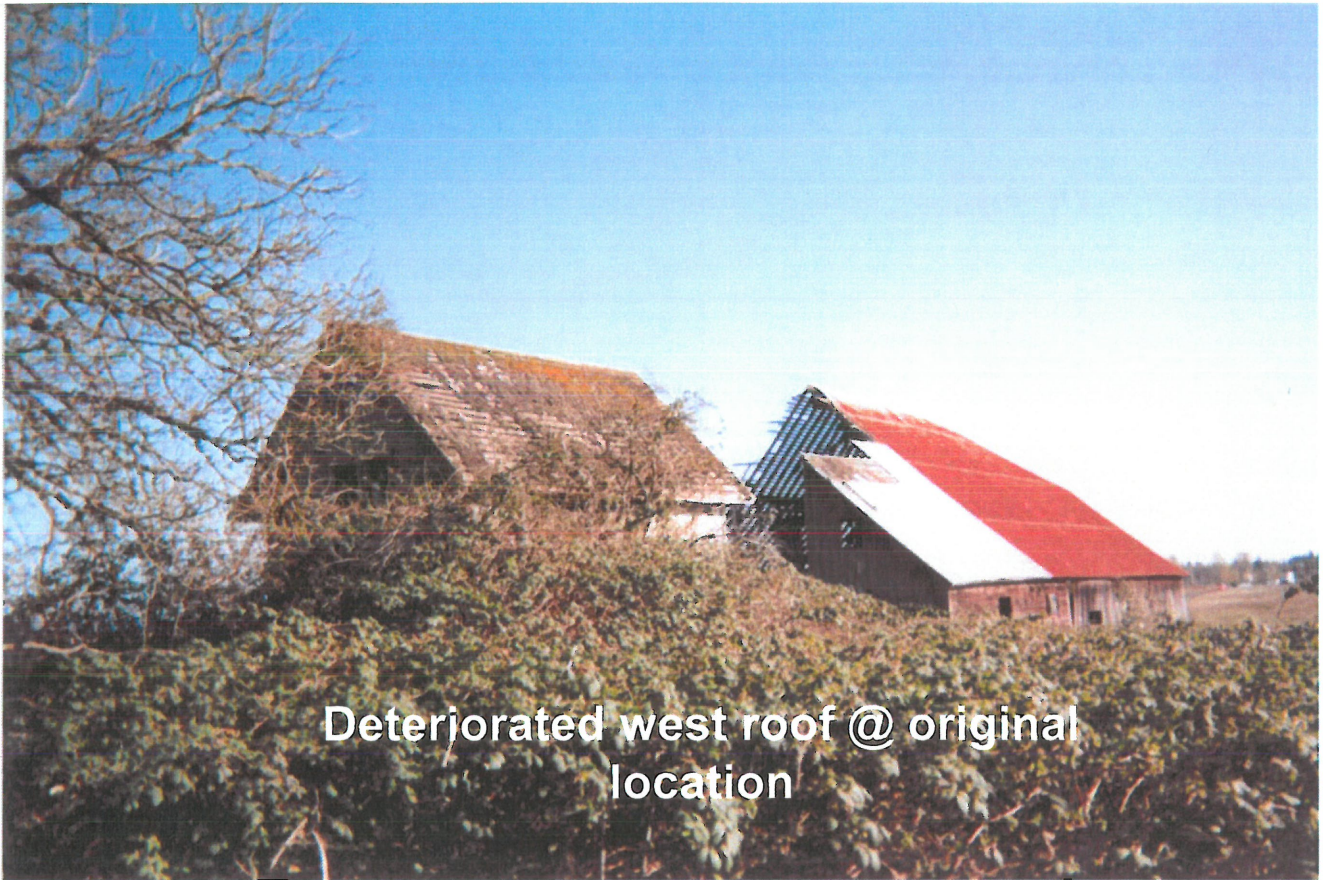
Deteriorated west roof @ original location

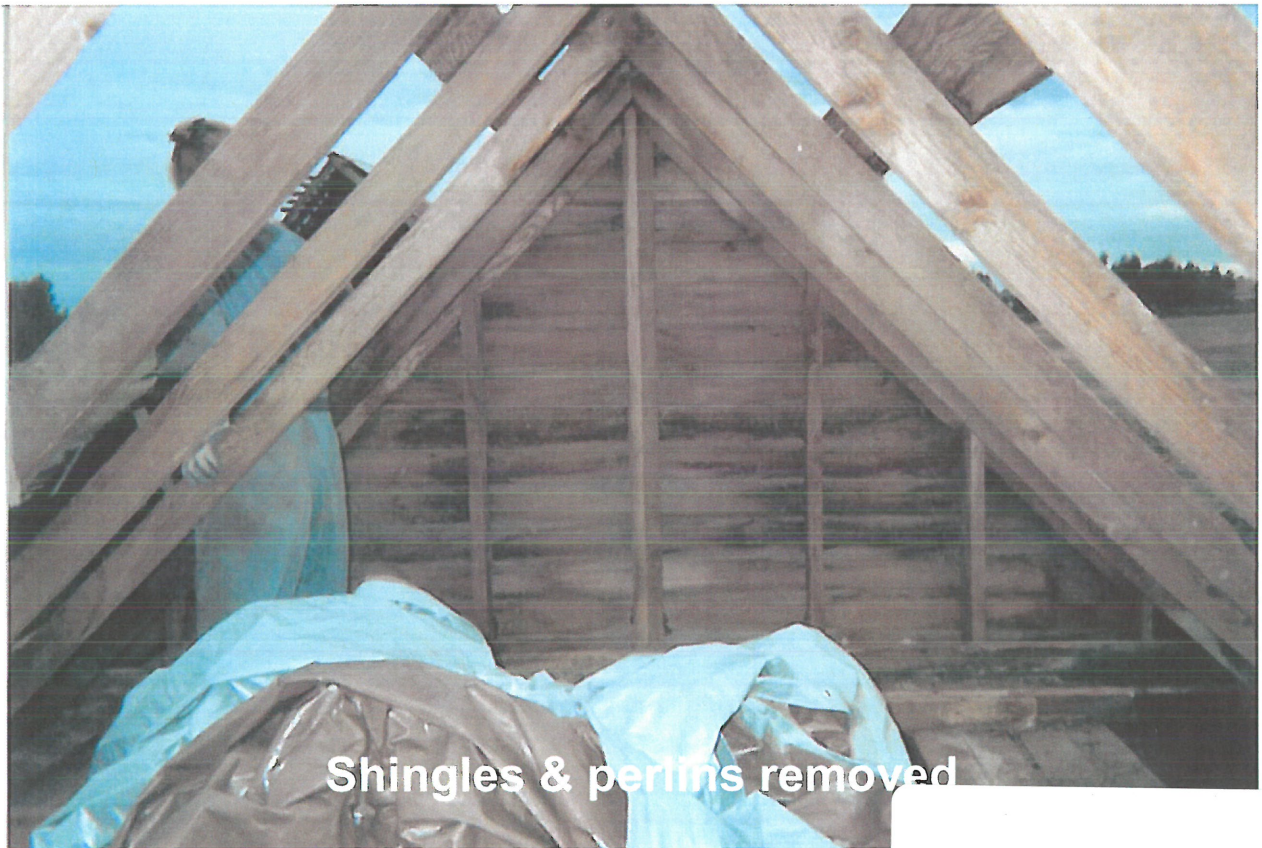
Shingles & perlins removed

Height reduced to clear utilities

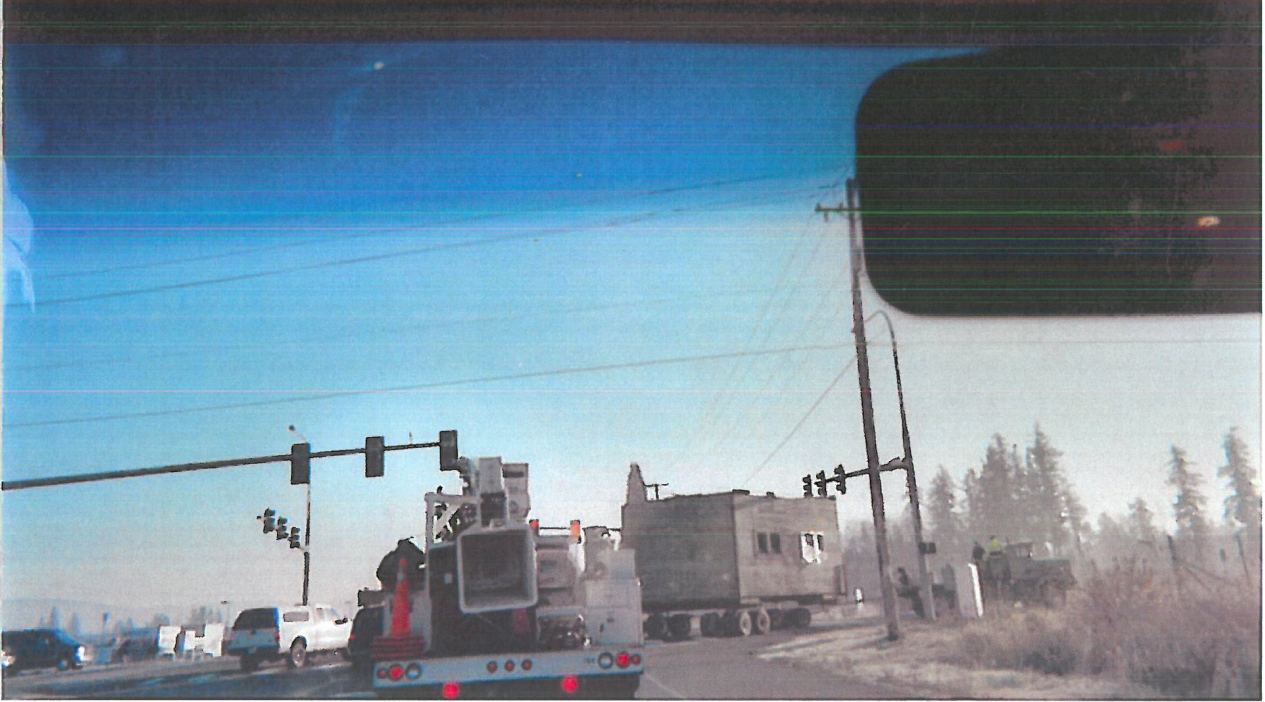
Pulling granary into relocation site

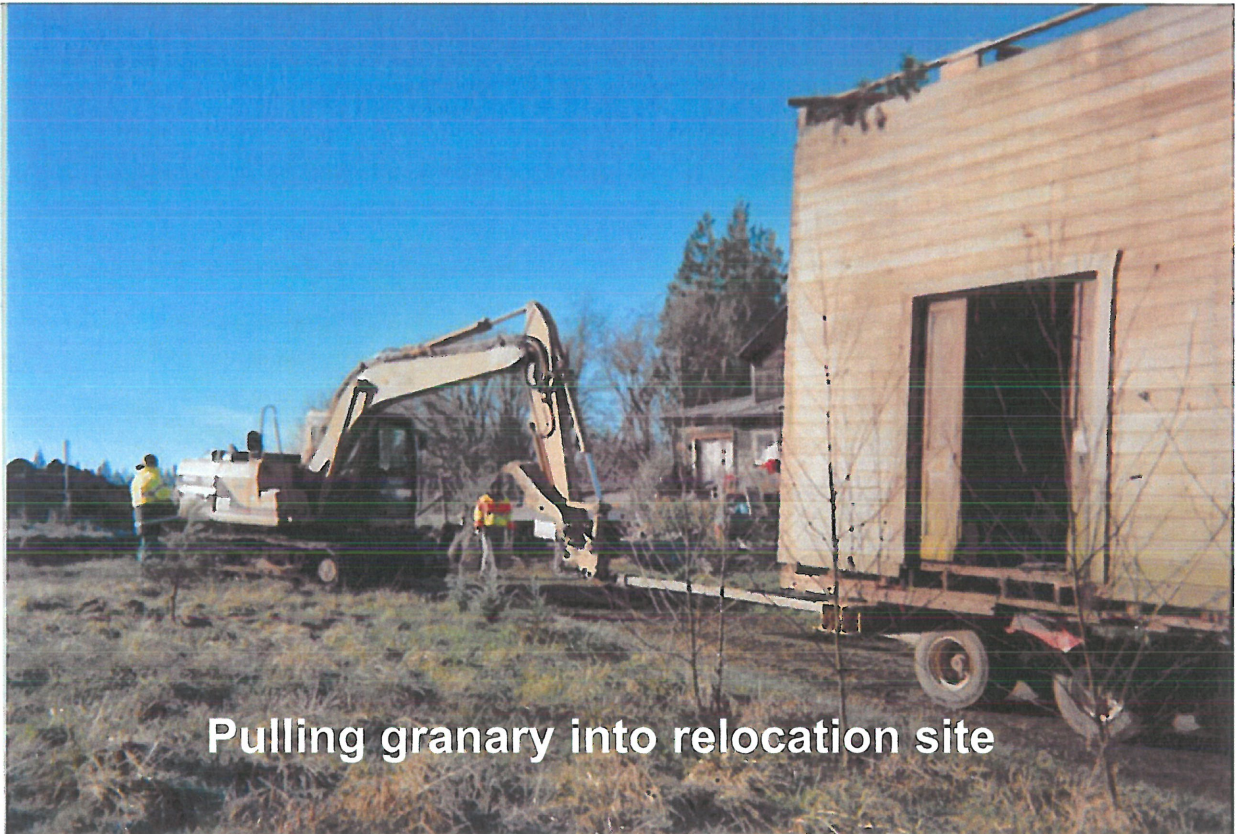
**Granary on blocking, new floor joists installed, west wall siding removed beginning to replace rotten studs**

The extensively rotted west wall and west four feet of the floors have been rebuilt using like materials. A support wall was added during the moving process approximately three feet from the west (historical orientations) wall. The wall is made of two by six's with a top and bottom plate and six studs. The wall is open between studs (salvaged from Kapus Barn).

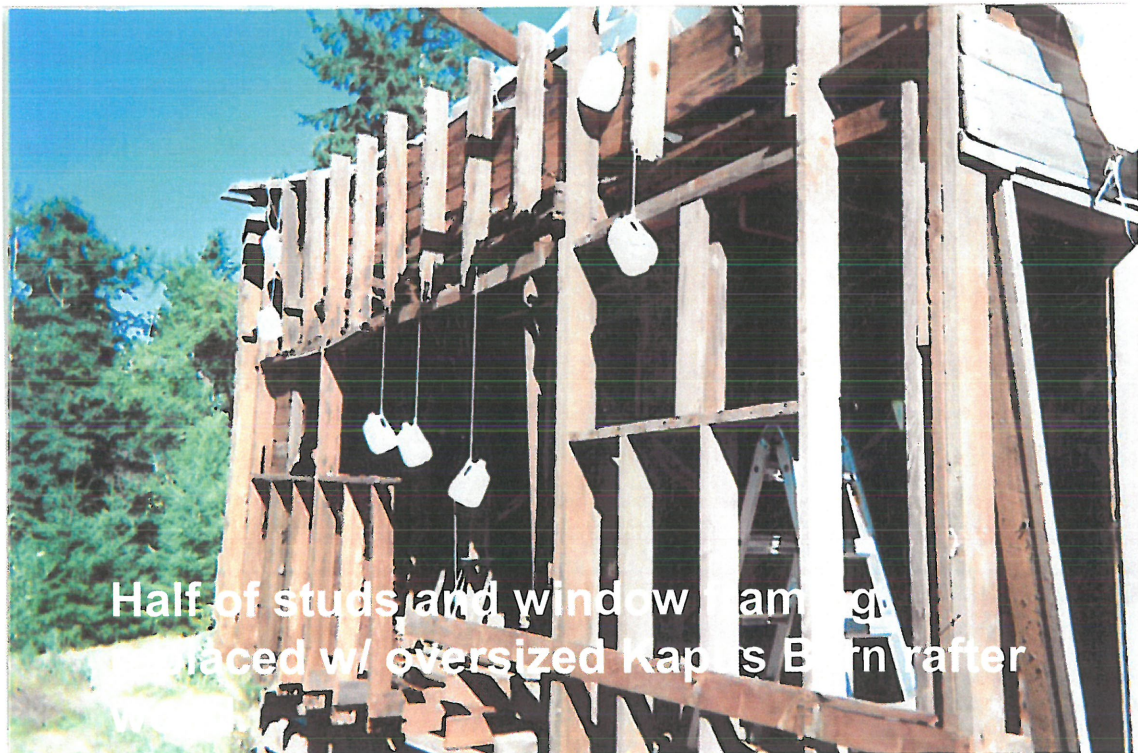
**Half of studs and window framing replaced w/ oversized Kapok's Barn rafter**
