# Clark County Heritage Register Nomination Form

Historic name The Kapus Granary  
Other names/site number Formerly at 27225 NW 11<sup>th</sup> Avenue, Ridgefield

PROPERTY NAME: KAPUS GRANARY  
CLARK COUNTY, WASHINGTON

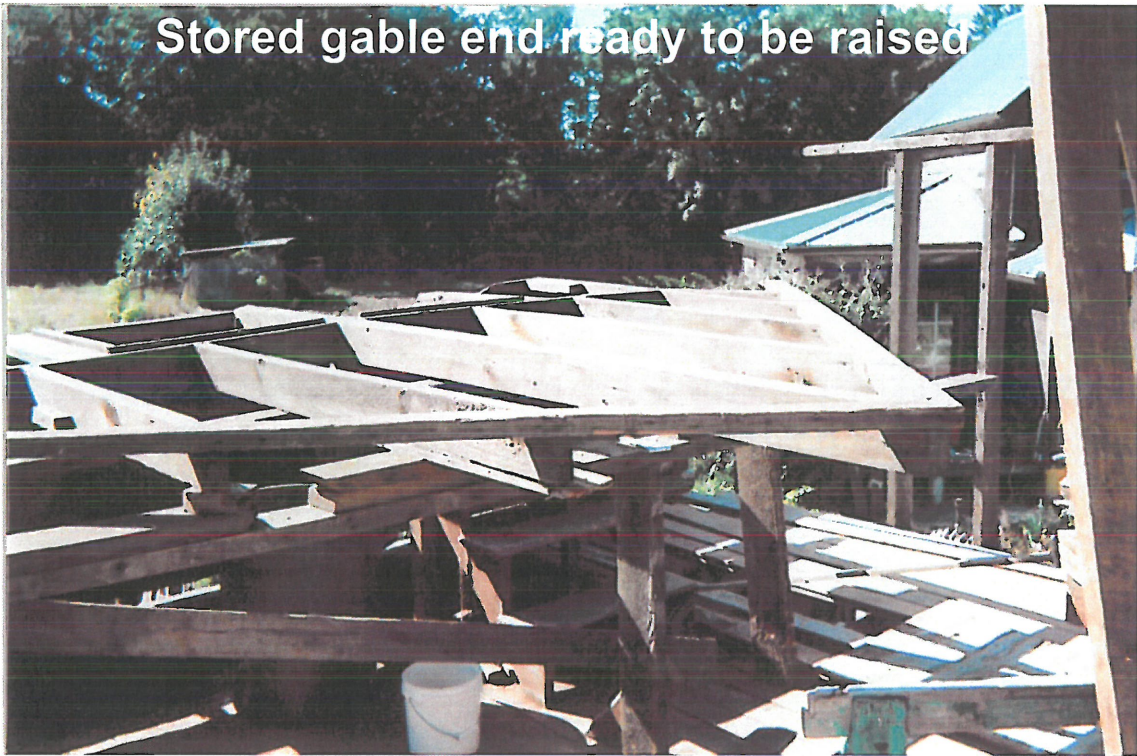
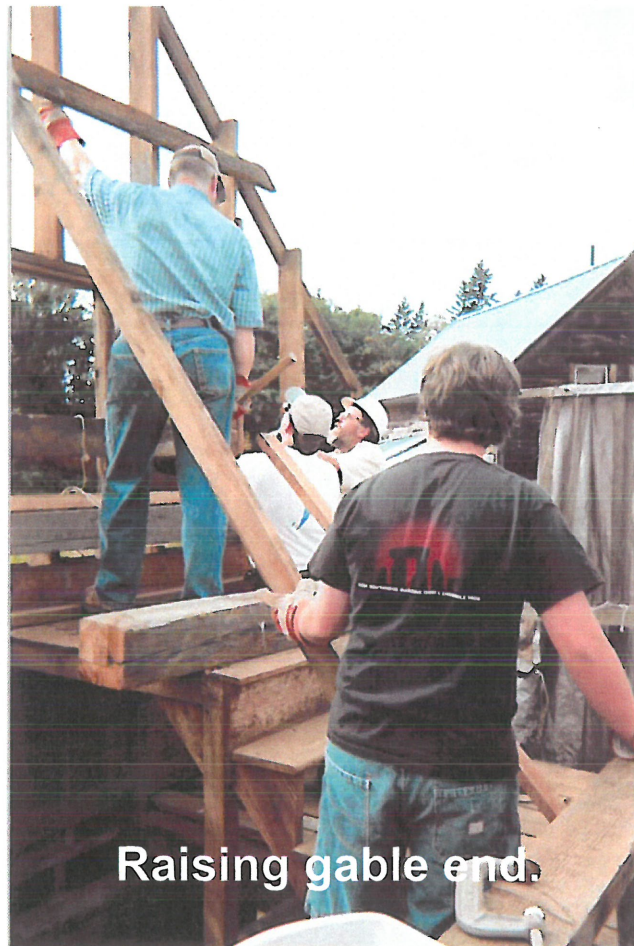
Raising gable end.

Relocation of the Kapus Granary revealed that the gable end walls were not constructed using a simple balloon frame technique but rise to a plate at the second and third floor and are framed as mirror image right triangles nailed together at the center. In its present location the building remains largely as described with the exception that the cedar shingle roof has been replaced with a standing seam metal roof and gutters and downspouts have been added. The building has been stained a natural gray and window trim has been painted a brownish red.

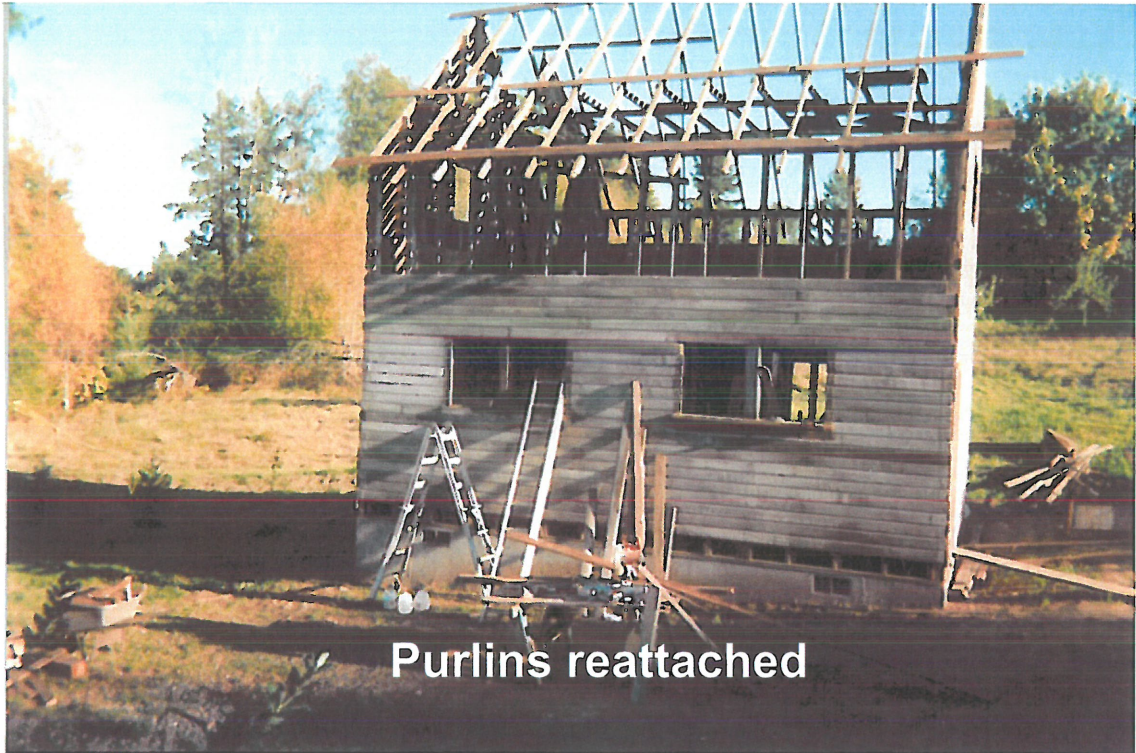
Purlins reattached

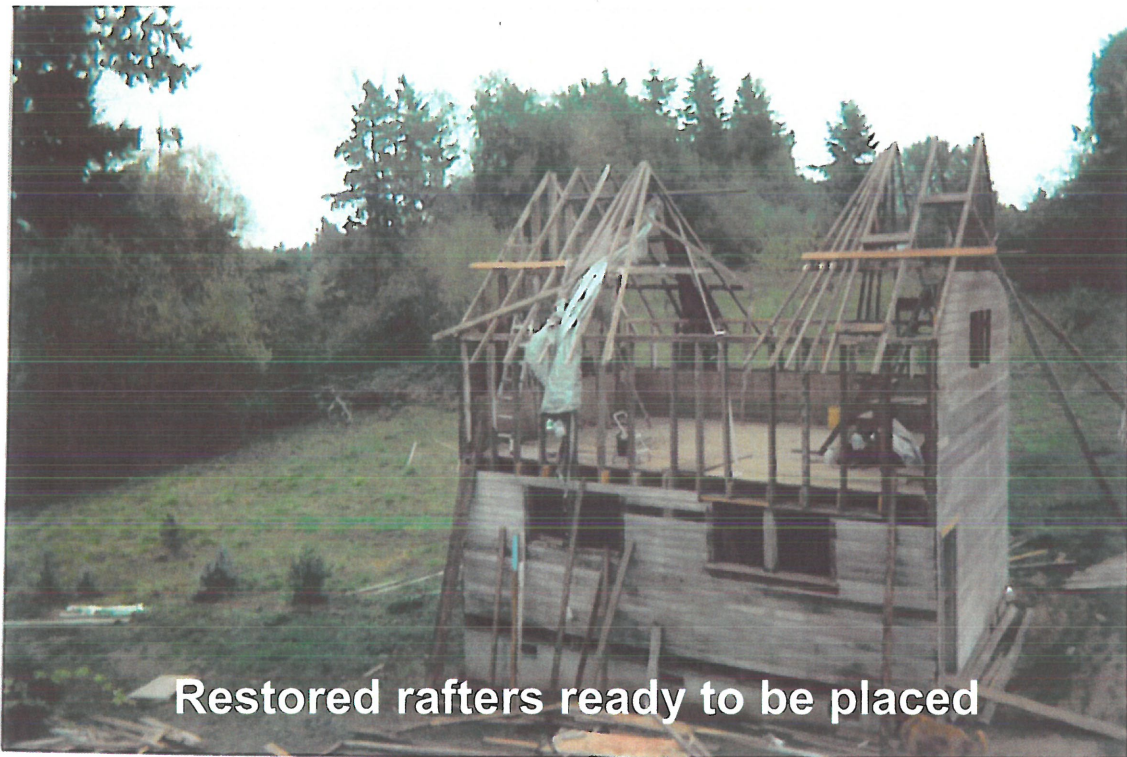
Restored rafters ready to be placed

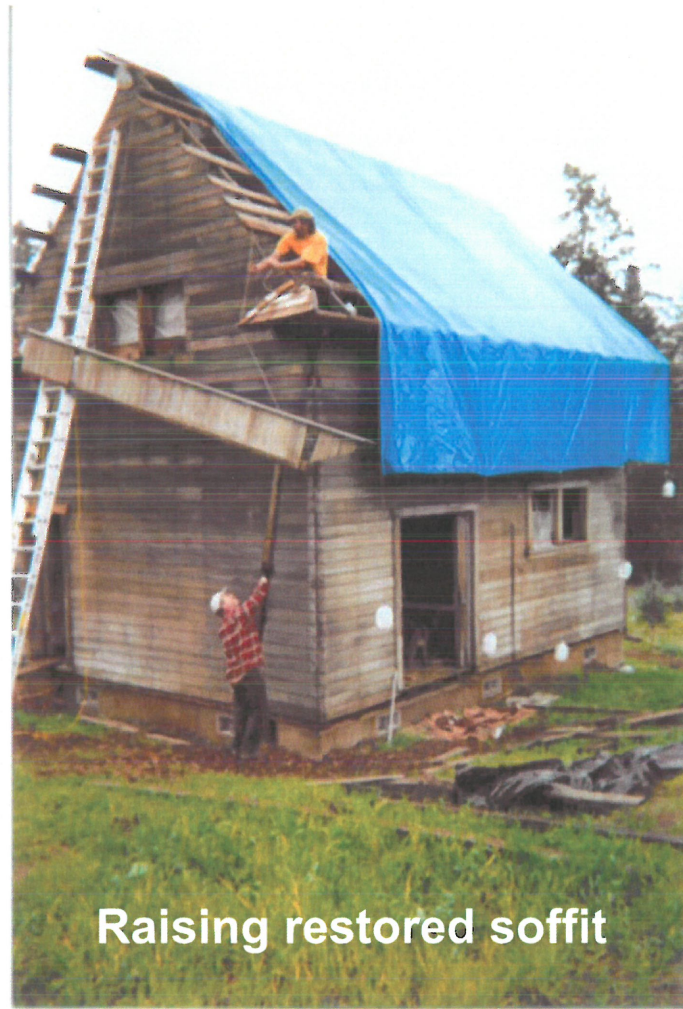
Raising restored soffit

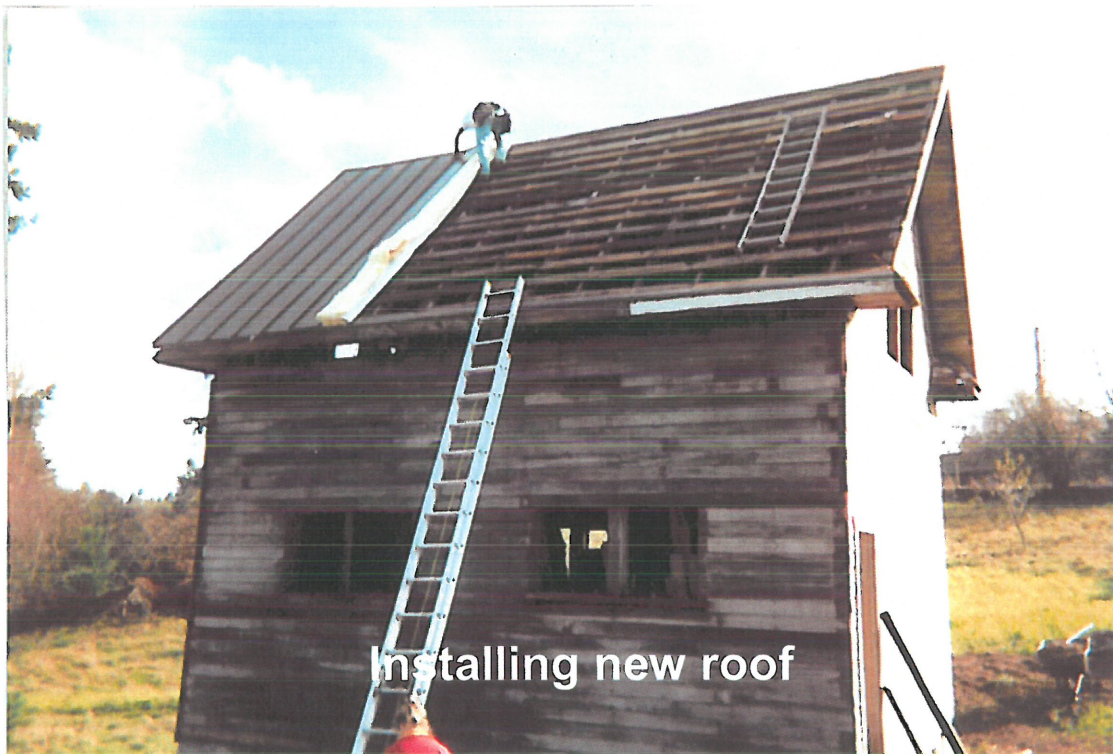
Installing new roof
