Clark County
Historic Preservation
Commission

Certificate of Appropriateness Application

Nelson Farmhouse Proposal for Exterior Modifications

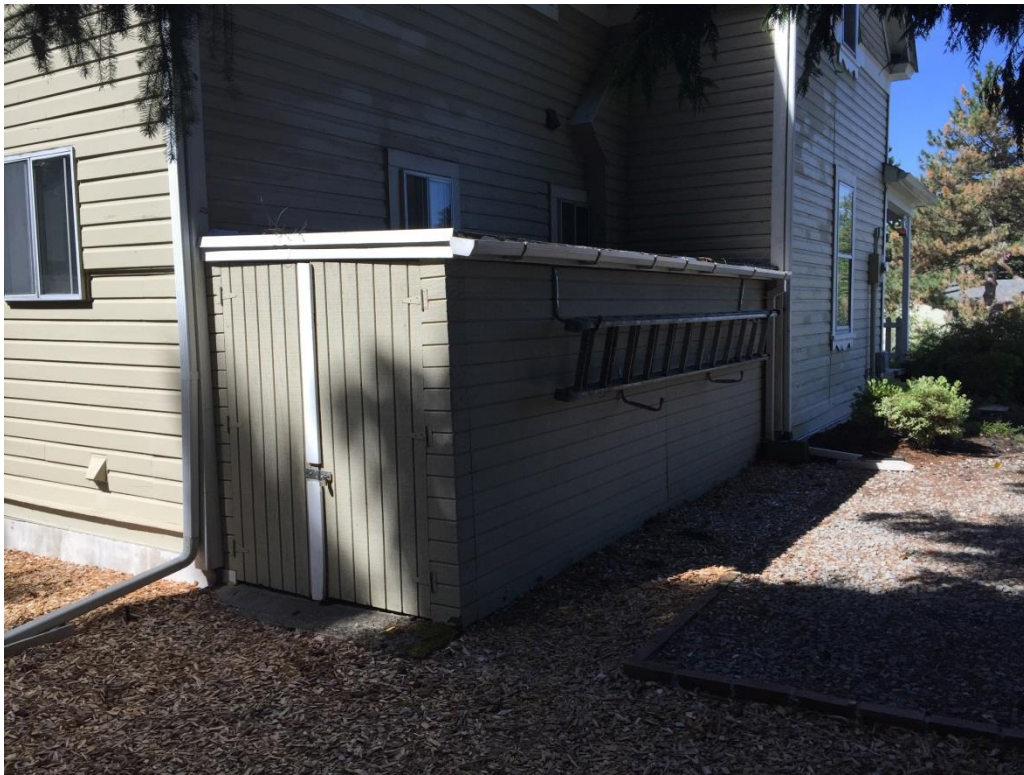
Exhibit 1 Garden Shed Profile

The attached garden shed is located on the southeastern exterior wall of the main house. The shed has a foot print of 5.5' x 17.5' and an average ceiling height of approximately 6' (Exhibit 1).

- Removal and disposal of the attached garden shed structure and materials.
- The existing concrete slab shed foundation will be left in place at this time. It is a flat slab poured to the same dimensions of the garden shed structure.
- Repair and preservation of existing main structure siding – if siding needs to be replaced it will be replaced with custom milled profile matching the original siding placed on the house. Focus on the siding will be on preservation over replacement.
- Repair of the two small windows including appropriate flashing and trim to match the existing trim that was installed originally with the windows.
- All siding and trim involved with the shed removal will be sealed/caulked, primed, and painted to match the rest of the house.

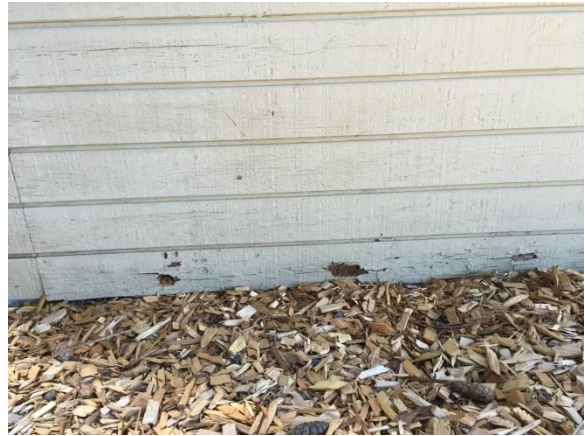
Exhibit 2 Dry Rot Example

The shed is of historically incorrect and non-conforming construction. As a result, extensive dry rot has set in on the eastern wall of the shed siding. Additionally, the torch down roof and associated flashing of the shed have failed in several areas due to incorrect installation and age (Exhibit 2 & 3). We are concerned this structure may begin to be a vector point for water to enter into the main structure walls. There are also two main structure windows (circa 1980's aluminum storm windows) at the same elevation of the shed roof (Exhibit 4). The combination of a shallow pitched roof with repeated past tar build up from repairs has begun to let water to intrude into the sills of both windows. We propose to remove the garden shed structure as it was not part of the original farmstead and is considered a risk to the parent historical structure.

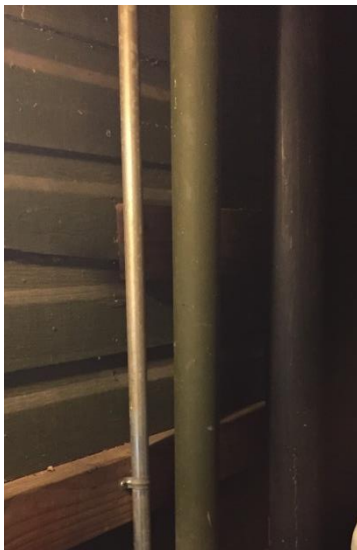
Exhibit 5 Chase Plumbing

The plumbing chase houses one electrical $\frac{3}{4}$ " Ø conduit, one galvanized 1 $\frac{1}{2}$ " Ø, and one 2" Ø ABS waste water pipes (Exhibit 5). The plumbing chase appears to have been constructed at a different time than the garden shed but was tied structurally into the roof of the shed upon construction. The chase appears to use modern dimensional lumber and a mismatched lap siding similar to what can be found at most chain lumber stores. The chase is not water tight and utilizes an inadequate pitched cap atop the chase that is simply painted (Exhibit 6A & 6B). The chase is haphazardly flashed and tarred at the base to the shed roof. The construction of this chase is similar in methods to the garden shed and provides little protection from the elements. We would like to remove the chase to avoid moisture and rot from moving into the original structure wall.

- Removal and disposal of the plumbing chase structure and material.
- Repair and preservation of existing main structure siding – if siding needs to be replaced it will be replaced with custom milled profile matching the original siding placed on the house. Focus on the siding will be on preservation over replacement.
- Contractor flashing and sealing of pipe egresses from the house to be water tight.
- All siding involved with the plumbing chase removal will be sealed/caulked, primed, and painted to match the rest of the house.
- All piping and conduit will be painted in siding and trim profile colors to provide visually consistent aesthetics in an effort to minimize visibility.

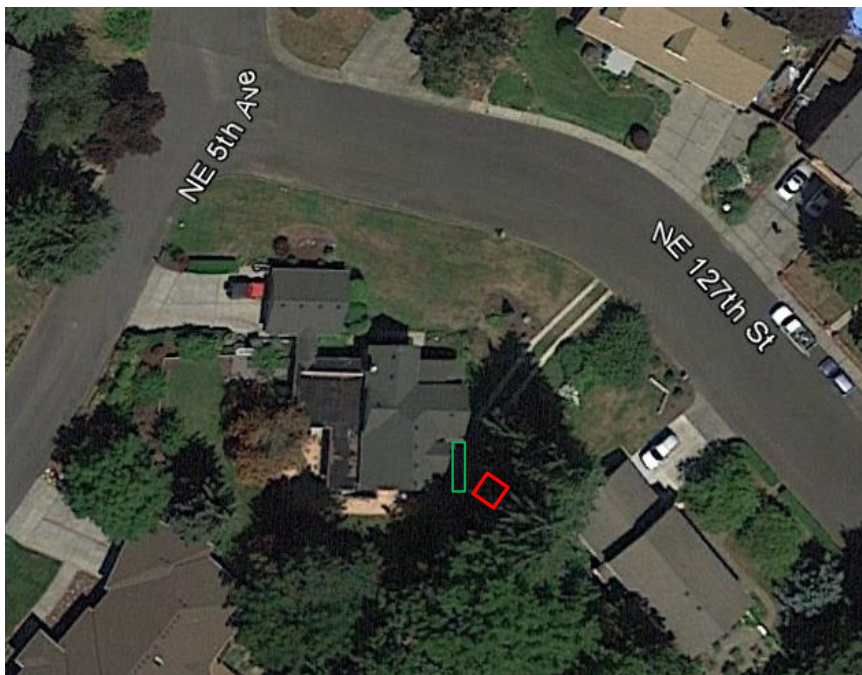
Exhibit 8 New Shed Location

We are proposing the installation of a prefabricated all wood construction detached garden shed. The new structure will have an 8'x8' finished footprint. Walls are to be 8' in height and finished with a gabled roof and double barn style locking door. The roof will be finished in a green 30 year architectural shingle to match the shingles on the main home. The shed will be painted to match the home siding and trim colors. Exhibits 8, 9, and 10 show the proposed location for the new shed placement in red and the removal of the old shed in green. The wood yard debris bin will be removed. The shed placement was chosen to provide adequate working distances from the home and minimal visual impact from the street.

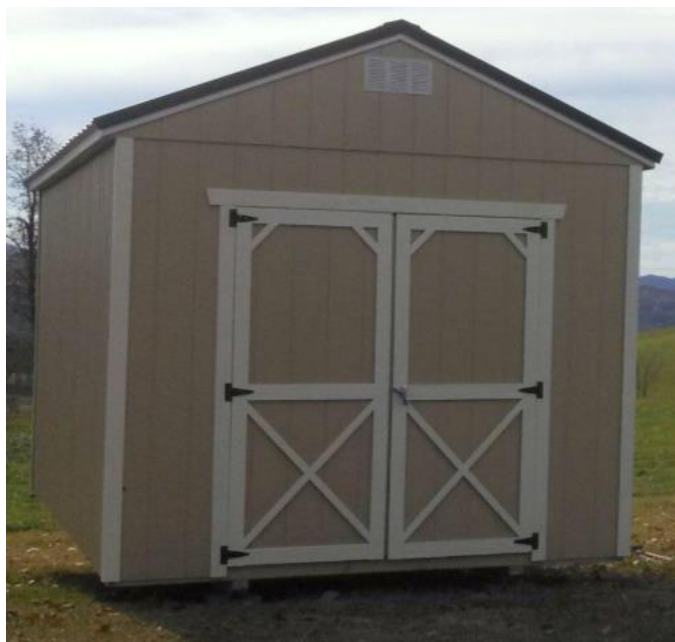
Exhibit 11 New Shed Example

The manufacturer of the shed provides delivery and installation including the concrete block surface footings/shims to support and level the structure. Exhibit 11 shows a typical view of the proposed shed. Structural drawings are available upon request.
