ADA Compliance Program

Clark County Facilities Transition Plan Public Works Operations Center

Date of Survey: November 5, 2007 and December 6, 2007

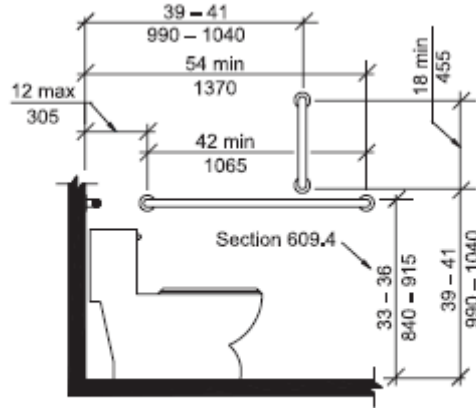
Fig. 604.5.1
 Side Wall Grab Bar for Water Closet

Item # 9
 Issue: Vertical Grab Bars
 Issue: Forward Reach
 Issue: Flush Controls
 Issue: Clear Floor Space
 Location: Conference Center
 Code: ANSI 604.5.1 – Vertical Grab Bar
