2008 Stormwater Needs Assessment Program

Salmon Creek (RM 03.83)/Cougar Creek
Subwatershed Needs Assessment Report

Clark County Public Works Clean Water Program

April 2009

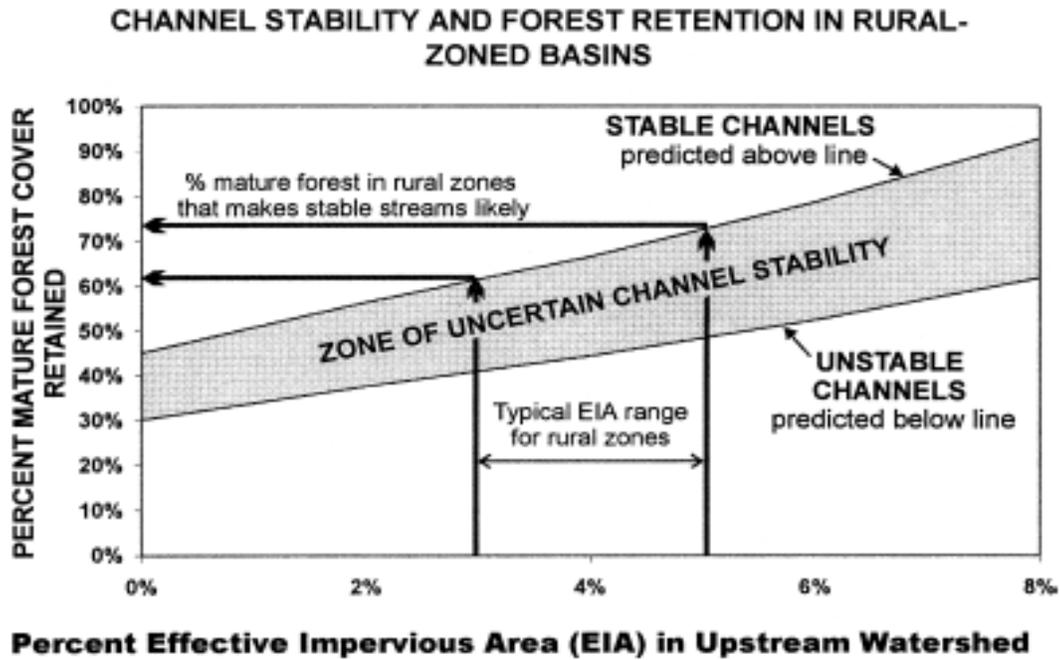
Figure 2: Channel stability in rural areas (Booth, Hartley, and Jackson, June 2002).

In a recent publication by Booth, Hartley, and Jackson (June 2002), a relationship between forest and percent EIA was presented as a graphic (Figure 2). According to this figure, streams in both subwatersheds would be expected to have very unstable channels.

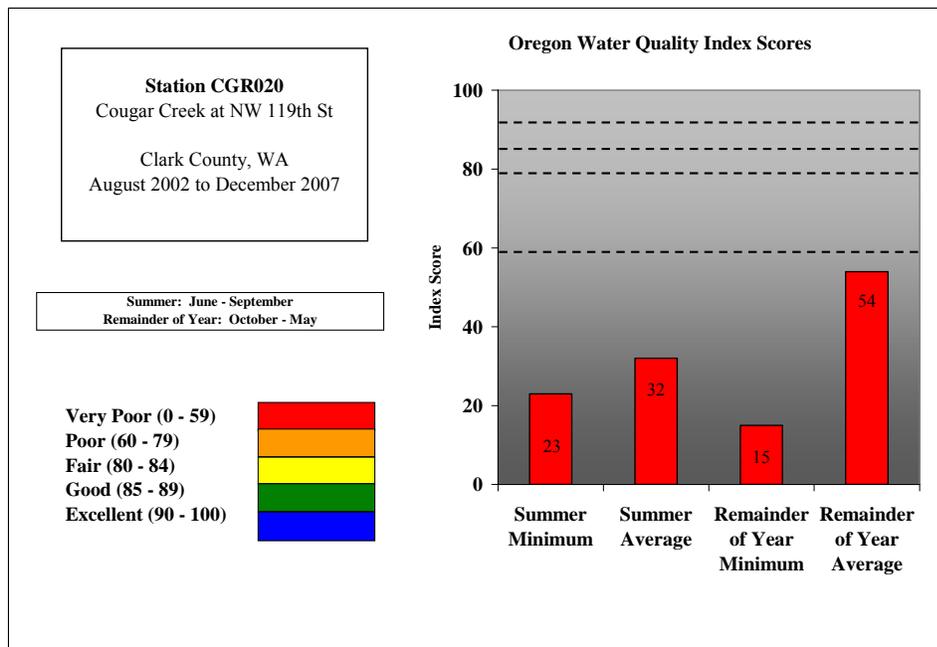
Figure 3: Average Water Quality, Cougar Creek station CGR020, 2002 through 2007, Oregon Water Quality Index

Figure 3 shows seasonal mean OWQI scores for Station CGR020 from 2002 through 2007. Among 15 long-term monitoring stations county-wide, Station CGR020 ranked second worst in overall water quality during this time period (Hutton and Hoxeng, 2007).

Monthly OWQI values since 2002 ranged from Very Poor to Fair, although for most months (43 out of 62 months sampled) OWQI values were in the Very Poor category. Monthly sub-index scores for total solids and inorganic nitrogen were consistently very poor, while scores for total phosphorus were typically in the poor range. Fecal coliform scores ranged widely, from very poor to excellent. Scores for water temperature, dissolved oxygen, and pH were consistently excellent.

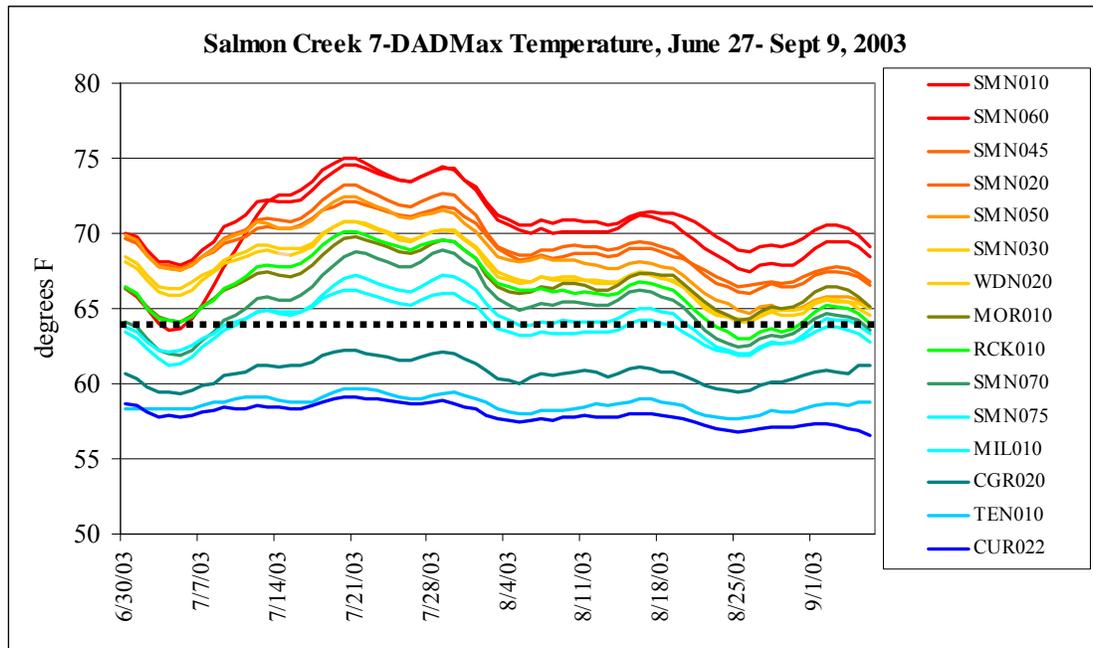
Figure 4: Time-series plot of 7-DADMax temperatures, Salmon Creek, summer 2003. (from Schnabel, 2004). Dotted line at 64° F represents the pre-2006 Washington state stream temperature criterion. The current criterion is 60.8° F.

Figure 4 shows 7-DADMax temperatures during the summer of 2003 for 15 stations throughout the Salmon Creek watershed. The 7-DADMax is the maximum of the 7-day moving average of daily maximum temperatures. Ecology standards utilize this metric to determine temperature compliance (criterion for this assessment area is 60.8 degrees F).

Based on current state criteria for Salmon Creek, Tenny Creek was the only station meeting criteria within this assessment area; though Cougar Creek exceeded the criteria only slightly. Despite the addition of cool tributary flow from Tenny Creek and Cougar Creek, mainstem Salmon Creek within this assessment area remains very warm, substantially exceeding the state criterion.

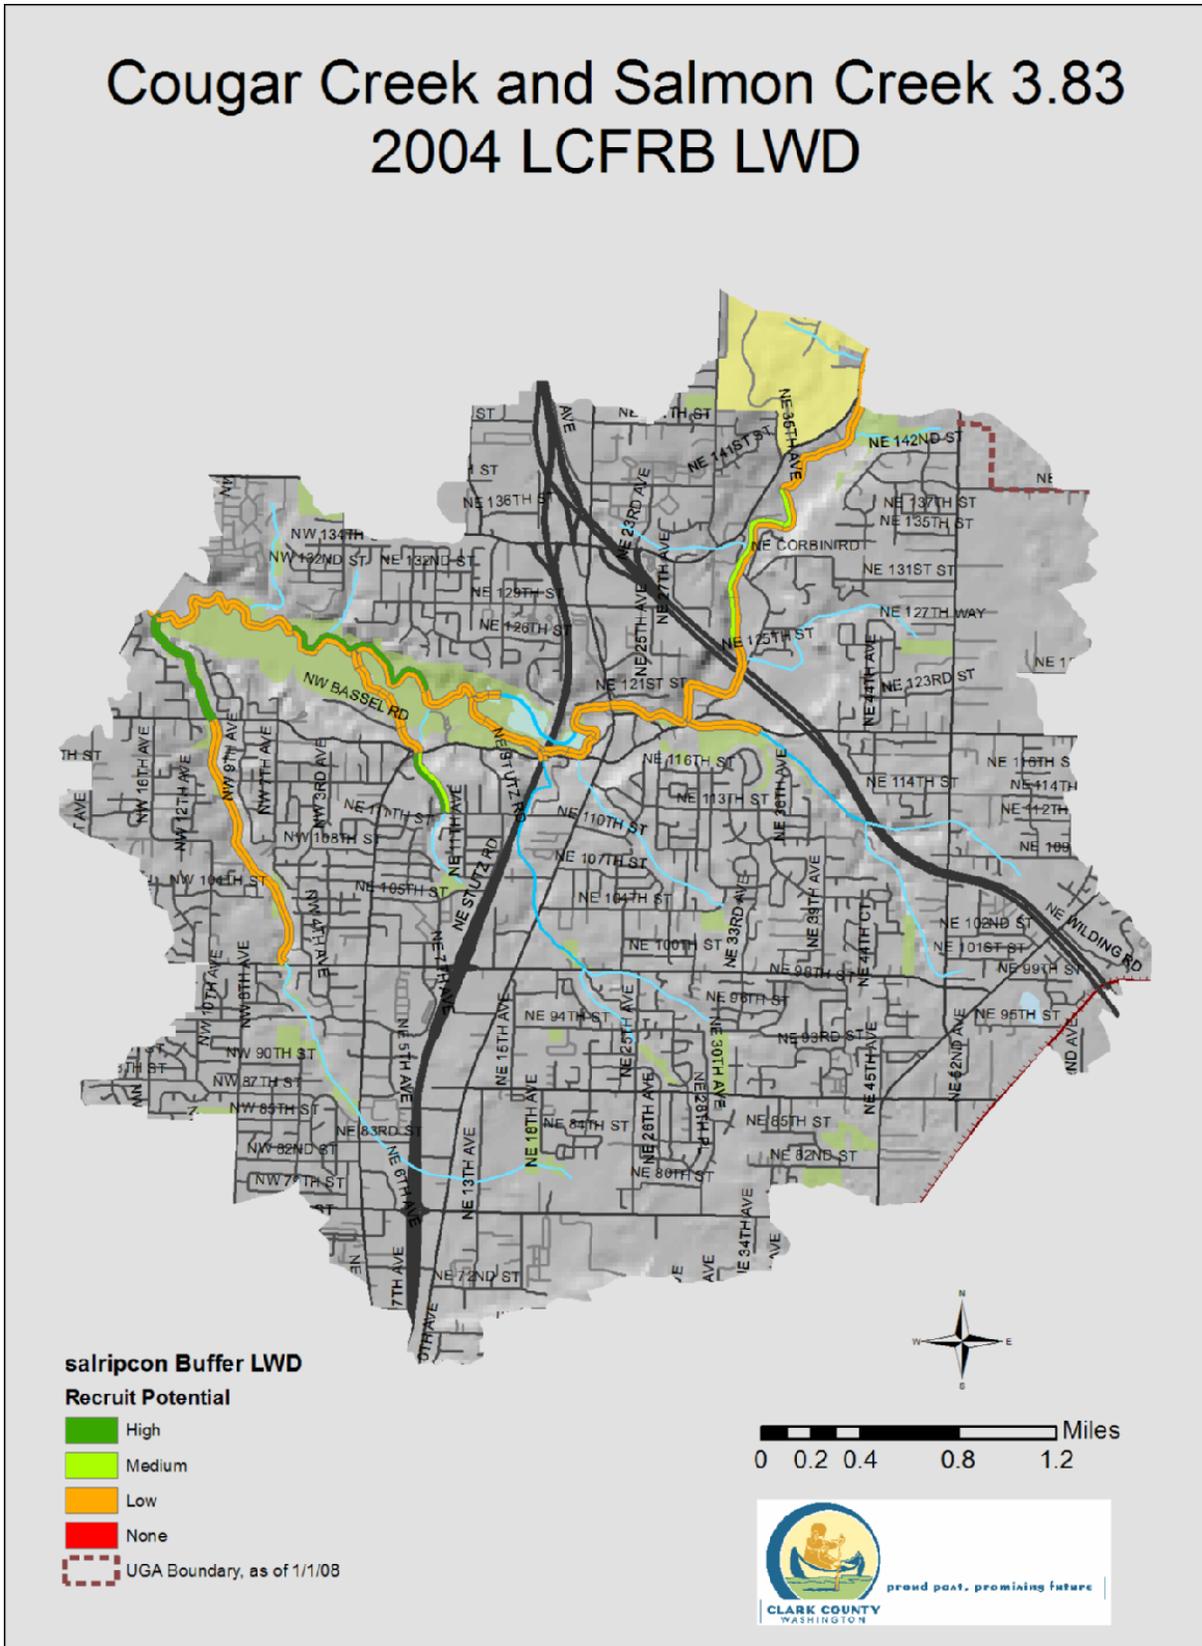
Figure 17: Salmon Creek (RM 03.83) and Cougar Creek LWD Recruitment Potential (adapted from R2 Resource Consultants, Inc., 2004)

Figure 17 shows the Salmon Creek (RM 03.83) and Cougar Creek subwatersheds LWD delivery potential. Within the Salmon Creek (RM 3.83) subwatershed, the survey includes the mainstem of Salmon Creek and portions of Suds and LaLonde Creeks. The mainstem of Salmon Creek is shown as having primarily low LWD recruitment along the approximate three mile distance surveyed. Review of the surveyed area and non-surveyed areas of Suds Creek, Tenny Creek and LaLonde Creek indicated primarily low LWD recruitment levels, with some small areas of medium recruitment.

The Cougar Creek subwatershed survey addresses only the lower reaches of Cougar Creek, which transitions from high levels of recruitment near the mouth of the creek, to lower levels further upstream. Review of orthophotography in the upper reaches estimated LWD recruitment potential ranging from low to none, with the lowest levels of recruitment located near the headwaters of Cougar Creek.

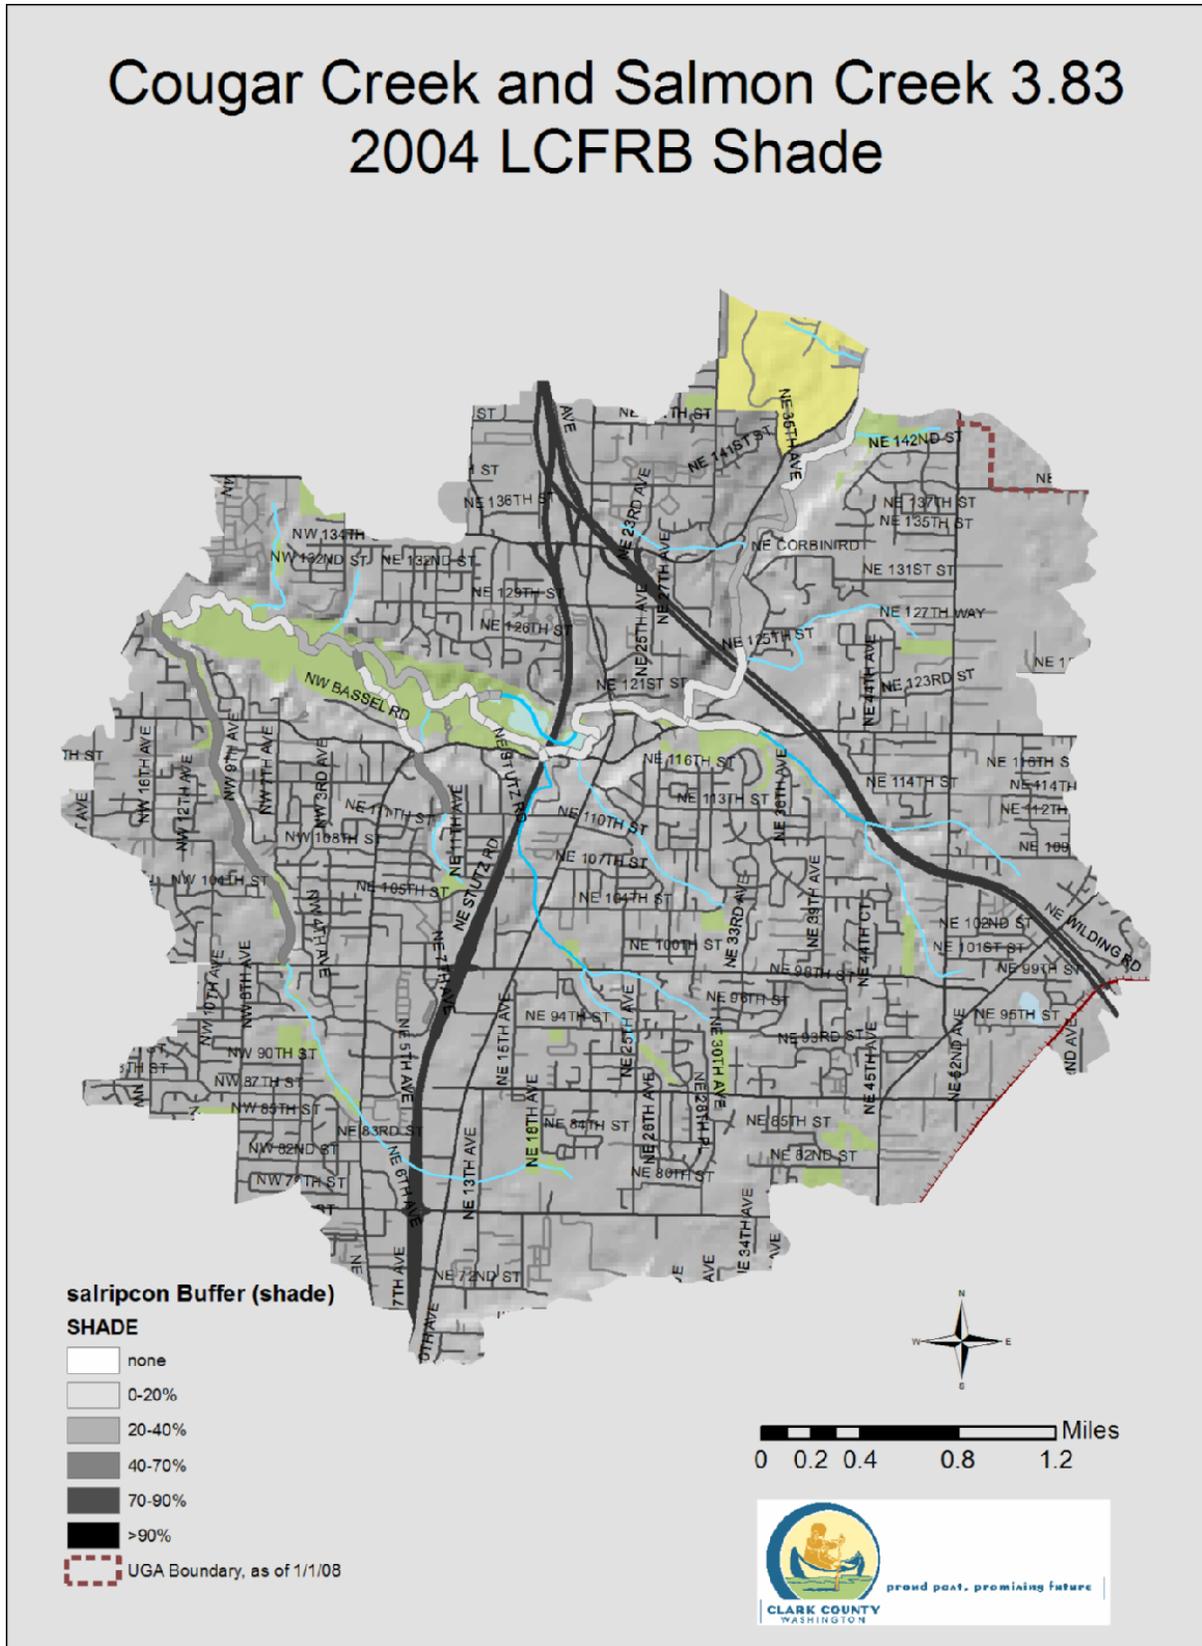
Figure 18: Salmon Creek (RM 03.83) and Cougar Creek Shade Values (adapted from R2 Resource Consultants, Inc., 2004)

The Salmon Creek (RM 03.83) and Cougar Creek subwatersheds shade ratings from the 2004 LCFRB Habitat Assessment are illustrated on Figure 18. Within the Salmon Creek (RM 03.83) subwatershed, the survey covered the mainstem of Salmon Creek and portions of Suds and LaLonde Creeks. The mainstem of Salmon Creek within the Salmon Creek (RM 03.83) subwatershed has shade levels ranging from 0 percent to 40 percent. Review of the surveyed area and non-surveyed areas of Suds Creek and LaLonde Creek indicated shade levels of varying from 0 percent to 70 percent. Tenny Creek is estimated to have shade levels ranging from 0 percent to 40 percent, based on orthophotography review.

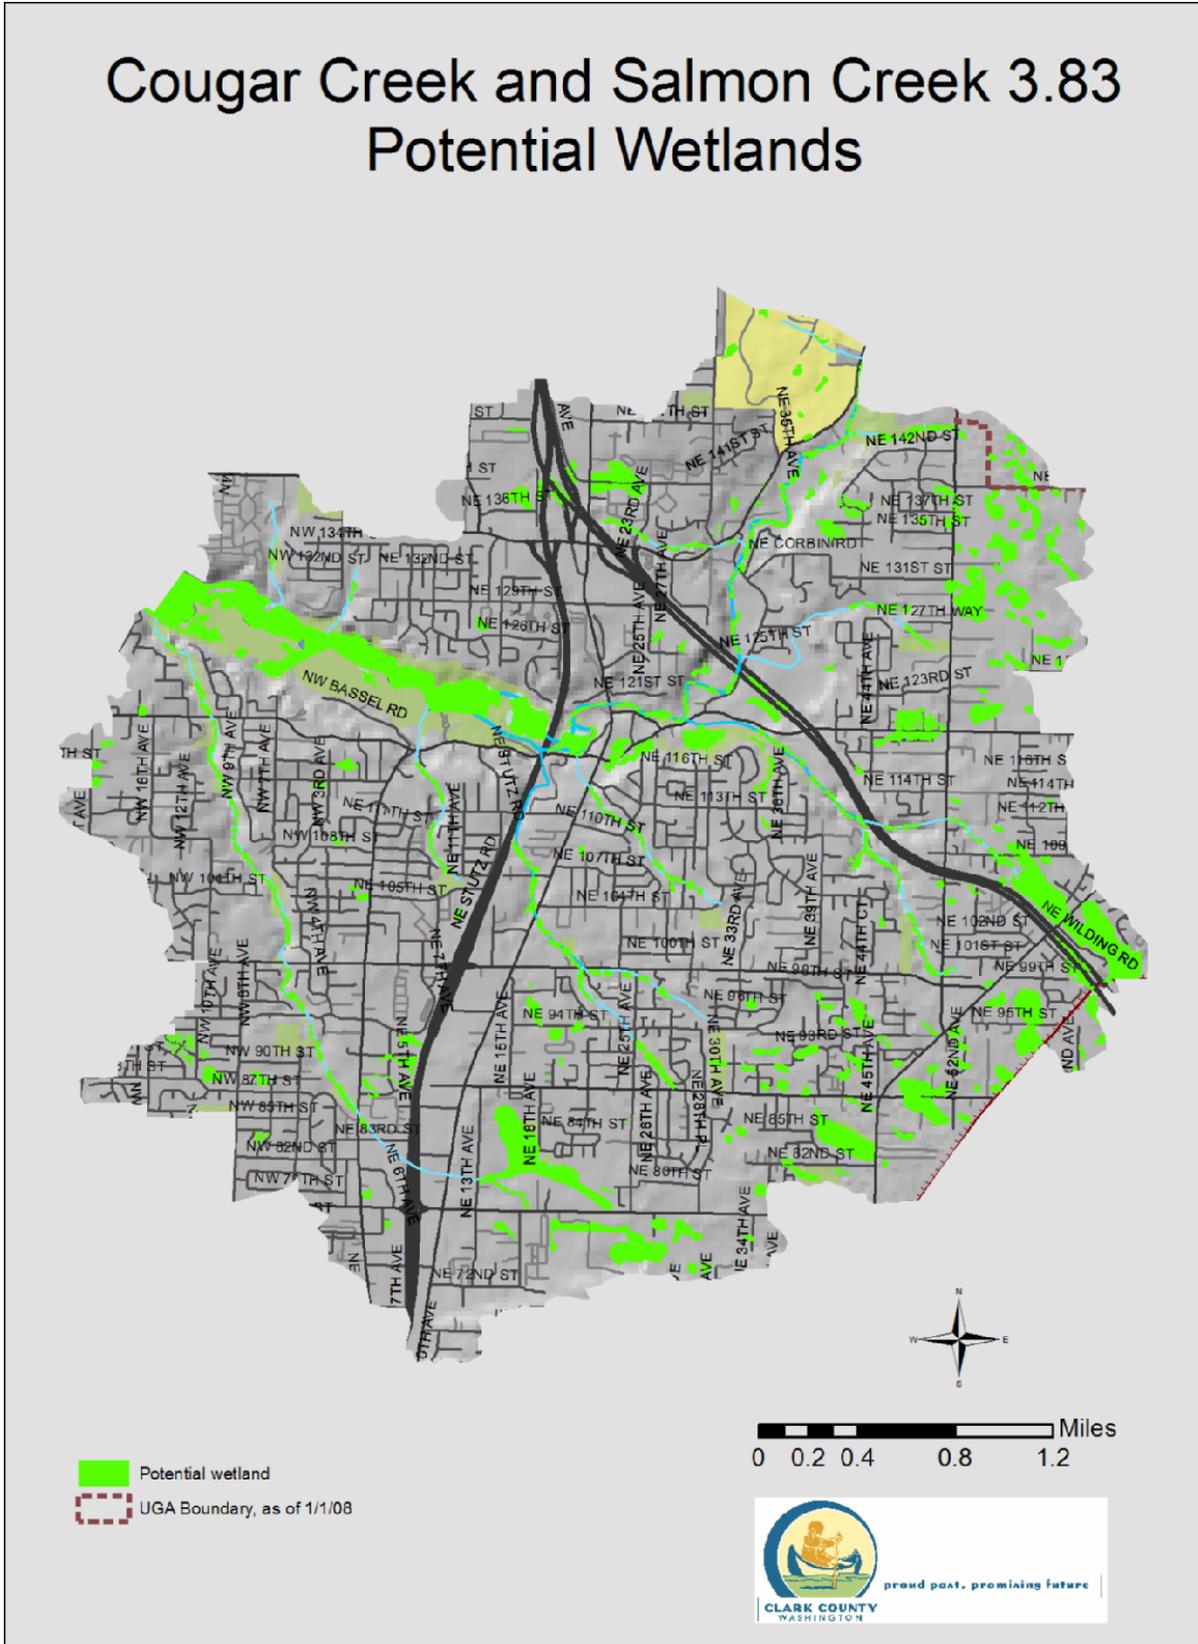
Figure 19: Salmon Creek (RM 03.83) and Cougar Creek Potential Wetlands

Figure 19 shows potential wetland areas within the Salmon Creek (RM 03.83) and Cougar Creek subwatersheds based on data from the county wetlands atlas, including the Clark County wetland model, National Wetlands Inventory, and high-quality wetlands layer.

Review of the wetland inventories and studies identified several project opportunities within publicly held or tax-exempt land. Within the Salmon Creek (RM 03.83) watershed, there are potential wetlands in the vicinity of the headwaters of Tenny Creek. Additionally, potential wetland areas owned by Clark County are located at the headwaters of Cougar Creek.

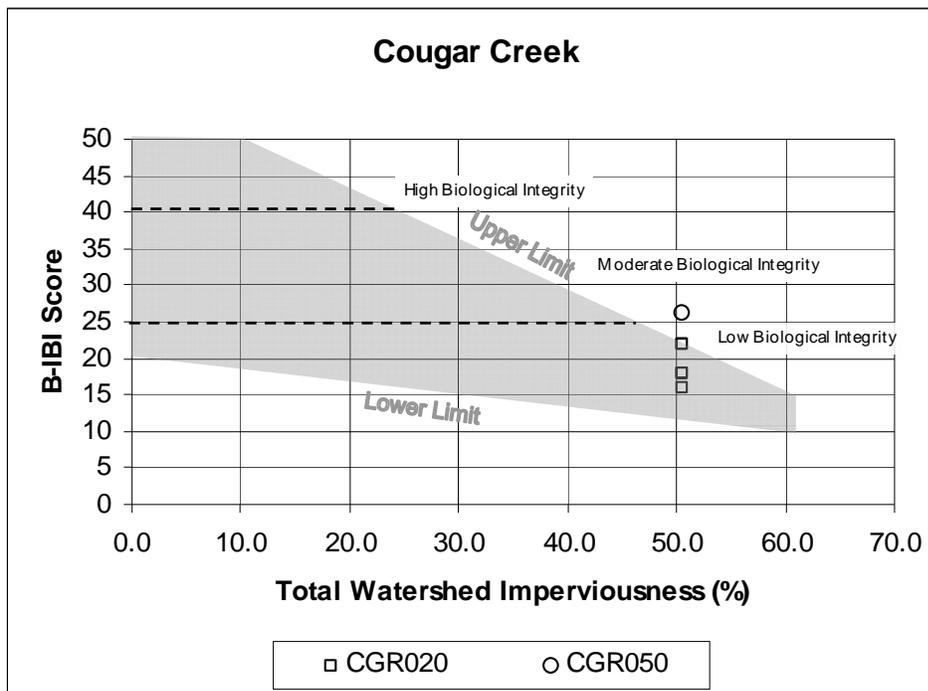
Figure 21 shows that three of the five annual Station CGR020 B-IBI scores are in the middle and two are at the upper limit of the range of expected scores, whereas Station CGR050's single B-IBI score is above the upper limit (estimated 2000 Total Impervious Area from Wierenga, 2005).

Given most of Cougar Creek's B-IBI scores fall within or slightly above those typically found for subwatersheds with 50 percent impervious areas, there may be limited opportunity to improve scores into the moderate range through habitat rehabilitation.

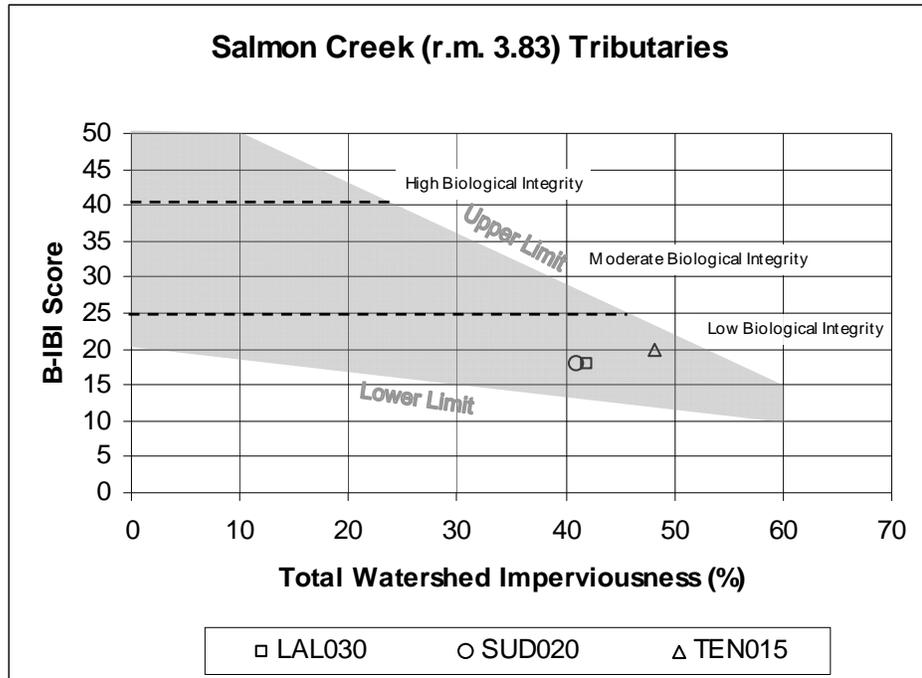
These three Salmon Creek tributaries B-IBI scores fall mostly in the middle of the expected ranges for their relatively high estimated 41 percent to 48 percent impervious areas. This implies an opportunity to increase the level of their biological integrity by improving habitat and stream conditions. Management strategies that limit further degradation and promote stewardship are important to possible improve biological integrity.

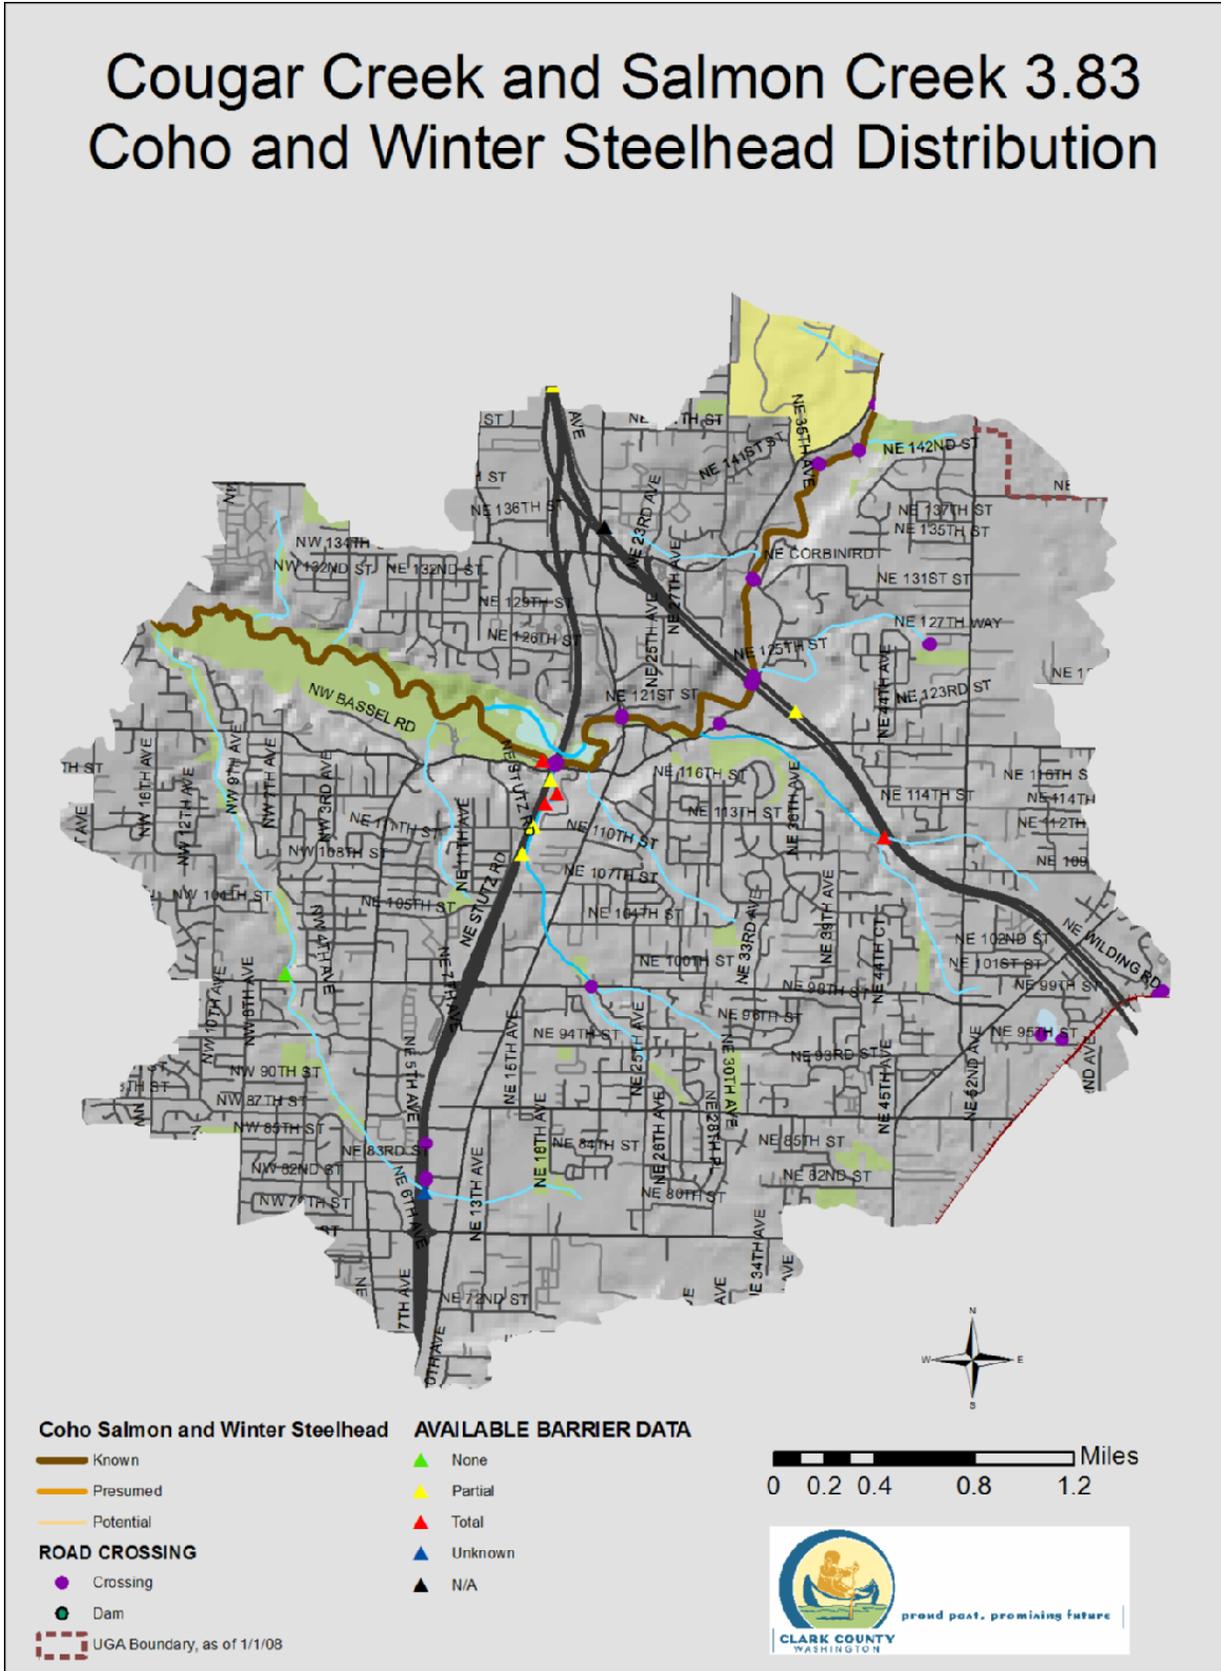
Figure 23: Salmon Creek (RM 03.83) and Cougar Creek Fish Distribution and Barriers

The fish distribution mapping figure suggests that anadromous fish use within the Salmon Creek (RM 03.83) subwatershed includes Coho salmon and winter steelhead (Figure 23). The SalmonScape fish distribution data also identified the known presence of fall Chinook within the mainstem of Salmon Creek.

The Cougar Creek subwatershed was not listed as having any known anadromous fish use. The SalmonScape fish distribution data identified the presumed presence of Coho salmon and winter steelhead within the mainstem of Cougar Creek. A series of waterfalls and cascades near its mouth probably block fish passage.
