78th Street Heritage Farm Preservation & Maintenance Plan

County Council Work Session, Aug. 8, 2018, 6th Floor Training Room

Preservation and Maintenance Plan

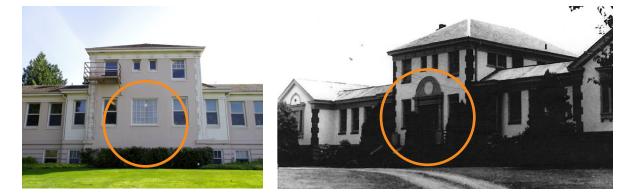
Administration Building (1926)

- Water infiltration behind insulated panels
- Improper flashing over windows
- Organic growth of roof
- Unattached post and beam frame
- Water damage in basement laboratory

Immediate – Minor Repair broken cornice return. Repair exterior wood trims and make watertight. Remove peeling paint and rust and repaint. Repair and repaint damaged interior doors. 	 Long Term – Minor/Maintenance Remove biological growth. Prevent animal infestation. Infill and repaint cracks in floors and ceilings.
 Immediate – Major Inspect and repair or replace EIFS system on south elevation's west wing. 	 Long Term – Major Restore the original main entrance. Evaluate post-and-beam structure for seismic capacity.

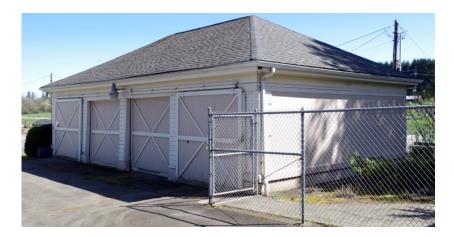
Garage (1926) Overall Recommendation: Preservation/Rehabilitation

- Cracking in structural tile on east elevation
- Cracking in structural tile under windows
- Organic growth of roof
- Crumbling mortar on window sills
- Broken wood window frame

Immediate – Minor Repair missing horizontal board siding. Repair broken window frames. Prepare surfaces and repaint peeling paint and rust. Repair and finish exterior walls structural cracking. 	 Long Term – Minor/Maintenance Remove biological growth. Monitor structural cracks. Infill and repaint cracks in floor. Removed abandoned electrical wiring.
Immediate – Major • N/A	 Long Term – Major Finish walls and ceilings. Insulate building. Install new electrical system. Install new mechanical equipment.

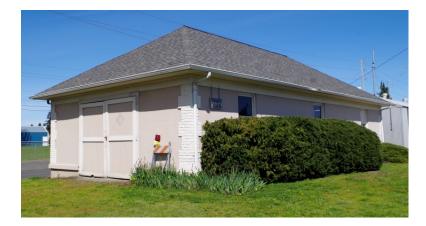
Milk House (c. 1936)

- Structural cracking at southeast corner
- Cracking in exterior stucco
- Exposed structural tile
- Organic growth on foundation
- Rotting wood on doors

Immediate – Minor	Long Term – Minor/Maintenance
 Replace rotting wood door panels. Repair and refinish structural cracking. 	 Remove biological growth. Repair damaged aluminum gutter Remove abandoned electrical wiring. Infill and repaint exterior cracks in stucco. Infill and repaint exposed structural block. Repair and repaint peeling paint. Infill and repaint cracks in floor and ceiling.
Immediate – Major	Long Term – Major
• N/A	Finish walls and ceilings.
	Insulate building.
	 Install new electrical system.
	 Install new mechanical equipment.

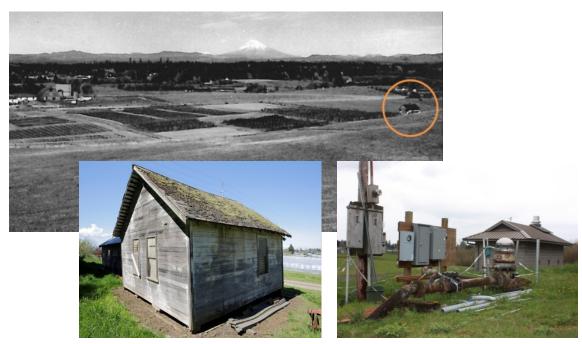
Bunk House (c. 1925/c.1955)

- Lacks permanent foundation
- Leaning exterior walls
- Collapsing roof
- Sagging floor boards
- Collapsing ceiling
- No accessible entry (no stairs)

Immediate – Minor	Long Term – Minor/Maintenance
 Secure entries to prevent unsafe access to building interior. 	 Interpret building's Poor Farm history.
Immediate – Major	Long Term – Major

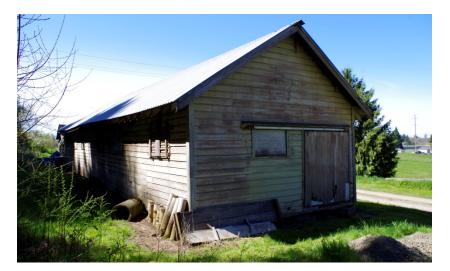
Hog Barn (c.1920/c.1955)

- Lacks permanent foundation
- Deficient foundation beams
- Sagging roof
- Rotting floor joists
- No accessible entry (no stairs)

Immediate – Minor Remove and repaint peeling paint. Replace missing windows. Replace rotting wood door. Repair rotting floor joists. Install formal entry. 	 Long Term – Minor/Maintenance Remove and repaint interior peeling paint. Remove abandoned electrical wiring.
Immediate – Major Replace foundation. Replace roof. 	Long Term – Major ● N/A

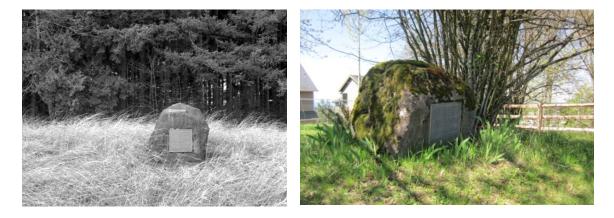
Cemetery (1913) Overall Recommendation: Preservation

- Commemorative boulder at northwest corner
- Missing burial makers
- Wood fence delineates cemetery boundary
- Chain link fence at west end
- Vegetation abuts north access

Immediate – Minor	Long Term – Minor/Maintenance
Install interpretive sign.	 Identify and locate individuals buried in cemetery. Improve north access to cemetery. Consider relocation of commemorative boulder.
Immediate – Major	Long Term – Major
• N/A	• N/A
