CLARK COUNTY  
STAFF REPORT

REQUEST: Accept and Approve the 2012 Annual Bridge Report.

# 2012 Annual Bridge Report

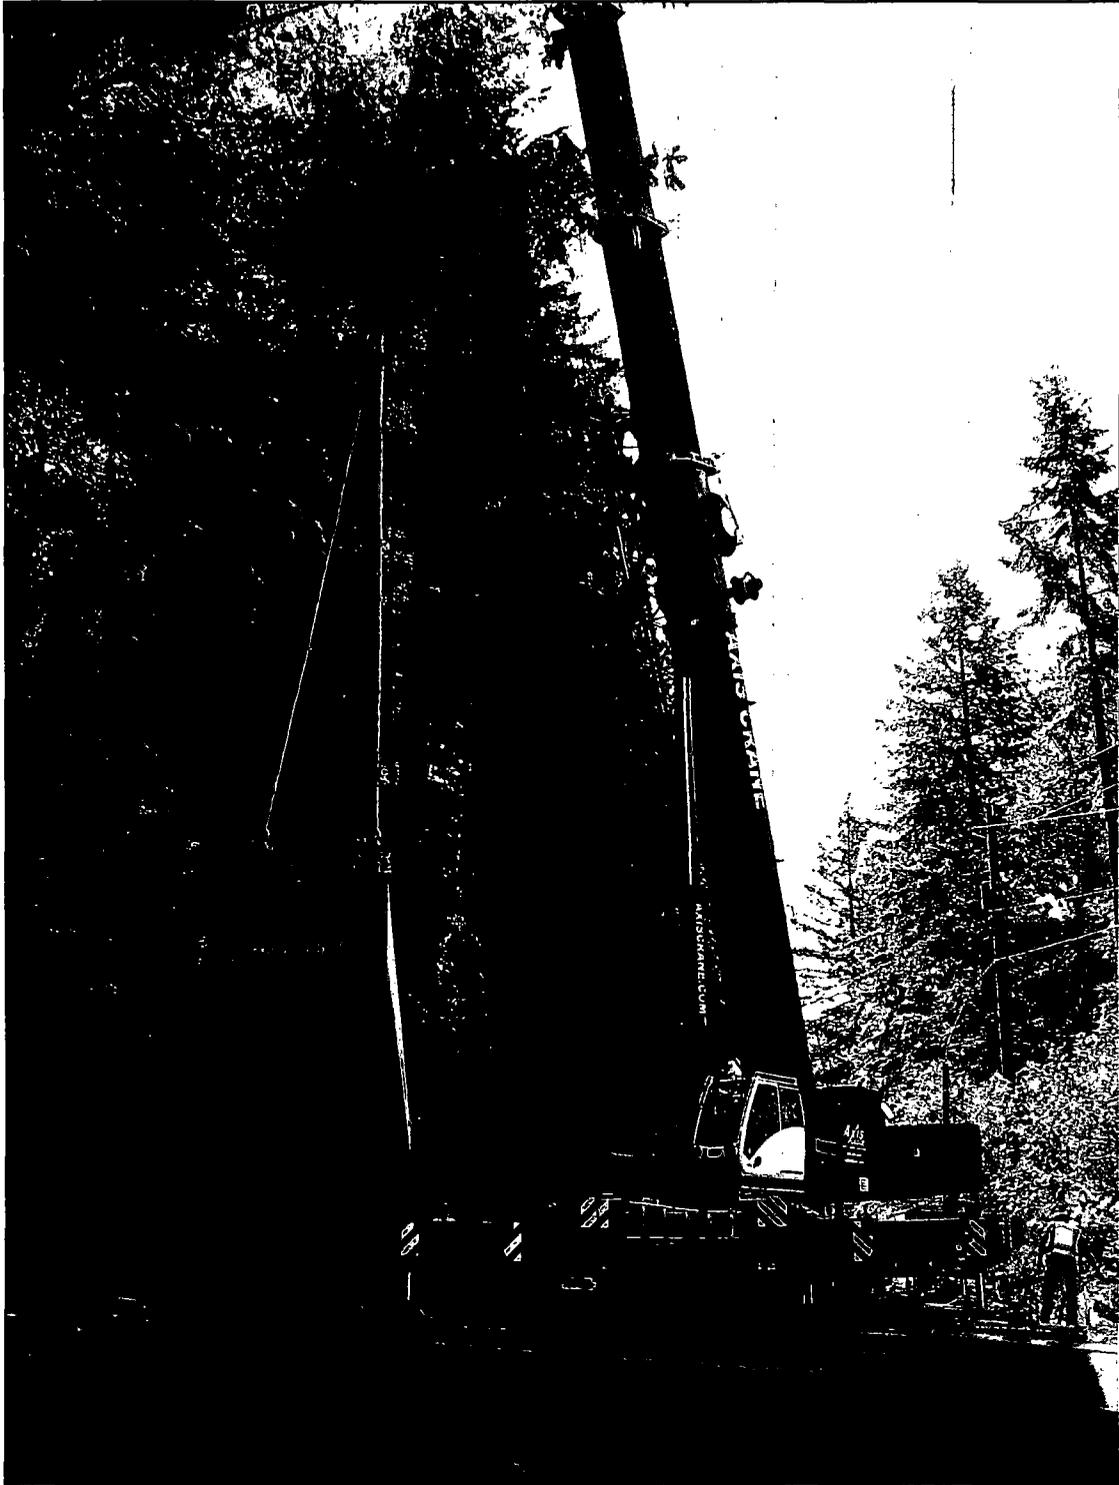
Cougar Creek Bridge #1409- Setting new girders 2012

Two bridge projects were completed in 2012, the Cougar Creek Bridge No. 1409 replacement and the Daybreak Bridge No. 273 – Seismic Retrofit. In addition, design and permitting work continued on the Cedar Creek Bridge No. 65 Bridge Replacement Project, the Dayton Bridge No. 75 Scour Repair Project and the Pleasant Valley Bridge No. 33 Scour Repair Project.

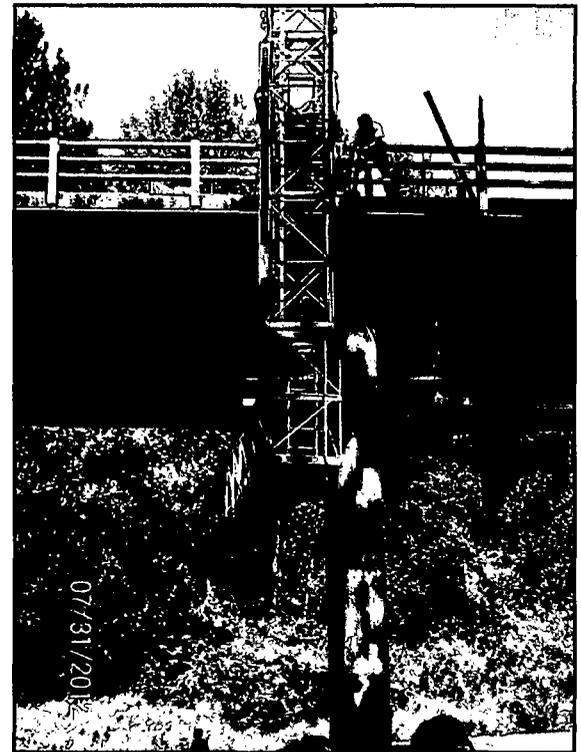
Daybreak Bridge # 273 - Inspection

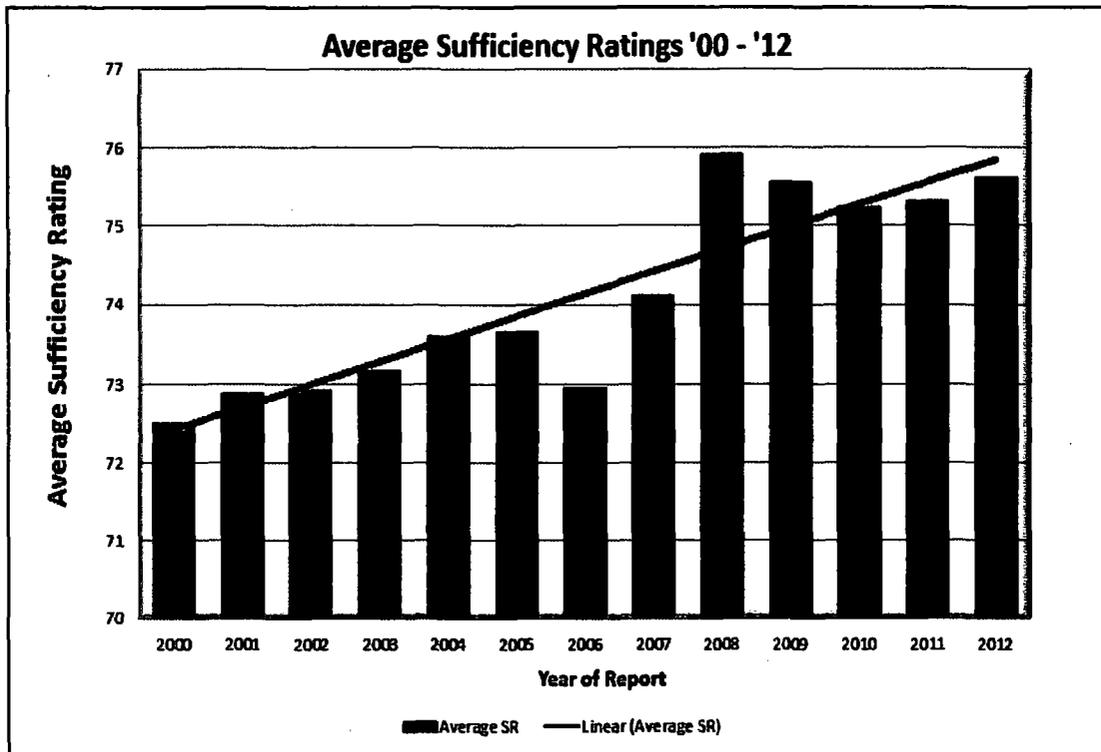
**Figure 2: Average annual Sufficiency Rating (SR) for bridges owned by Clark County with twelve year trend line.**

Overall, the SR for the county inventory of bridges shows a positive trendline with minor fluctuations from year to year. Due to the overall number of bridges in the inventory and the fact that the inventory continues to age, it is a significant accomplishment to maintain a positive trend in the SR. With only one new bridge anticipated in the six year plan, the upward trend will be adversely affected. Figure 2 illustrates the average annual SR over the last twelve years, while Figure 3 depicts the percentage of bridge inventory in four age ranges.

Generally speaking, bridges with a SR greater than 50 have a fair amount of useful life remaining. Bridges with a SR less than 50 require more attention and may need major repairs or complete replacement. The Bridge Replacement Advisory Committee (BRAC) are only screening bridges with a SR of 30 or less for replacement eligibility and a SR of 50 or less for rehabilitation eligibility. It is important to note that while the SR for the overall inventory is 75.65, there are a number of individual bridges with SR below 50. There is a direct correlation between the SR and the age of the bridge and we can expect the average SR rating to begin to decline if bridge maintenance and repairs needs are not addressed. In addition to using the SR as a measure of the condition of a bridge, the NBIS defines two types of deficient bridges – **structurally deficient (SD)** and **functionally obsolete (FO)**.
