Thomas Wetland Summer 2004 Temperatures Technical Report

Clark County Public Works
Water Resources Section

September 26, 2005

**Clean Water Program
Thomas Wetland
Project #400110**
Clark County Public Works - Water Resources
January 2005

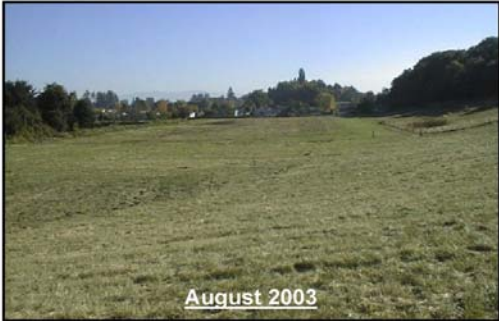
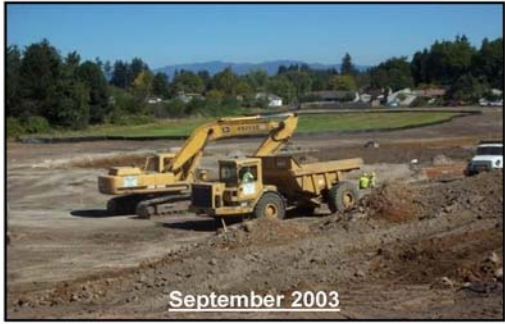
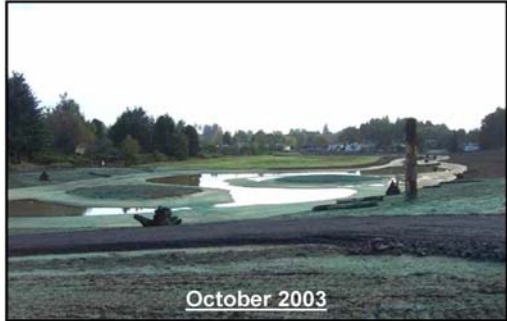
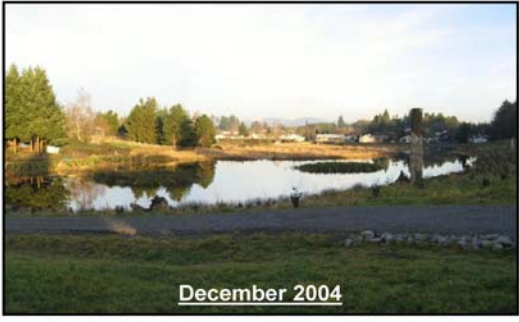
Figure 1 Thomas Wetland Construction and Plant Establishment.

Prior to construction.

During construction.

Shortly after construction and hydroseeding.

In operation. Plants getting established.

Site characteristics will change over time from those created by the relatively recent construction and enhancement activities (Figure 1). Substantial regrading of much of the site was one of the initial site mitigation activities in the fall of 2003 (Christian, 2003). Early wetland mitigation monitoring shows progress on: the establishment of an adequate hydrologic regime, survival of phased native species plantings, maturing canopy expansion, and weed control (Christian, 2004). However, as often is the case, the potential benefits from the Thomas Wetland mitigation are expected to change over time as the site matures; necessitating ongoing management and periodic monitoring.

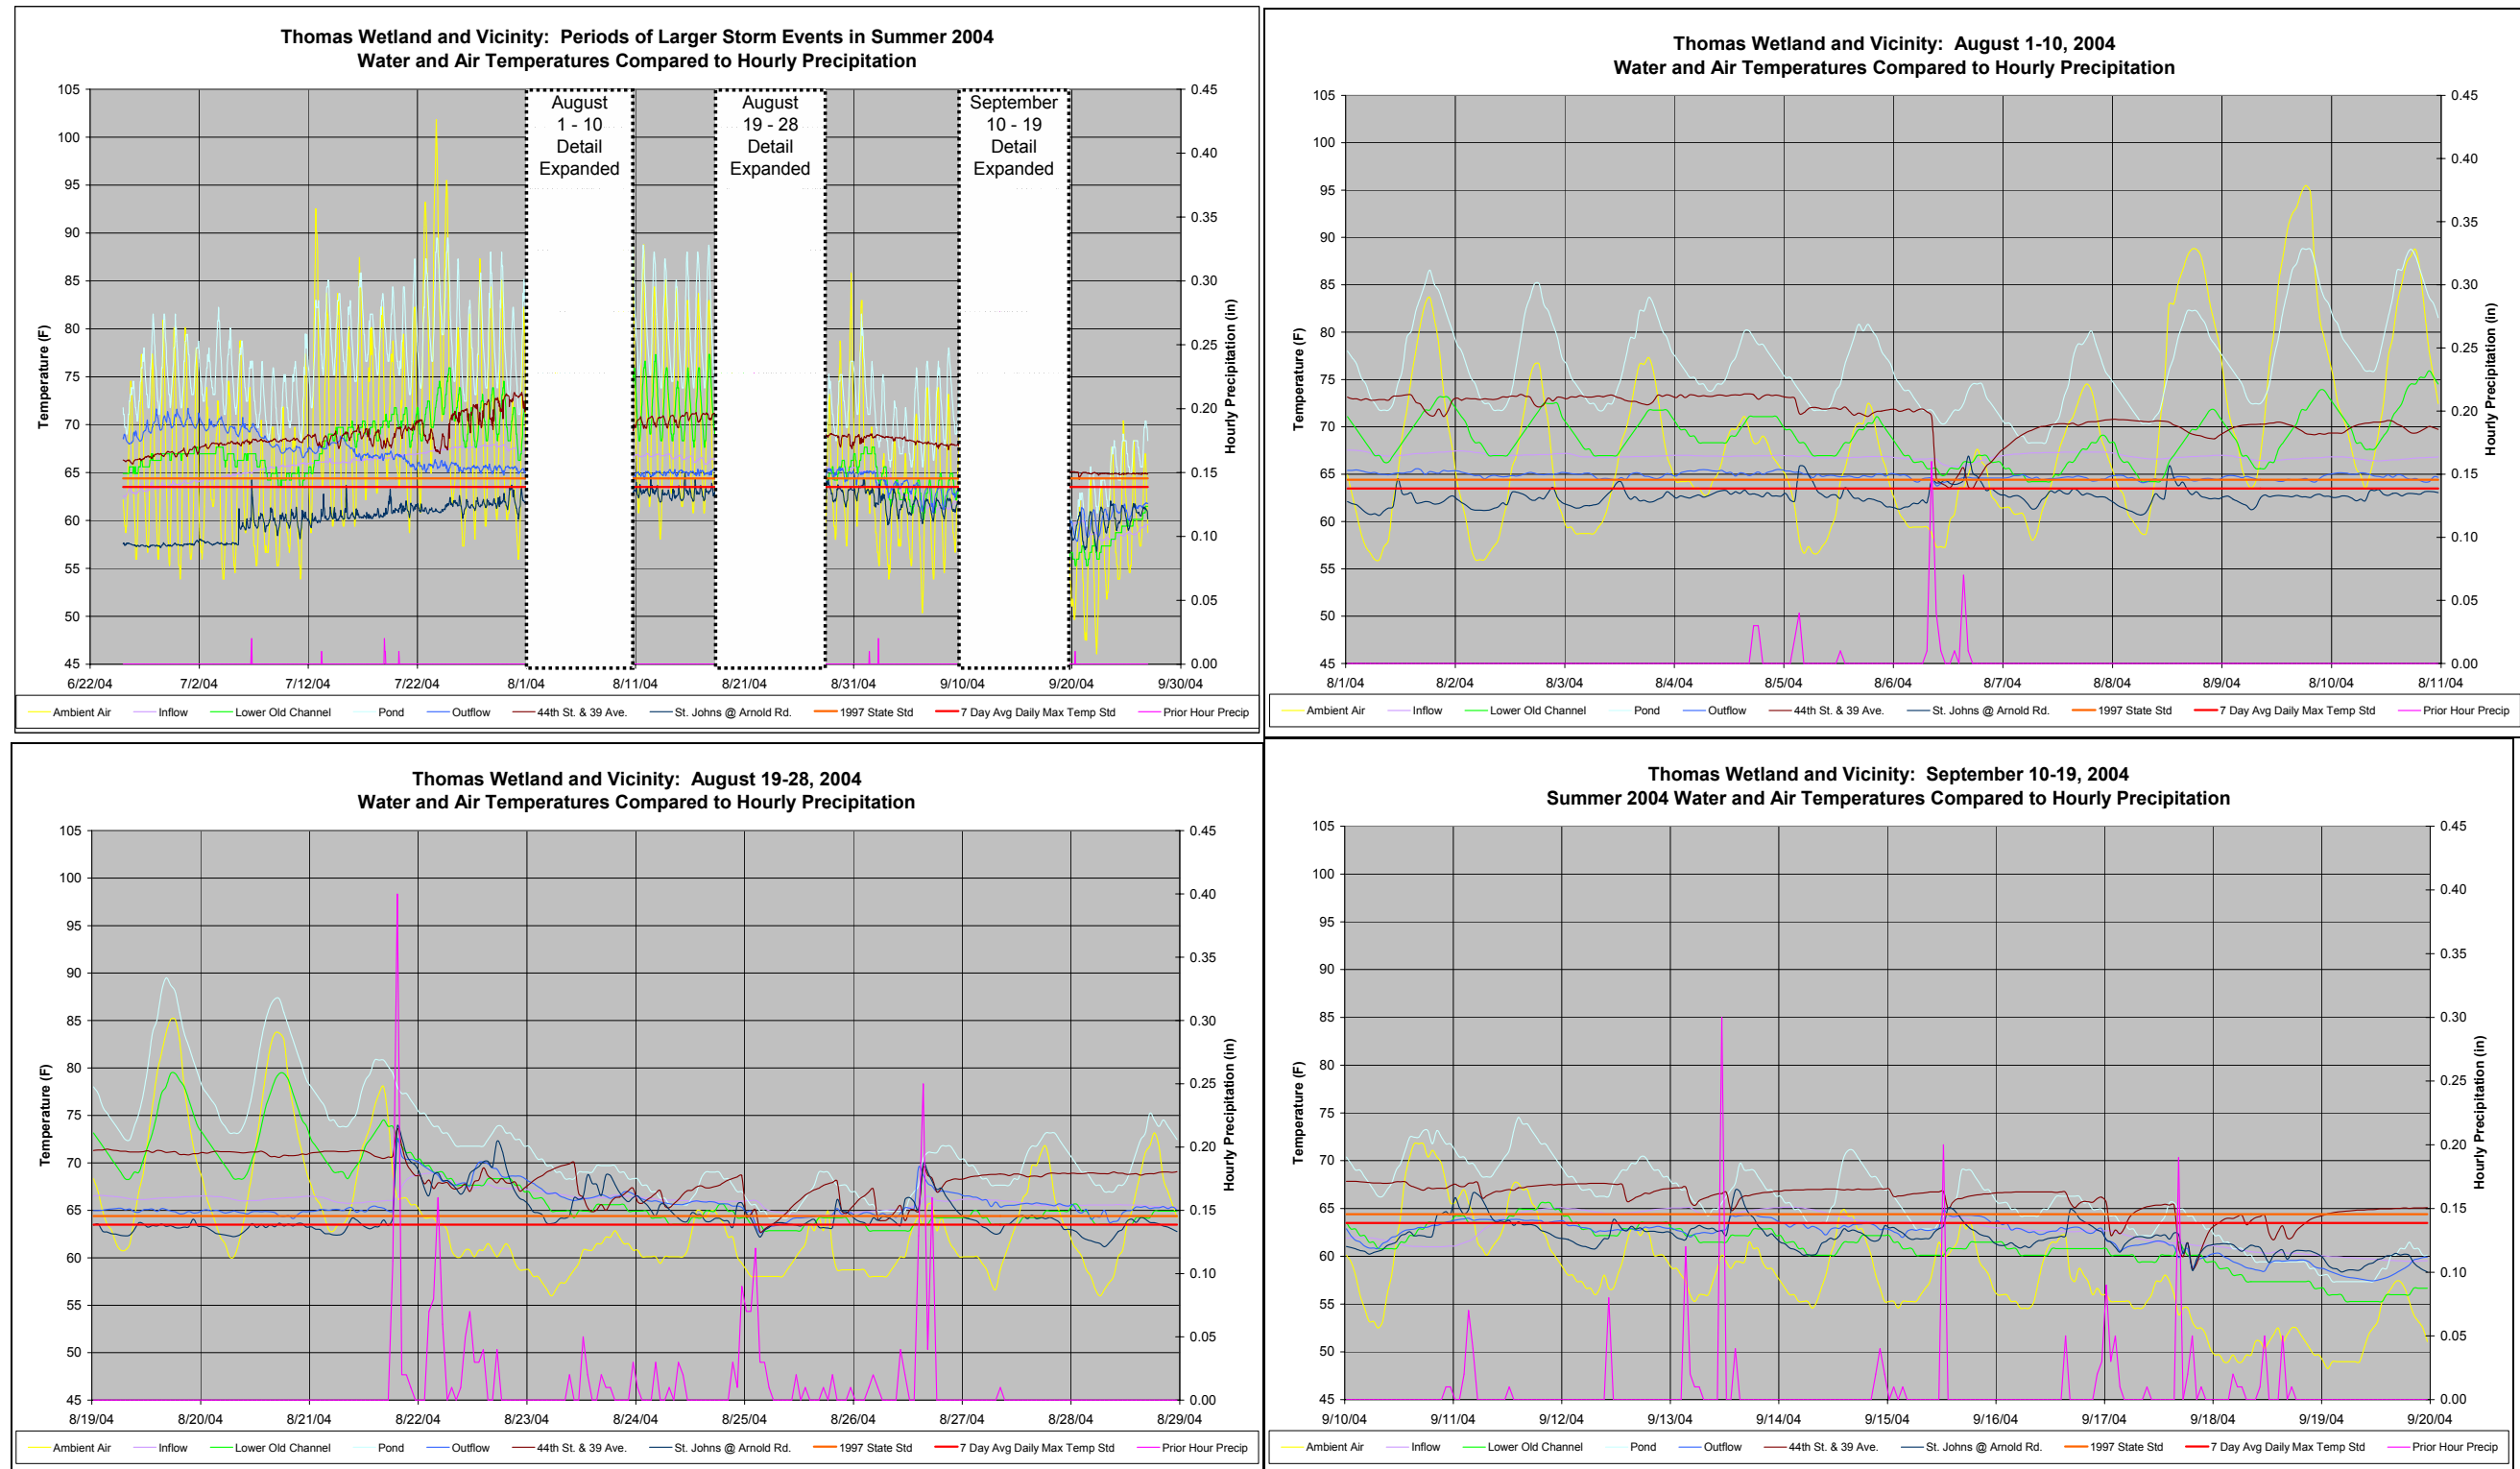
Figure 7 Larger Summer 2004 Rainfall Events for Thomas Wetland Temperature Time Series.

Event Periods Examined In Detail for Thomas Wetland Summer 2004 Temperature Time Series
